2nd RELINE OF ROGESA'S BLAST FURNACE NO. 5 IN DILLINGEN/SAAR, GERMANY¹

Abstract

In 2010 Rogesa executed a reline of its blast furnace No. 5 within a downtime period of 102 days. This report shows a very detailed description of the situation at ROGESA in Dillingen/Germany with regard to the operated blast furnaces and their performance during the different campaigns. The work which was carried out is shown thoroughly and the time schedule is explained. A major part in this report comprises the methodology of the erection of the new blast furnace shell. A specific topic amongst others is the installation of the new Paul Wurth BLT[®]GEN3 gear box to optimize the charging process and fuel consumption. Finally, the successful blow-in results are shown.

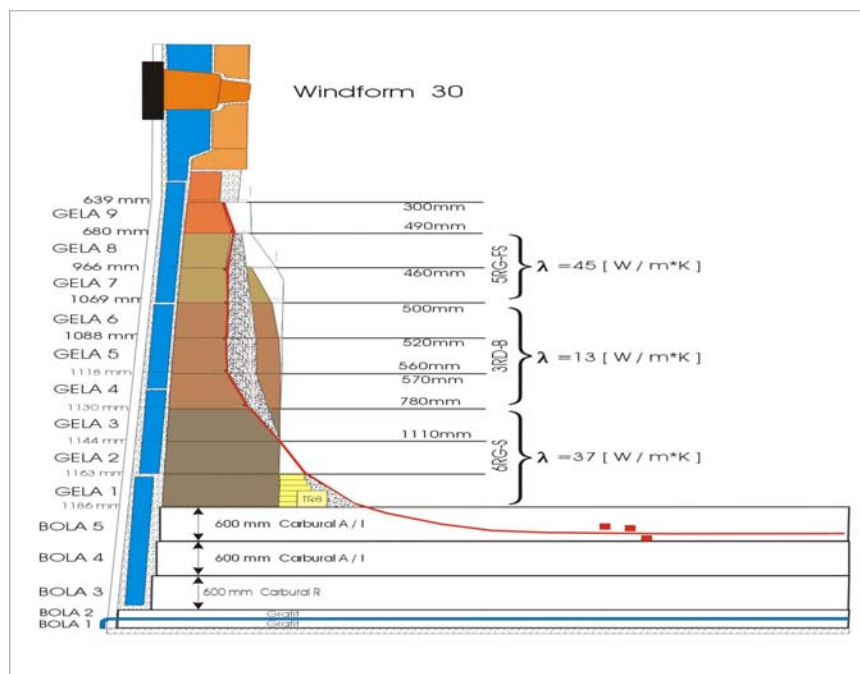
Figure 1. Hearth wall dissection and wear measurement at tuyère No. 30.

Figure 1 shows the use of different carbon block qualities at the interim reline. The different carbon block qualities showed specific results of the wear behavior like the formation of a brittle layer.

The reason was the non-availability of sufficient material at the emergency repair. Mainly in the rows GELA 4 to GELA 6 the plain carbon material „3 RD-B“ with low heat conductivity of 13 W/m K showed the formation of a brittle layer.

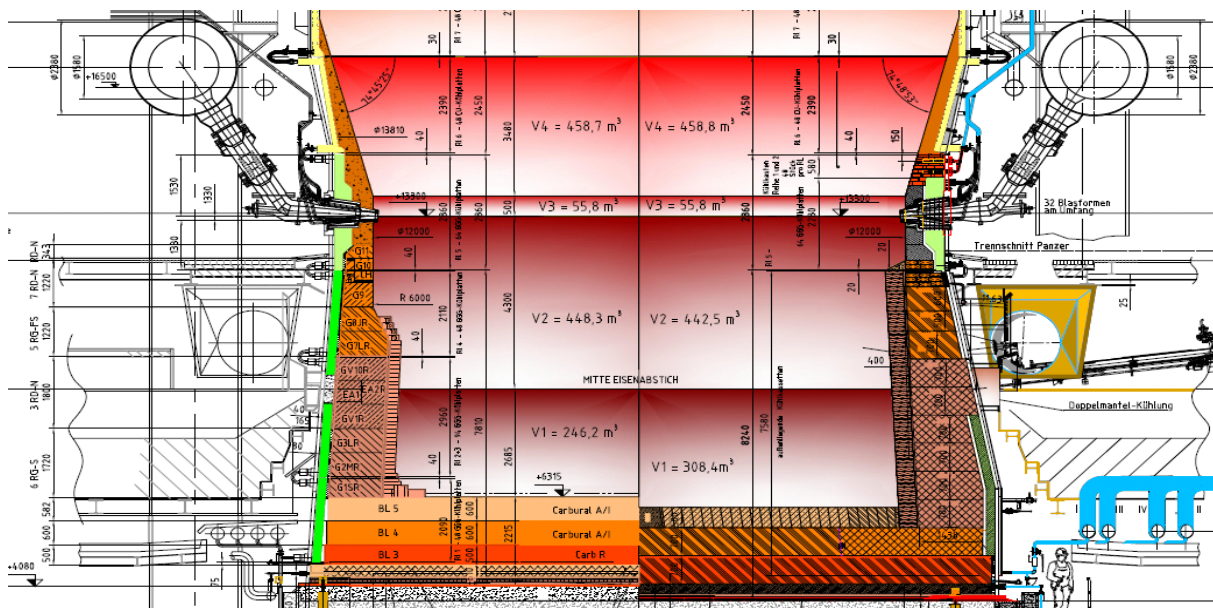
Figure 2. Old and new design of the hearth.

Figure 2 shows the comparison of the old (left) and new design (right). The shell of the new hearth was preassembled outside and ring wise installed after the demolition of the old bottom cooling and shell.

- The stave coolers inside the hearth shell were replaced by an outside channel cooling which is integrated into the stave water circuit,
- the slope angle of the shell was lowered in order to obtain a higher refractory thickness at the wall,
- the carbon block quality of the hearth wall was changed into a higher heat conductive super micro porous grade,
- the depth of the sump was increased and a low alumina upper bottom layer was built in, and
- a ceramic cup of nitride bonded high alumina refractory with a thickness of 400 mm was installed.

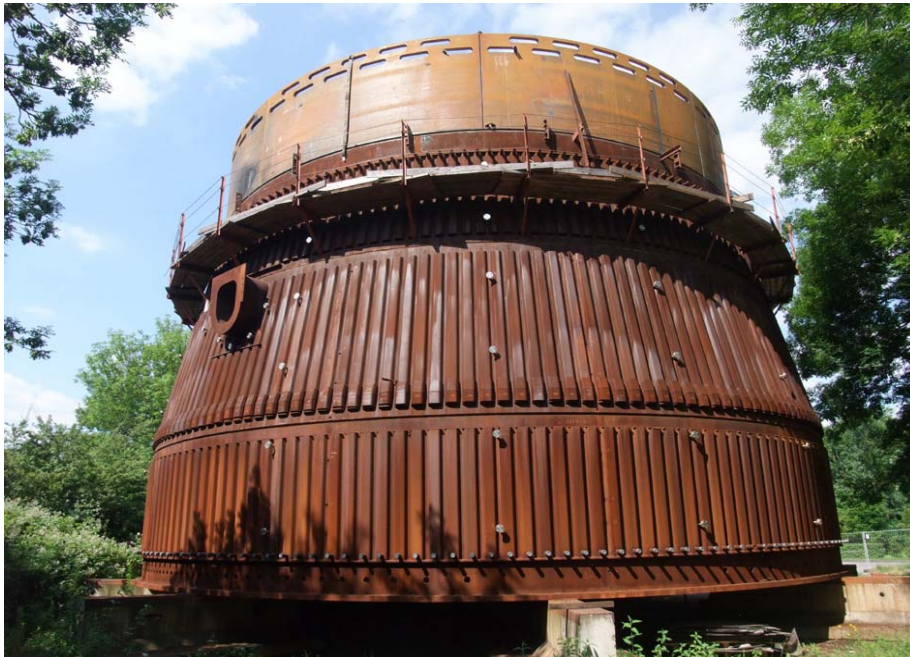
Figure 3. Preassembled shell of the hearth with the shell of the tuyère level thereupon.

Figure 3 shows the preassembled shell of the hearth with the shell of the tuyère level thereupon. The cutouts of the tuyères were made at site after installation.

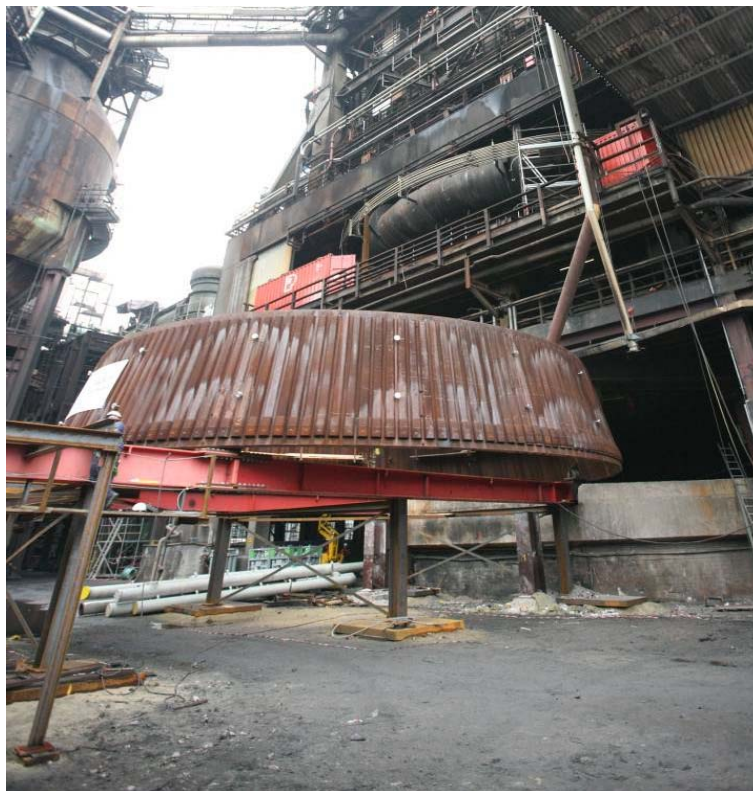
Figure 4. Displacement of a ring element of the hearth shell on the slide rail.

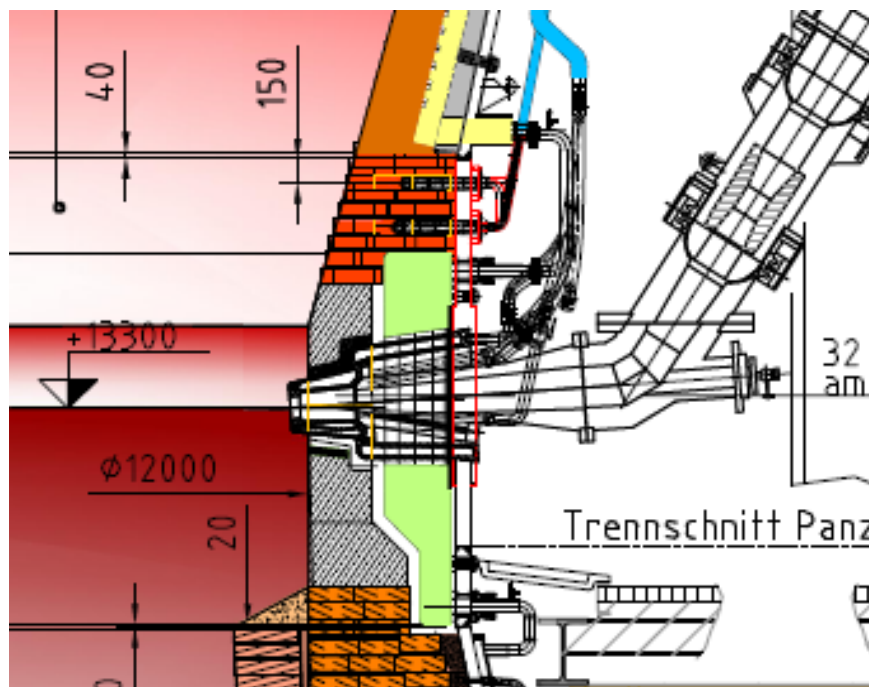
The „weak point“ of the cooling system of the furnace was at the tuyère level where also occurred a breakout in March 2010 which caused a three day stop for repair. In the future planning for the Rogesa blast furnaces, a high performance operation with also high levels of PCI is scheduled. These conditions consequently require a cooling system, which is capable to resist these higher heat loads. In order to improve the cooling capacity at that location and of the entire shell, the following improvements were implemented:

Figure 5. Cooling system at tuyère level and bosh.

- At the cast iron tuyère stave the upper part was replaced by two rows of copper cooling boxes between tuyère level and bosh (Figure 5),
- the copper staves of the belly and the two rows of the lower shaft were removed, overhauled and reassembled because of their good condition,
- one more row of copper staves was mounted at the mid shaft,
- four rows of cast iron stave from mid to upper shaft were renewed,
- two more rows of cast iron staves were mounted in the upper shaft up to the throat armor.

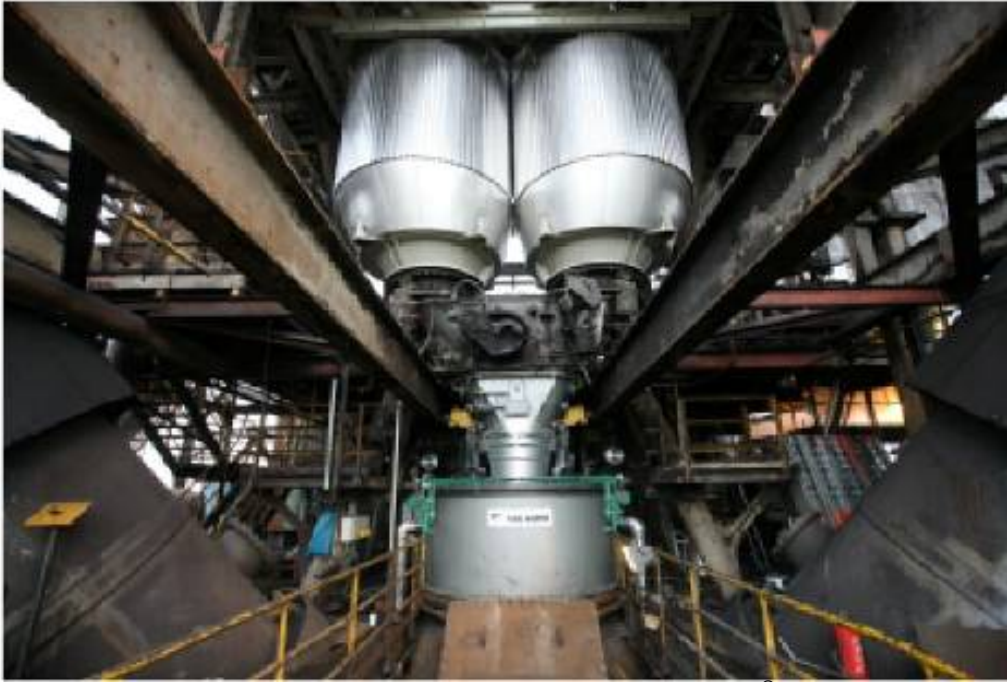
Figure 7. Shows the new hoppers and the Paul Wurth BLT[®]GEN3 gearbox

The burdening system was thoroughly renewed because the existing installation was in service since 1985 and was damaged by corrosion. The hoppers of the bell less top were replaced and enlarged to a capacity of 53 m³ (85 t burden material and 25 t for coke).

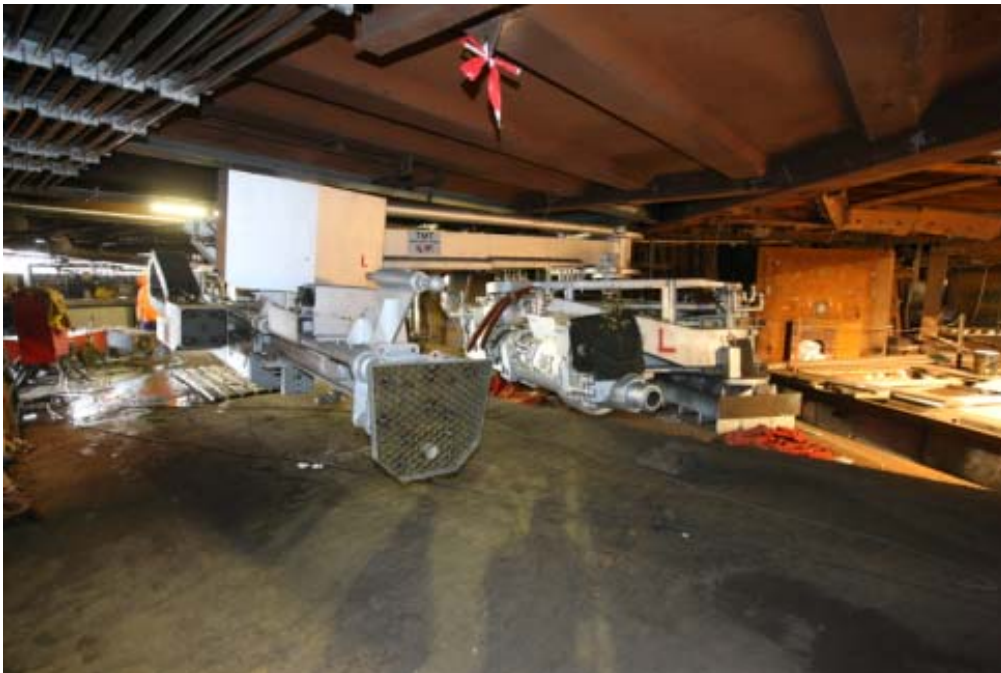
At the casthouse, the old machines were in service since 1985. The clay gun and the taphole drilling machine had to be dislocated because of the new geometry of the hearth shell, and they were replaced by new machines, the drill is now equipped with a fully hydraulic driven hammer. The existing dedusting system was overhauled (Figure 8).

Figure 8. Cast house machines.
