# APERAM (ACESITA) BLAST FURNACE NO. 2 – DESIGN AND PERFORMANCE OF THE BLAST FURNACE COOLING AND LINING SYSTEM<sup>1</sup>

The objective is to discuss the performance of the blast furnace after a repair performed in 2005 of the Upper hearth layer, Tuyere zone, Bosh and Belly. In May 2012 the furnace reached the seven year target of the repair for the Belly of the furnace. The article will cover the following items: design of the repair; start up and ramping up the production; casting practices; way of operating, using both coke and charcoal as fuel; devices and system for measuring the lining thickness over time; the continuation of the furnace campaign, campaign lifetime, the future.

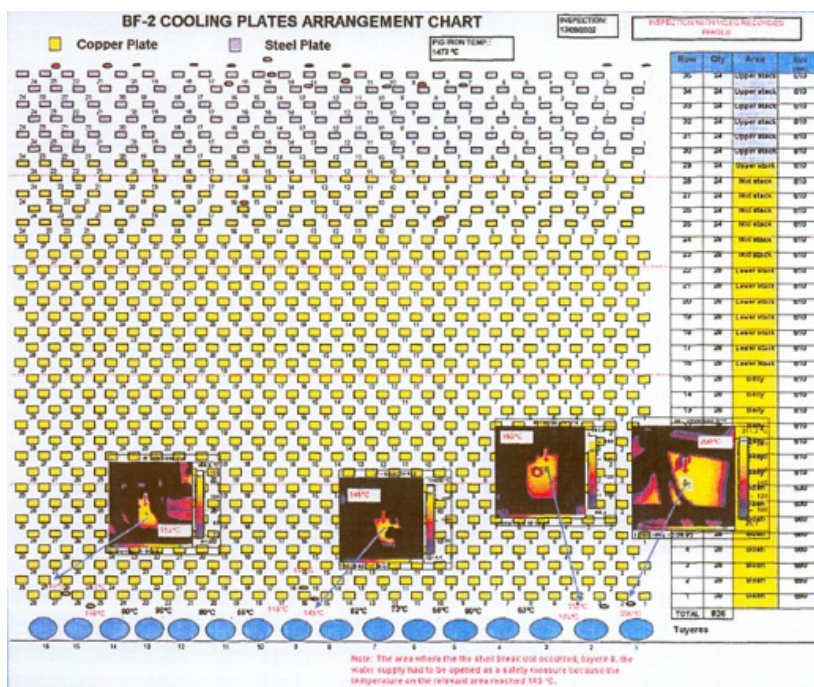
Figure 1. Locations of hot spots in 2002.

Problems in the bosh occurred in the fifth campaign of this blast furnace only two months after blow-in in 2002. High heat loads and hot spots were observed in the bosh and belly area followed by a breakout 6 months after start-up as (hot spots are indicated in Figure 1).

In the first months of the campaign hot spots were observed and grouting was initiated based on advise of the designer. Also an external spray system was installed. Two plate coolers in the bosh leaked and were isolated from the water system. At the end of the month of August a break out occurred in between plate cooler rows 2 and 3. In October again two plate coolers were found leaking, cooling water entering the furnace forced it to be stopped. The furnace was grouted at the tuyere zone and lower bosh where quite some refractory was found to be missing detected by drilling into the furnace tuyere zone and lower bosh.

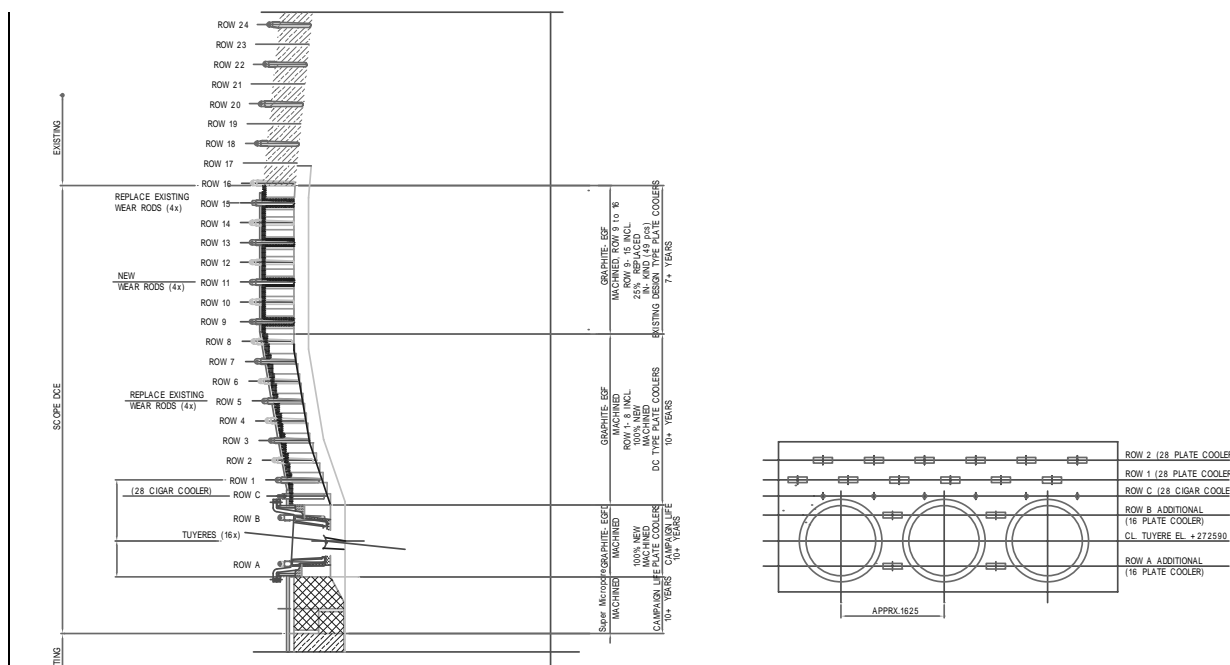
Figure 2. Drawing of the proposed design for repair.

The Bosh was designed as per the full Hoogovens design, the so-called Hoogovens Intregated lining and cooling system.  
 See the drawing below for the scope of work according to the General arrangement drawing that was part of the proposal and the contract.

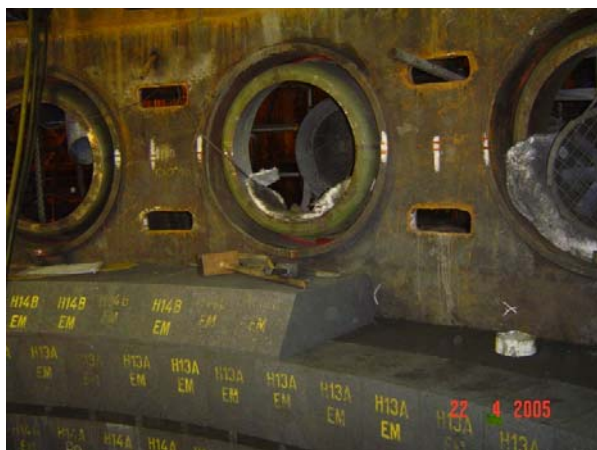
**Figure 5.**

Shell repairs, 3 days. Installation of Upper layer of hearth wall, 2 days (Figure 5).

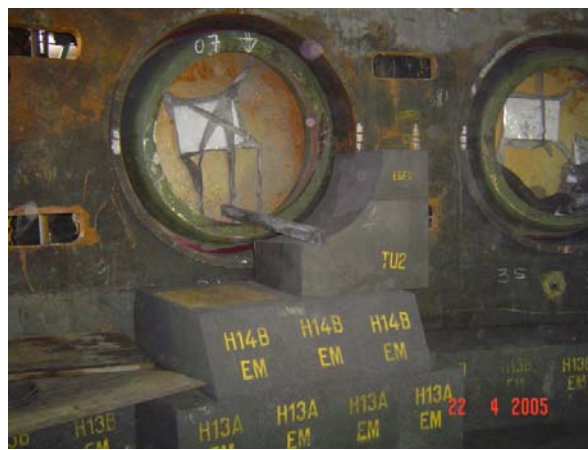
**Figure 6.**

Building the tuyere zone, 2 days (Figure 6).

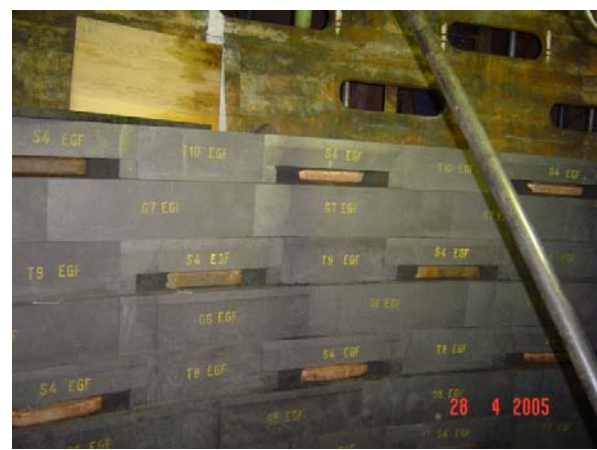
**Figure 7.**

Bosh construction, 5 days (Figure 7).  
 Belly installation, 4 days (Figure 8).

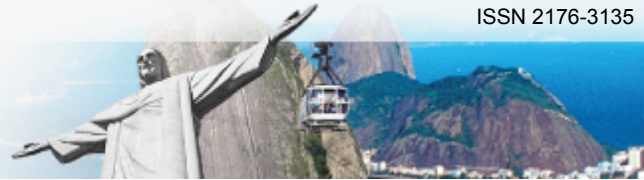
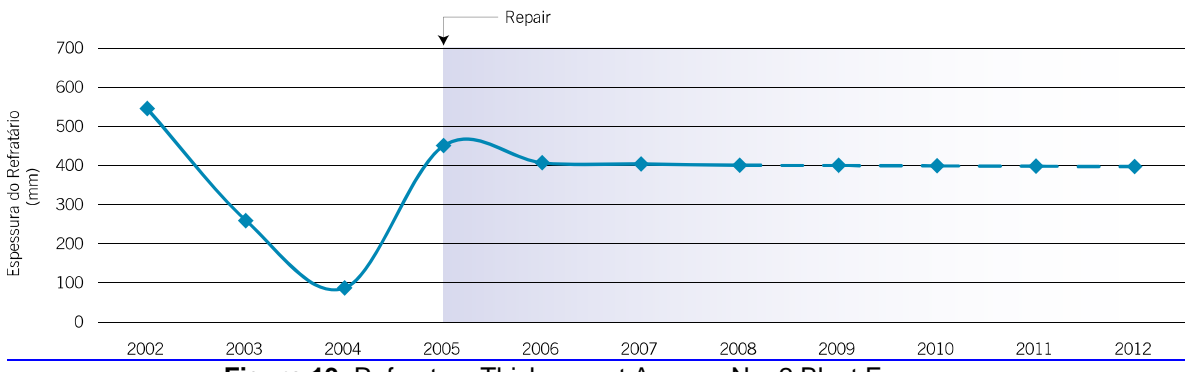
**Figure 13.** Refractory Thickness at Aperam No. 2 Blast Furnace.

Since the furnace was blown in, seven years have passed, the time the Belly's campaign life should last per client's request. The furnace lining and cooling is in very good condition the furnace will continue its normal operation.

The wear in time of the lining in Figure 13.
