DIAGNOSTIC STUDY AND CAMPAIGN LIFE EXTENTION OF COMPANHIA SIDERÚRGICA NACIONAL (CSN) # 2 BLAST FURNACE HOT BLAST STOVES¹

Sidiney Nascimento Silva²
Oscar Rosa Marques³
Giancarlo Sterhling Barbosa⁴
Fernando Vernilli Junior⁵
Elsion Longo⁶

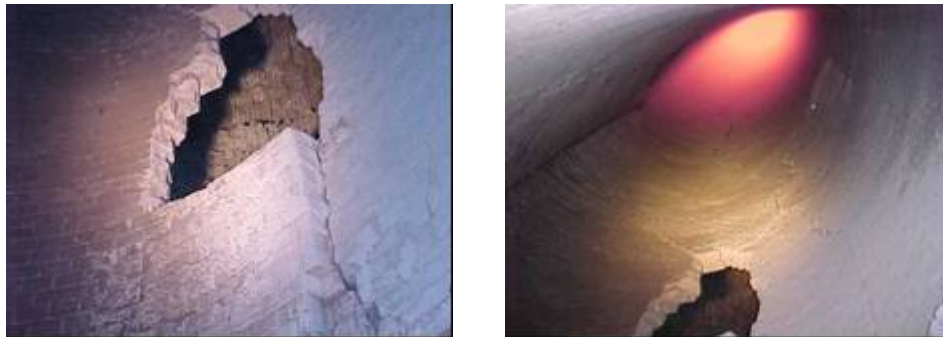
Back in 2002, upon 21 years' service, there was an accident at # 3 Hot Blast Stove following the collapse of Checker Chamber refractory lining at about 6m from bottom, causing dividing wall to break open and checker brick to cave in at Combustion Chamber bottom (Fig. 1). The diagnostic study was not able to predict it, which forcibly led to the end of the campaign and an emergency repair. As a result of this incident, it became quite clear the need for additional inspections for a more accurate and comprehensive assessment of the Hot Blast Stoves. While the brickwork was being torn down for the aforesaid general overhaul, checker bricks were sampled for a post mortem study, in order to determine the likely cause of the incident. A new technique was developed to sample, inspect and gauge Checker Chamber lining soundness, which was used later on to assess # 1 and 2 Hot Blast Stoves. According to the failure mechanism suggested, some changes were introduced to lining design over the course of the general overhaul.

Figure 1 – Dividing Wall Breaking Open and Checker Bricks Caving In at Combustion Chamber Bottom of Hot Blast Stove # 3, 2002.

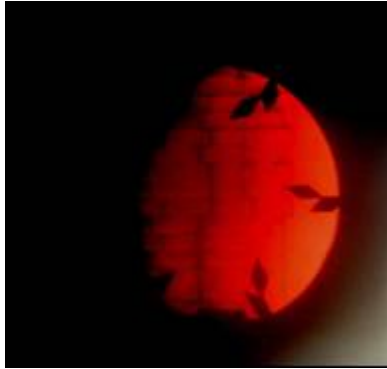
An inspection was carried out in the dividing wall on Combustion Chamber side, in the flame impact area – a critical point, through a peephole located at metal burner piping. Figure 2 shows the crack aspect found at Hot Blast Stoves # 1, 2 and 3 dividing wall. The lining design was developed back in the late 70's. The dividing wall consists of only two courses of dense refractory bricks, and there is no insulating material in-between. As a result, there exists a rather high temperature gradient between Combustion Chamber and Checker Chamber, during combustion and blast cycles, which accounts for nucleation and propagation of this kind of crack.^[1]

Figure 2 – Aspect of Dividing Wall Cracks in # 1, 2 and 3 Hot Blast Stoves Combustion Chamber

The dividing wall is inspected regularly and repaired by using ceramic welding, if need be, during maintenance shutdowns.

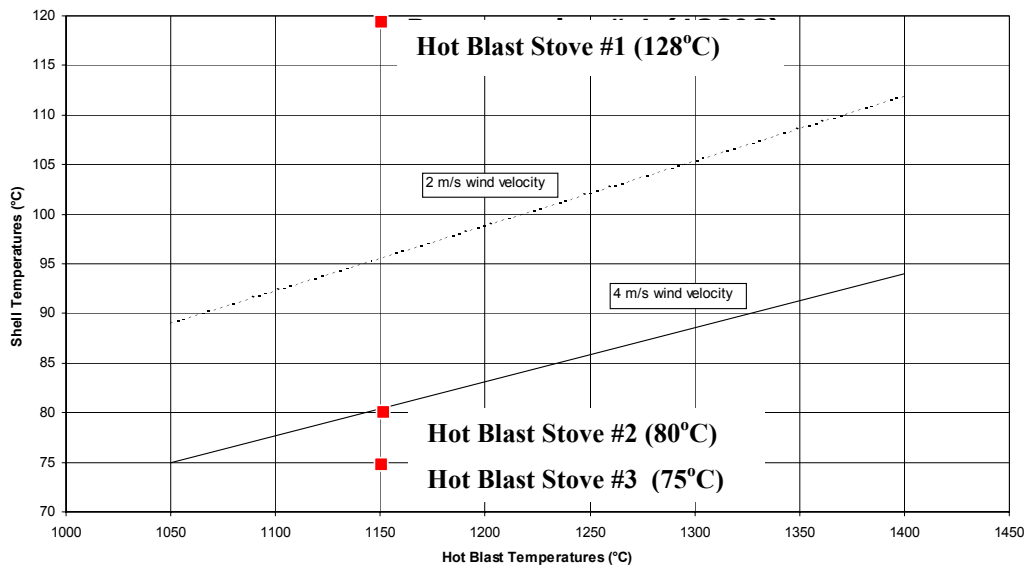
Figure 3 shows the maximum temperature at the shell recorded during a thermographic check in the Hot Blast Stoves. As per design,^[2] for a 1.150°C blast temperature, the theoretical temperature of Hot Blast Stove shell should range from 80°C to 95°C, depending upon wind speed – 4m/s and 2m/s, respectively.

Figure 3 – Maximum Temperature at the Shell recorded During a Thermographic Check and a Mathematical Model of Heat Transfer.^[2]

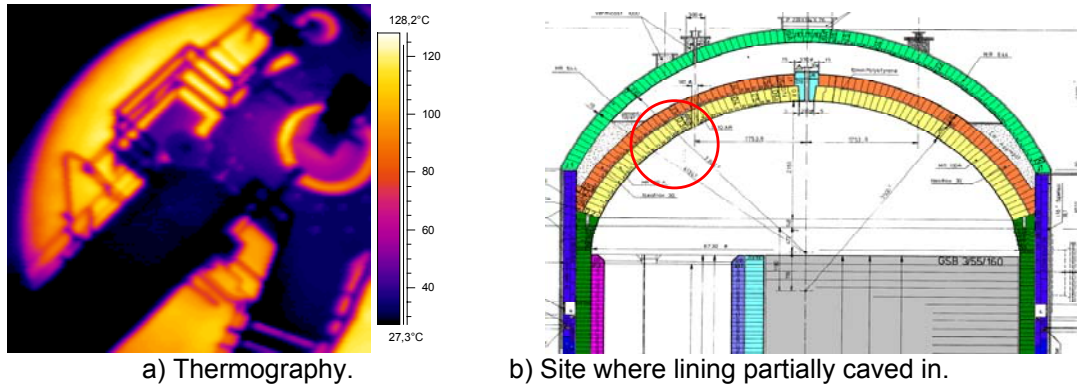
Figure 4 shows the thermography of Hot Blast Stove # 1 dome, where a maximum temperature of 128°C was recorded, higher than the upper limit value allowed in design which is 95°C. This high temperature was ascribed to lining partial fall-down toward Combustion Chamber – 1st and 2nd ring belonging to the roof.

a) Thermography. b) Site where lining partially caved in.
Figure 4 – Thermography of Hot Blast Stove # 1 Dome.

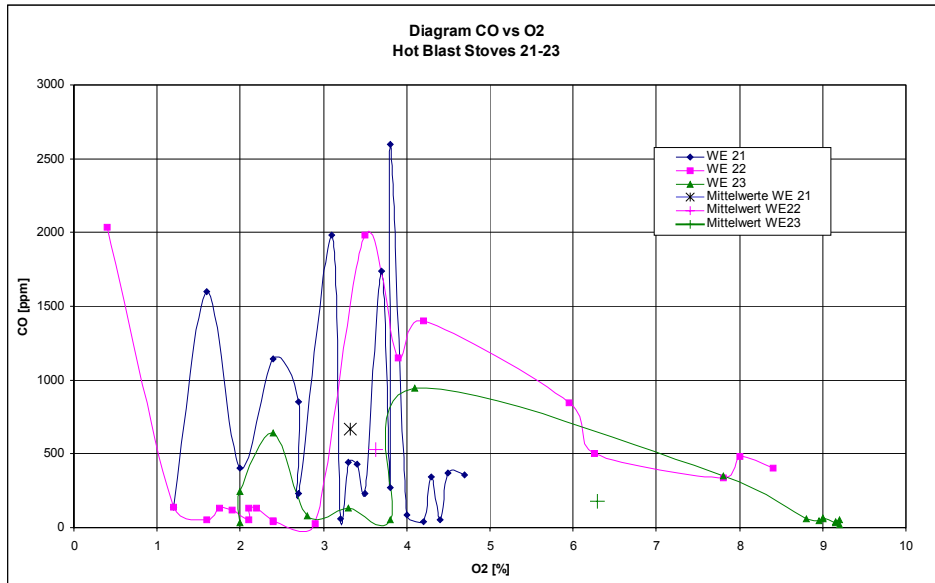
Figure 5 shows Hot Blast Stove fumes chemical analysis. CO values above 700ppm were found in all Hot Blast Stoves, even for high O₂ values above 3%. This problem is most likely ascribed to dividing wall cracks (Figure 2), something which leads to contact between Combustion Chamber and Checker Chamber. This allows unburned combustion gas straight into Checker Chamber, which impairs combustion efficiency, and ultimately Hot Blast Stove performance. Moreover, a fairly high fluctuation was found in combustion gas flow and in air/combustion gas ratio.

Figure 5 – Chemical Analysis of Hot Blast Stove Fumes.

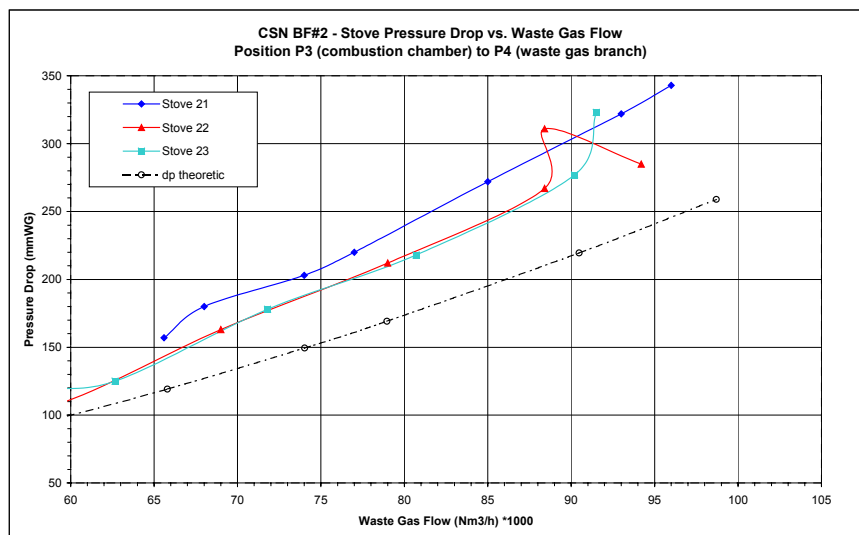
Figure 6 illustrates the pressure drops in air blast - theoretical (design) and actual (measured) between Combustion Chamber entry side and Checker Chamber delivery side for different fume flows. The values measured were above those theoretical ones for all Hot Blast Stoves, notably in Hot Blast Stove #1, thereby corroborating the assumption of checker channel clogging. This clogging might have been caused by the collapse of dome bricks upon checker and/or corrosion of checker upper layer channels by suspended solids found in combustion gas. Studies conducted by CSN / UFSCar[3] substantiated the silica reaction (SiO_2) of checker brick matrix with iron oxide fine particles (FeO) found in BF gas, leading to the formation of faialita ($\text{FeO} \cdot 2\text{SiO}_2$), a phase involving low melting point. Liquid phase formation favors checker channel clogging.

Figure 6 – Pressure Drop in Air Blast – Theoretical and Actual between Hot Stove Combustion Chamber Entry Side and Checker Chamber Delivery Side

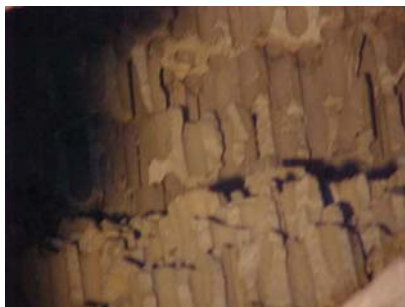
The checker bricks which fell down from Hot Blast Stove # 3 Combustion Chamber (accident) were thoroughly destroyed and with a number of fine, branch-shaped cracks, suggesting thermal shock, Figure 7.

a) Accident area.

Figure 7 – Aspect of Hot Blast Stove # 3 checker brick.

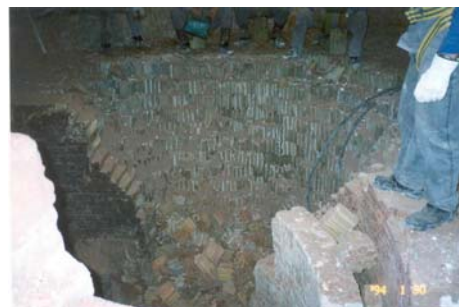
b) Remaining checker bricks.

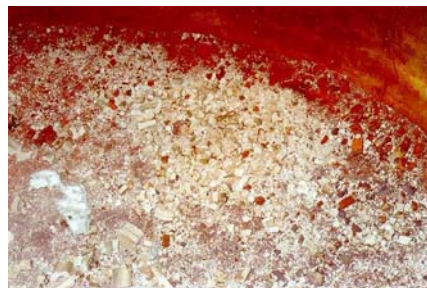
c) Checker bricks collapsed from Combustion Chamber.

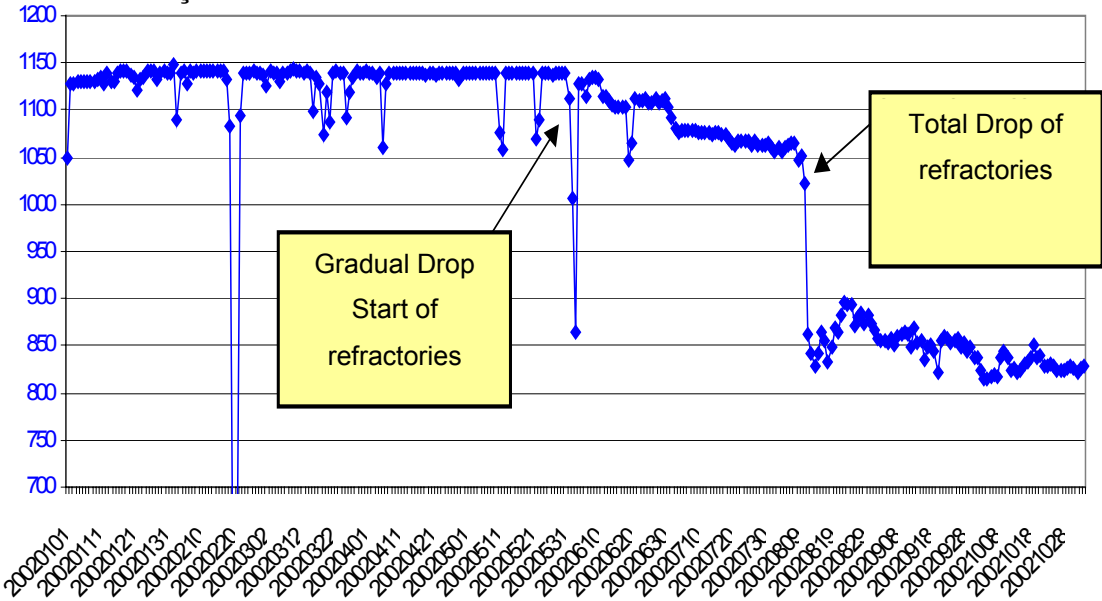
As mentioned earlier, the diagnostic study was not able to predict lining degradation of Hot Blast Stove # 3 Checker Chamber. Nonetheless, the gradual drop in blast temperature, Figure 8, clearly signaled some kind of abnormality with the equipment. In view of this fact, checker bricks of Hot Blast Stoves # 1 and 2 were sampled by using an unheard-of procedure at the same elevation as that of Hot Blast Stove # 3 accident, aimed at a more comprehensive assessment. Figure 10 shows retained mechanical strength of sampled checker bricks belonging to Hot Blast Stoves # 1, 2 and 3. The retained mechanical strength is the percentage relationship between fresh, unused brick compression resistance and that of sampled bricks after a lengthy operating campaign.

Figure 8 – BF # 2 Blast Temperature (Period: Jan. through Oct./2002).

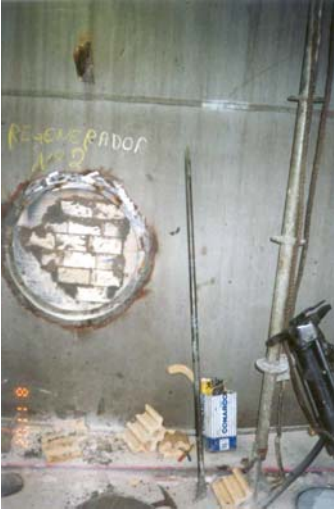
a) Opening Shell and Sampling

Figure 9 – Sampling Checker Bricks of Hot Blast Stoves # 1 and 2.

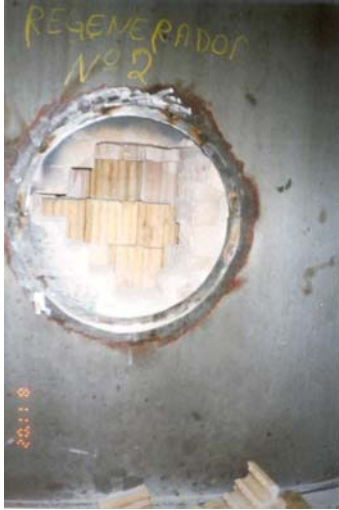
b) Laying Fresh Bricks and Checker Bricks Rebuilding lining.

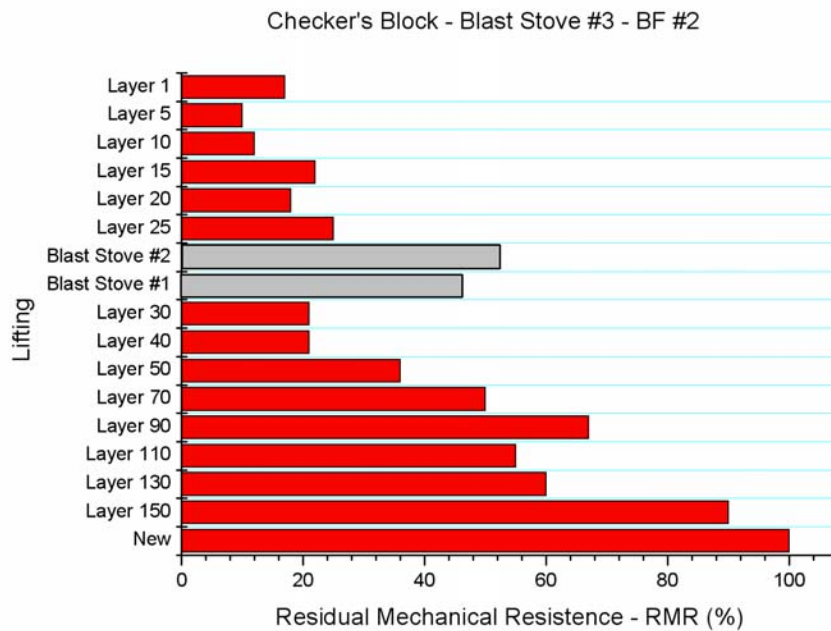
Figure 10 – Retained Mechanical Strength of Hot Blast Stoves # 1, 2 and 3 Checker Bricks.

At layer 30 of Hot Blast Stove # 3, where the failure took place, the retained mechanical strength was barely 21%, while for Hot Blast Stoves # 1 and 2 such values stood at 46% and 52%, respectively, suggesting that Checker Chamber lining was in fairly good condition.

Interestingly enough, the retained mechanical strength of bricks becomes lower and lower as one looks from top to bottom of checker. This degradation is caused by thermal shocks arising out of a whole myriad of blast and combustion cycles throughout equipment campaign. Cold air comes into Checker Chamber bottom and is heated up with the lining stored heat, as it moves upward toward top. Hence, the temperature gradient between air blast and checker bricks, which accounts for nucleation and crack propagation, becomes lower and lower from bottom to top. This explains the somewhat reduced retained mechanical strength values found in the lower layers of checker bricks, Figure 10.

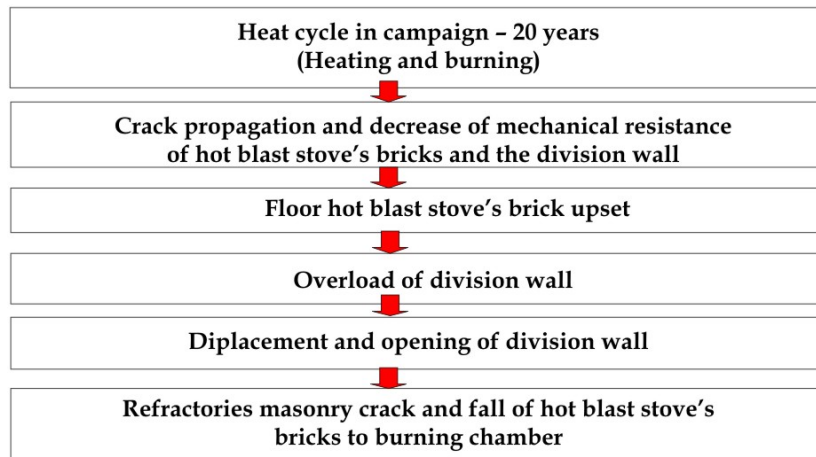
Based upon such results, the following failure mechanism for Hot Blast Stove # 3 is suggested (Figure 11):

Figure 11 – Suggested Failure Mechanism for Hot Blast Stove # 3.
