HIGH QUALITY PRODUCTION OF NIOBIUM MICROALLOYED STEELS¹

*Steven George Jansto²
Douglas Glenn Stalheim³*

Key words: Casting; Defect identification; Hot rolling; Root-cause analysis.

¹ *Technical contribution to the 44th Steelmaking Seminar, May, 26th-29th, 2013, Araxá, MG, Brazil.*

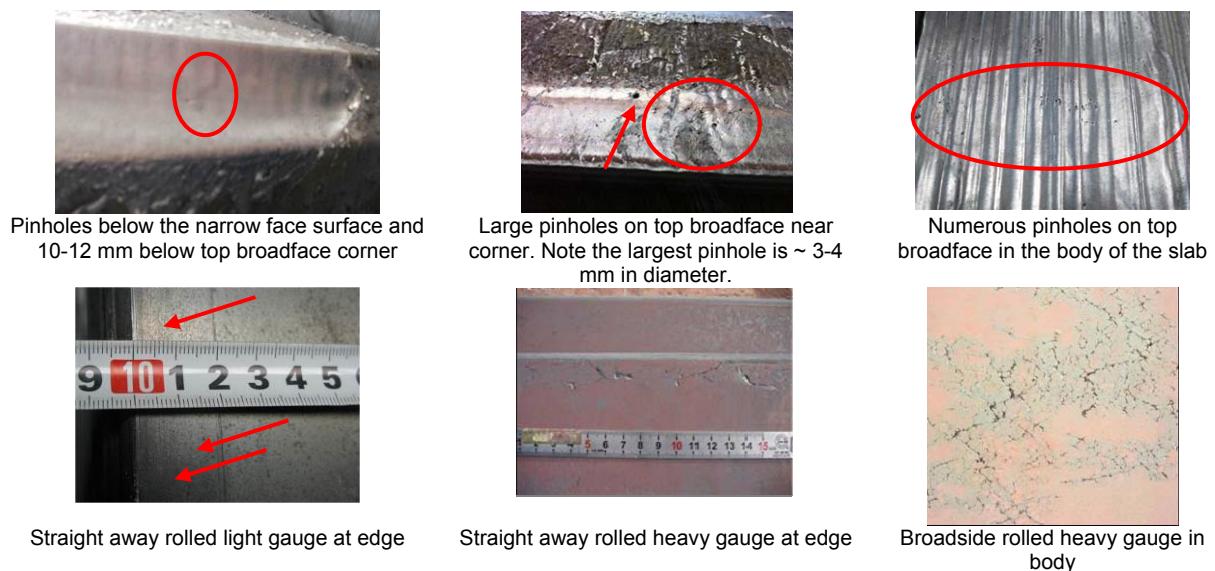
The most common slab/billet defects most casters encounter and often overlooked are surface pinholes/porosity. Depending on the rolling sequence (straight away vs. broadside rolling) for producing the product width, the diameter of the pinhole/porosity along with the final product thickness or diameter (for bar) will determine final geometry or features. Examples of slab pinhole/porosity exposed by scarving and resultant plate/coil defects are illustrated in Figure 1.

Figure 1. Example of slab pinhole/porosity defects by rolling logic and gauge.

The critical success factor here is to lower the total gas content in the liquid steel to minimize formation of pinholes/porosity. Operational metallurgy adopting the Niobium- Low Carbon Low Alloy (Nb-LCLA) approach to minimize this defect by moving to lower carbon contents is currently being successfully utilized. It is not expected that every pinhole/porosity will be eliminated, but the goal is to minimize the size and frequency to create the desired finished surface quality of the slab, plate and coil.

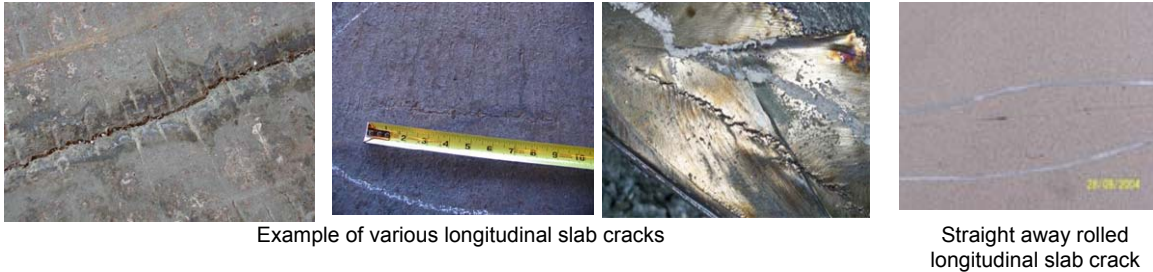
transverse cracking with good steelmaking practices. Longitudinal cracks can be shallow or deep and are typically in the body of the slab, but can be near the edges in some situations. They are located on either top or bottom (Figure 2). Longitudinal cracks can sometimes be seen as dark lines on the as-cast slab surface as the slab exits the caster.

Figure 2. Example of longitudinal slab cracking.

The majority of the longitudinal cracks will roll out appearing as a long seam-like defect, especially if straight away rolling is employed (Figure 2). If broadsiding is used then the longitudinal crack will exhibit some width, but will still have similar features to that of a slab rolled straight away.

Proper control of one or several of the key parameters listed above results in the desired result of minimization or total elimination of longitudinal cracking issues. Current operational metallurgy is adopting the Niobium- Low Carbon Low Alloy (Nb-LCLA) approach to eliminate this defect utilizing lower carbon contents and moving out of the peritectic carbon (0.09%-0.15%) casting region.

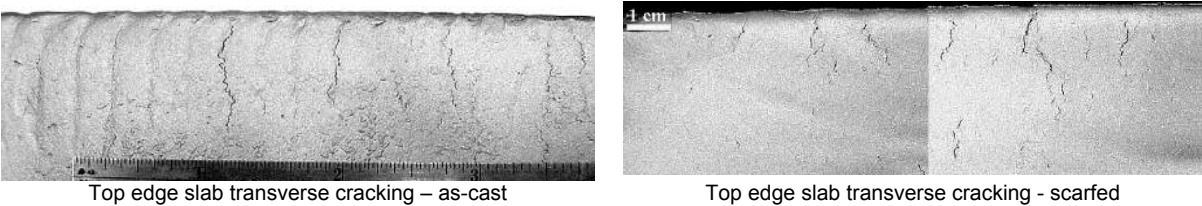
Transverse cracking is typically located on the top near at the edges of the slab or billet. In more severe cases they can be located in the body of the slab/billet. They are typically on the top as they are usually associated with low ductility trough associated with temperature that may result in cracking during the unbending of the slab/billet through the straightening section. However, based upon recent research, the reduced reduction in area at straightening temperatures through the unbending section are more related to the melting and casting operational parameters than the inherent ductility trough of microalloyed steels.⁽²⁾ Figure 3 shows transverse cracks found on the top of the slab at the corners in both the scarfed and un-scarfed condition.⁽³⁾ These types of cracks can be very small and difficult to see with the unaided eye on the as-cast slab/billet surface. Hence, scarfing is the best tool to inspect for these types of cracks.

Figure 3. Example of top edge slab transverse cracking.

Transverse cracks can roll out looking like those created by pinholes/porosity regardless of rolling logic (straight away vs. broadside rolling) due to their geometry. Star cracks typically form from grain boundary embrittlement from mold contamination (Cu pick up from the mold) or oxidation. They form on the slab/billet face where the mold contamination may occur. Figure 4 shows an example of a star crack.⁽⁴⁾ Star cracks use to be fairly prominent issue in casting, however with the technology and understanding of the causes of these types of cracks, today they are virtually none existent.

Proper control of anyone or combination of the key parameters can result in successful casting of slabs free of any transverse cracks. Current operational metallurgy is adopting the Niobium- Low Carbon Low Alloy (Nb-LCLA) approach to eliminate this defect by reducing the formation/frequency/distribution of carbide formation.

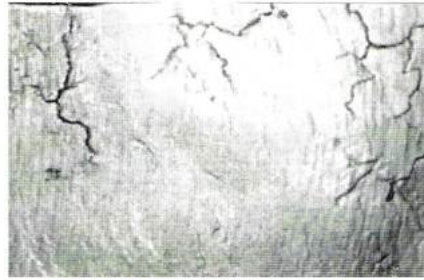
Figure 4. Example slab star crack

Star crack is a problem that has for the most part been decreased with proper alloy designs in the molds. It is not a typical problem for today's casters.

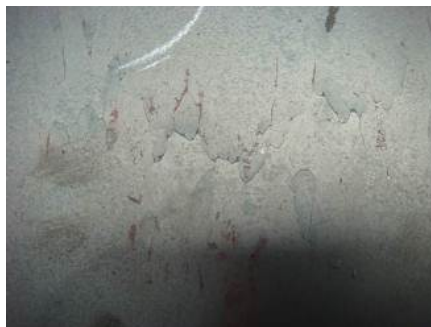
There are numerous mechanical issues that can occur during the casting and handling of slabs/billets. However, in general these are typically very rare occurrences. An example of mold wall contamination can be seen in Figure 7.

Figure 7. Example of surface defects from hot shortness caused by copper contamination from casting mold. Note this is not the same type of defect as seen in star cracks.

There can be mold wall contamination similar to what can cause star cracks that result in hot-shortness during heating/rolling. There can also be scratches and/or gouges, etc. that if deep enough will not oxidize off during reheating and result in a rolled in defect. These typically are not a major issue, but again care in handling slabs will minimize any scratches and/or gouges. Mold wall contamination is controlled in today's casters through proper mold wall alloy designs.

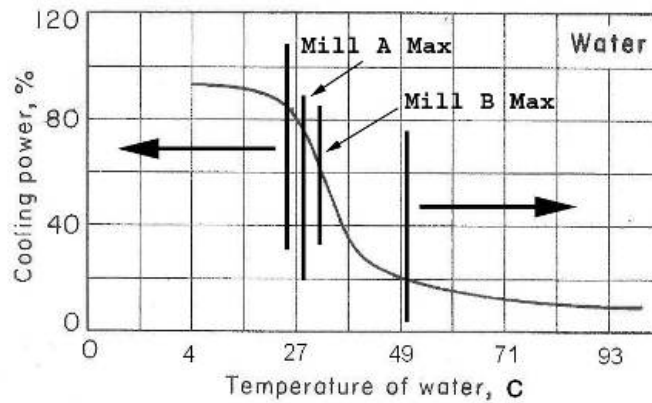
- poor mold level control - > ±5 mm;
- mold water inlet temperature > 35°C, Figure 9 shows the effect of water cooling efficiency vs. increasing water temperature with a steep drop in cooling efficiency in the 27°C-49°C range. This of course changes the heat transfer characteristics between the mold and steel significantly;

Figure 9. Cooling efficiency of water vs. temperature affecting heat transfer characteristics during casting. Note control limits examples of two different mills.

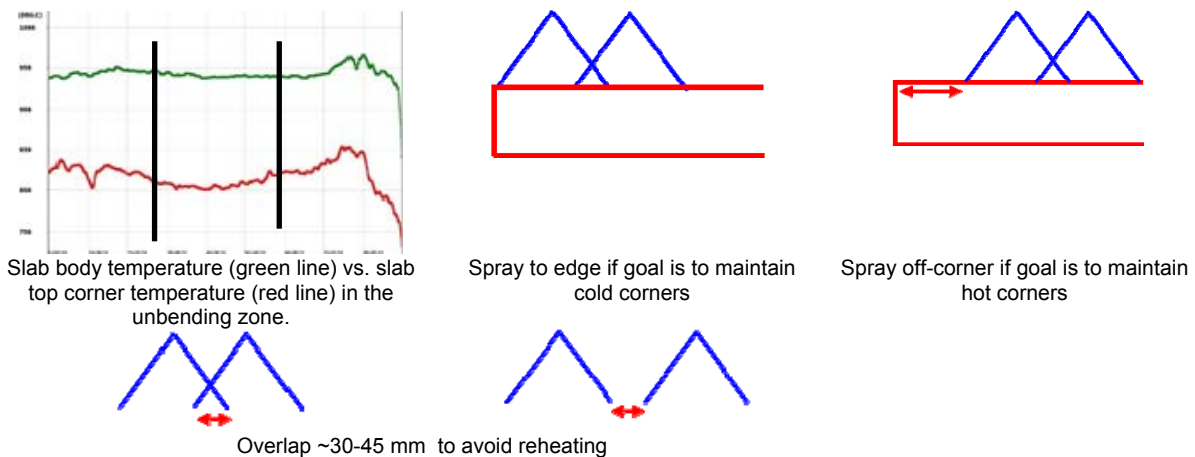
When the ductility is affected by one or multiple parameters listed above and the steel is put into tension at the caster, crack formation may occur in either the bending zone below the mold or the unbending zone further down the length of the caster. It has been well documented over the years that there are temperature zones of low ductility due to the various factors shown above during the casting process. This temperature zone is typically in the 700°C-900°C range depending on the factors or combinations of factors involved. It is in this range where the ductility may be low enough such that when the slab is put into tension or there are other potential stress risers present such as deep oscillation marks. However, in many cases only some slight modification to one or several factors are sufficient to raise the ductility a few percentage points to successfully cast without cracking. Poor superheat control and temperature variation is often the root cause for cracking in higher carbon equivalent steels with deep hot ductility troughs. Figure 10⁽⁶⁾ shows the temperature variation between the top corner of the slab in the unbending zone vs. that of the body. Note that the corner is below 900°C and the body is above 900°C which puts the corner into a potential lower ductility temperature zone. Also can be seen an effect of reducing the casting speed 0.1 m/min (between black lines) on the top slab corner

temperature vs. very little influence on the body temperature. Figure 10 also gives illustration on how to control the secondary water cooling in the spray chamber to regulate the slab temperature across the width of the slab.

Figure 10. Example of various edge/body secondary spray cooling patterns to control slab temperatures properly for improved ductility.

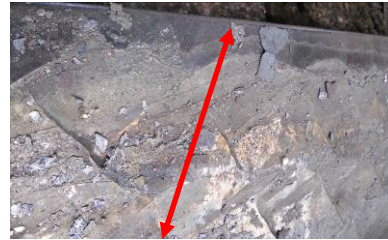
Example of good scarfing showing flat transition near the slab edge. Note the overall smoothness across the scarfing.

Generally, if proper technique is used, then rolled surfaces will be free of defects associated with this operation. A good practice to assure a smooth transition is that the scarfing pass width should be 6x the scarfing depth (feathered technique). Examples of proper scarfing techniques can be seen in Figure 11.
