# MORPHOLOGY OF $\gamma'$ PRECIPITATES AFTER SIMPLE AGING IN FIRST STAGE LOW PRESSURE TURBINE BLADE OF NI-BASED SUPERALLOY AFTER SERVICED<sup>1</sup>

#### Abstract

To estimate the distribution of the temperature and the stress, and the stress direction of the blade in service, the morphology of the  $\gamma'$  precipitates in the Ni-based superalloy serviced as the 1st LPT blade of the aircraft engine and this aged one was investigated. Microstructure observations by a FE-SEM were carried out on the forty portions of the both sides of the perpendicular and the orthogonal sections at the vicinity of the blade surface in the suction and pressure sides. Most of the  $\gamma'$  precipitates kept cuboidal in shape in serviced blade. A lot of the secondary  $\gamma'$  precipitates in the  $\gamma$  matrix were observed at the root part. On the contrary, at the leading edge of the tip part, there were no secondary  $\gamma'$  precipitates. After simple aging, the low complete rafted  $\gamma/\gamma'$  structures were appeared at the suction sides of 70mm part, while the other portions, coarsening of the  $\gamma'$  precipitates was observed. Consequently, the 1st LPT blade in service, a

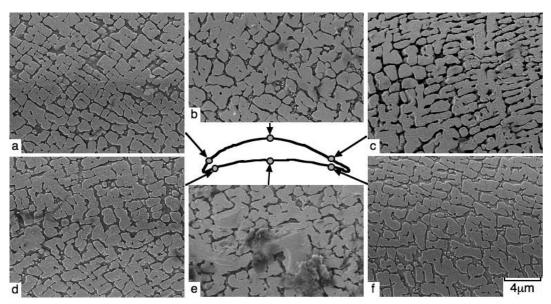
The SEM micrographs at the pressure and suction sides of the tip part are shown in Fig.1. The dotted line on the photos are intersection lines of the orthogonal two planes, the upper side is perpendicular section on the boundary of this line, and the lower side is the orthogonally section. The right side of photos of the pressure side and the left side of photos of the suction side are parallel to the outside surface of the blade.

The cuboidal  $\gamma'$  precipitates becomes rounded in all portions. At the suction side, at the portion with the distance of 23mm from the leading edge, that is, 23mm portion, the fine secondary  $\gamma'$  precipitates are slightly observed in the  $\gamma$  matrix. The denuded zone of the secondary  $\gamma'$  precipitates are recognized at the matrix phase near the  $\gamma/\gamma'$  interfaces (Fig.1b). On the contrary, at the leading and trailing edge, there are few secondary  $\gamma'$  precipitates (Fig.1a and c). At the pressure side, the secondary  $\gamma'$  precipitates are only observed at the trailing edge, and the morphology and the distribution of ones are similar to the 23mm portion at the suction side (Fig.1e).

**Figure 1.** SEM micrographs of the suction and pressure sides of the tip part : the leading edge (a) and (d), 23mm portion (b) and (e) and the trailing edge (c) and (f), respectively.

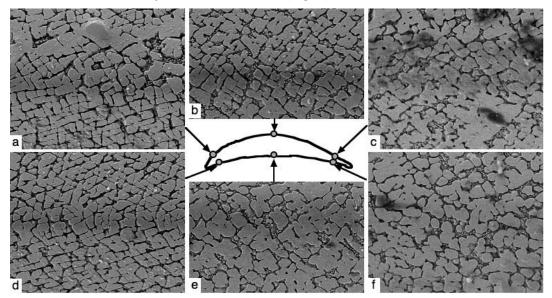
The SEM micrographs at the pressure and suction sides of the 40mm part are shown in Fig.2. At the suction side, most of the cuboidal  $\gamma'$  precipitates kept cuboidal in shape (Fig.2a-c). A lot of the fine secondary  $\gamma'$  precipitates are observed in the  $\gamma$  matrix at the 23mm portion and the trailing edge (Fig.2b,c). At the pressure side, the cuboidal  $\gamma'$  precipitates still remain as well as the suction side. No secondary  $\gamma'$  precipitates are observed at the leading edge (Fig.2d). However, the amount of the secondary  $\gamma'$  precipitates in the  $\gamma$  matrix increased toward the trailing edge(Fig.2d-f). And at the trailing edge, a large number of the secondary  $\gamma'$  precipitates are observed at the vicinity of the  $\gamma/\gamma'$  interfaces (Fig.2f).

**Figure 2.** SEM micrographs of the suction and pressure sides of the 40mm part : the leading edge (a) and (d), 23mm portion (b) and (e) and the trailing edge (c) and (f), respectively.

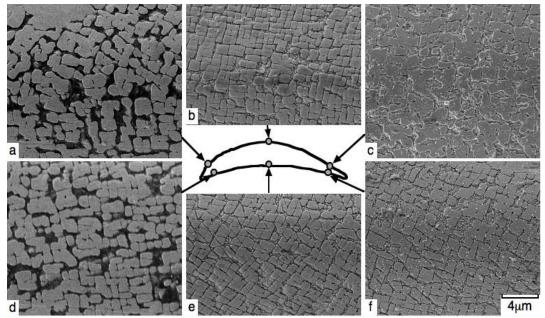
The SEM micrographs at the pressure and suction sides of the 70mm part are shown in Fig.3. Most of the  $\gamma'$  precipitates keep cuboidal in shape in all portions. There are few secondary  $\gamma'$  precipitates at the leading edge (Fig.3a,d), while the other portion, the secondary  $\gamma'$  precipitates are observed. The amount of the secondary  $\gamma'$  precipitates increased markedly toward the trailing edge. In particular, at the trailing edge, the secondary  $\gamma'$  precipitates are closely precipitated at the  $\gamma/\gamma'$  interfaces (Fig.3c,f).

**Figure 3.** SEM micrographs of the suction and pressure sides of the 70mm part : the leading edge (a) and (d), 23mm portion (b) and (e) and the trailing edge (c) and (f), respectively.

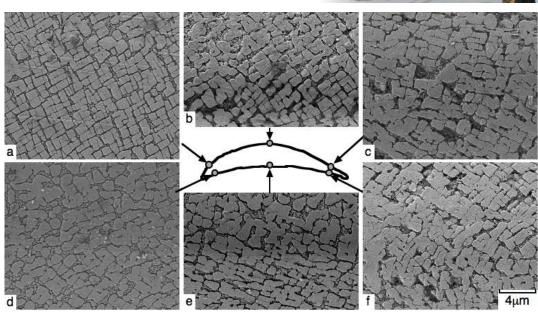
The SEM micrographs at the pressure and suction sides of the root part are shown in Fig.4. Most of the  $\gamma'$  precipitates keep cuboidal in shape similar to the other part. At the suction side, a lot of the secondary  $\gamma'$  precipitates are observed in the  $\gamma$  matrix in the all portions, whereas the ratio of volume fraction of secondary  $\gamma'$  precipitates is high as leaving from the leading edge. At the 23mm portion and trailing edge, the fine secondary  $\gamma'$  precipitates in the  $\gamma$  matrix are closely precipitated at the  $\gamma/\gamma'$  interfaces (Fig.4b,c). At the pressure side, A large number of the fine secondary  $\gamma'$  precipitates are observed in all portions as well as the suction side (Fig.4d,f).

**Figure 4.** SEM micrographs of the suction and pressure sides of the root part : the leading edge (a) and (d), 23mm portion (b) and (e) and the trailing edge (c) and (f), respectively.

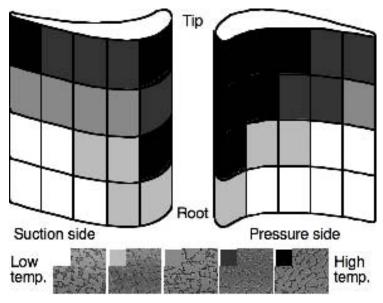
Fig.5 shows the schematic illustration of the temperature distribution of the blade in service. The temperature is classified into five from the morphology of the secondary  $\gamma'$  precipitates in the  $\gamma$  channel and the existence of one at the vicinity of the  $\gamma/\gamma'$  interfaces. The highest temperature is assumed that the secondary  $\gamma'$  precipitates had disappeared. The distribution from low temperature to high temperature is shown in shades from dark to light. At the suction side, the secondary  $\gamma'$  precipitates are not observed in the  $\gamma$  matrix at the leading and trailing edge of the tip part, temperature is relatively high. At the trailing edge side from the 40mm to the root parts where the many fine secondary  $\gamma'$  precipitates are precipitated in the  $\gamma$  matrix, the surface is exposed to the lowest temperature condition. At pressure side, at the leading edge side of the tip part and the leading edge of the 40mm part where the secondary  $\gamma'$  precipitates are disappeared, the surface is exposed to the highest temperature condition.

However, at the trailing edge side of the 70mm and root parts where the high amount of the fine secondary  $\gamma'$  precipitates exists at the vicinity of the  $\gamma/\gamma'$  interfaces in the  $\gamma$  matrix, the surface is not enough to be exposed to the high temperature condition.

Figure 5. Schematic illustration of the distribution of the temperature of the 1st LPT blade in service.

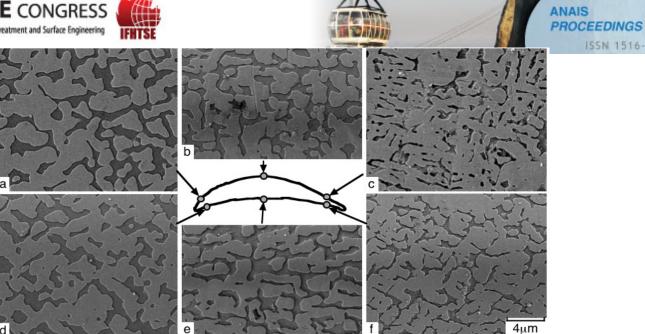
The SEM micrographs of the aged blade at the pressure and suction sides of the tip part are shown in Fig.6. There are no secondary  $\gamma'$  precipitates in  $\gamma$  matrix. At the suction side, coarsening of the  $\gamma'$  precipitates are observed (Fig.6a,c). At the pressure side, remarkable coarsening of the  $\gamma$  precipitates are observed at the leading edge, whereas the degree of coarsening of the  $\gamma'$  precipitates is low as leaving from the trailing edge (Fig.6d,e).

Figure 6. SEM micrographs of the aged blade of the suction and pressure sides of the tip part : the leading edge (a) and (d), 23mm portion (b) and (e) and the trailing edge (c) and (f), respectively.

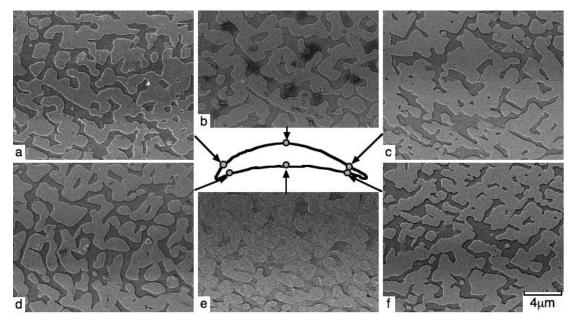
The SEM micrographs of the aged blade at the pressure and suction sides of the 40mm part are shown in Fig.7. The adjacent  $\gamma'$  precipitates contact with each other. The secondary  $\gamma'$  precipitates are not observed in the  $\gamma$  matrix as well as the tip part.

Figure 7. SEM micrographs of the aged blade of the suction and pressure sides of the 40mm part : the leading edge (a) and (d), 23mm portion (b) and (e) and the trailing edge (c) and (f), respectively.

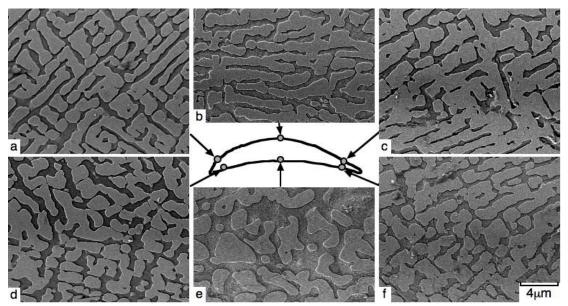
The SEM micrographs of the aged blade at the pressure and suction sides of the 70mm part are shown in Fig.8. The secondary  $\gamma'$  precipitates are disappeared. At the suction side, most of the  $\gamma$  precipitates are connected two specific directions, and the interface between the  $\gamma/\gamma$  phase is straight (Fig.8a). At the 23mm portion, the rafted  $\gamma/\gamma$  structure are observed, and the interface between the  $\gamma/\gamma$  phase is also straight (Fig.8b). At the trailing edge, the low complete rafted  $\gamma/\gamma$  structure are observed (Fig.8c).

At the pressure side, the morphology of the  $\gamma'$  precipitates are different from the suction side, further coarsening of the  $\gamma$ ' precipitates are observed.

Figure 8. SEM micrographs of the aged blade of the suction and pressure sides of the 70mm part : the leading edge (a) and (d), 23mm portion (b) and (e) and the trailing edge (c) and (f), respectively.

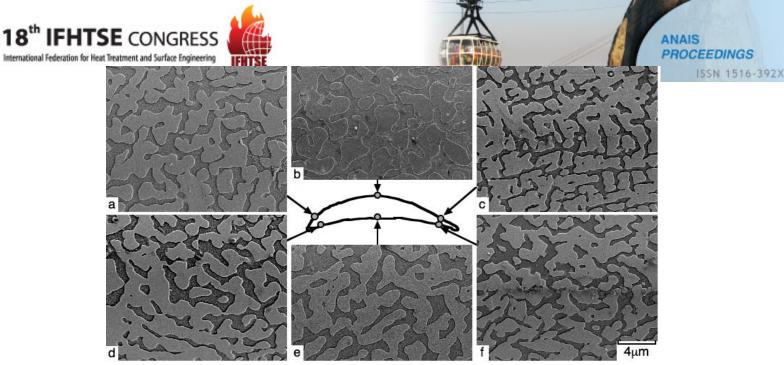
The SEM micrographs of the aged blade at the pressure and suction sides of the root part are shown in Fig.9. The rafted  $\gamma/\gamma$  structures and the secondary  $\gamma$  precipitates in the  $\gamma$  matrix are not observed in all portions.

**Figure 9.** SEM micrographs of the aged blade of the suction and pressure sides of the root part : the leading edge (a) and (d), 23mm portion (b) and (e) and the trailing edge (c) and (f), respectively.

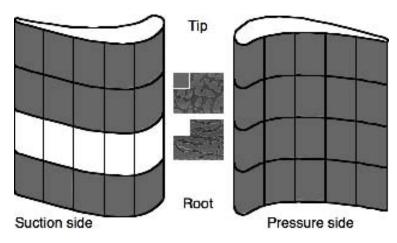
Fig.10 shows the schematic illustration of the stress distribution of the blade in service. The distribution from low temperature and low stress sides to high temperature and high stress sides is shown in shades from dark to light. The rafted  $\gamma/\gamma'$  structures are only appeared at the suction sides of 70mm part. However the completeness of the rafted  $\gamma/\gamma'$  structures is low. This microstructure evidence indicated that the amount of the deformation is extremely little, and the loaded stress is low on the 1st LPT blade in service. While most of the portions in the blade, coarsening of the  $\gamma'$  precipitates are observed. Therefore, it is supposed that there is almost no influence of stress.

Consequently, the stress for the 1st LPT blade in service is slightly high at the suction side of the 70mm part in comparison with other parts, but is extremely low overall.

Figure 10. Schematic illustration of the distribution of the microstructure of the aged 1st LPT blade in service.
