QUICK RECOVERY FROM A CHILLY HEARTH OF COSIPA #1 BLAST FURNACE ¹

Abstract

This paper describes all the operations carried out and the lessons learned in the recovery of Cosipa # 1 blast furnace from a hearth chilling occurred in October 2007 after a 52,8 hours stop. The furnace recovery strategy involved the coke rate changing at the burden column, the accomplishment of the connection between tuyeres and tapholes by lancing and the sequential tuyeres preparation and opening after programmed stops. The slag – iron separation and the two tap holes operation succeeded 4 and 6 days after the blow in respectively which helped the recovery to be controlled, safe and very fast and also allowed the furnace to going back to normal operation in 10 days only. The operation and maintenance crews did excellent jobs and Cosipa and Danieli Corus teams worked in a constructive atmosphere sharing all the information, decisions and actions in one of the quickest recoveries worldwide.

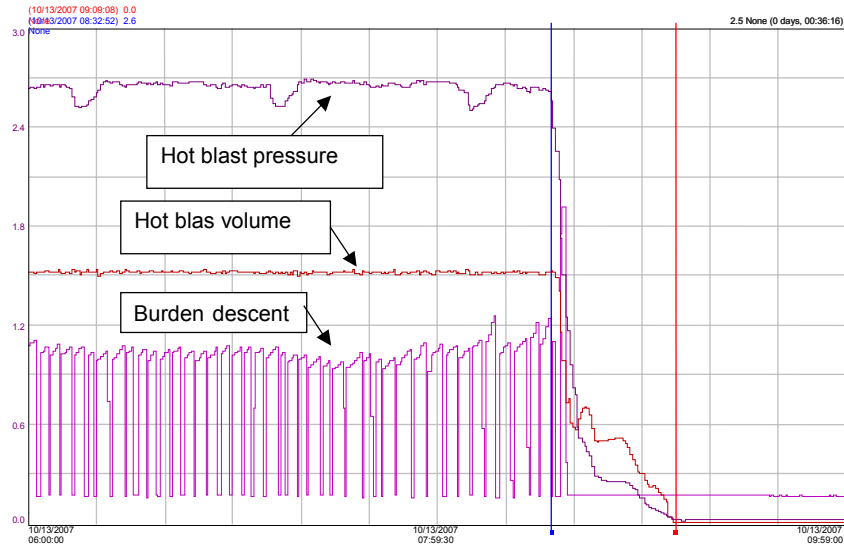
Figure 1 – Main process variables

As it was said above, # 23 tuyere and cooler burnt out suddenly without any signs that could help the operators to prevent this occurrence. The operation was being held quite normally at that time and the main process variables were going under control as it can be seen at the following Figures 1 and 2.

It can be noticed from the Figure 1 that the hot blast volume and burden descent were very stable and the hot blast pressure presented only a small normal drop during the stoves change.

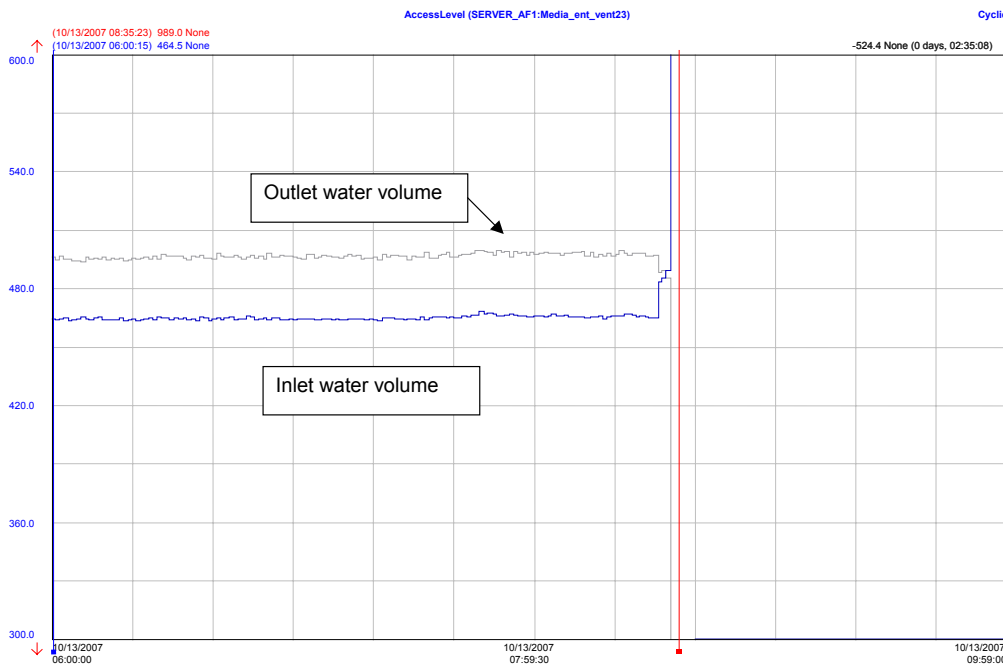
Figure 2 – Inlet and Outlet water volume of # 23 tuyere

Form the Figure 2 it can be seen a regular value of the inlet and outlet water volume and it means that there was no problem at the tuyere cooling system. The difference between the inlet and outlet values represents only that the measuring equipments were not equalized, because it was known that there was no leakage at the cooling system. On the other hand the outlet water volume value was in a higher level than the inlet water volume value fact that is impossible to happen when a tuyere burns.

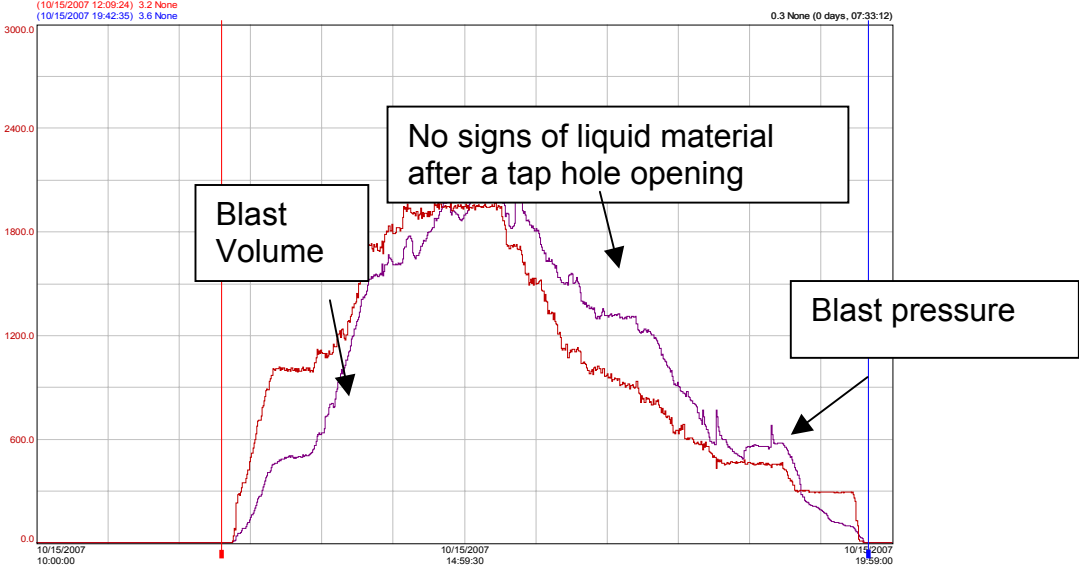
Figure 3 – Blast volume and pressure during the first blow in

After 3h13 min of operation the blast volume started to be reduced because there was no signs of liquids at the tap holes and accumulated amount of pig iron inside the hearth totaled 200t (see figure 3).

Initially the tuyeres were operating well but they worsened at the same time the remaining liquid material increased inside the furnace. Tuyeres # 22, 23, 24, 1, 2 and 3 were blocked with slag at 16 hrs pm and signs of water were seen at tuyeres # 9, 19, 21 and 24.

The blow out happened at 19h 30 min on 15/10 due to the critical situation of the tuyeres and no evidence of connection between tuyeres and tap holes. Almost all tuyeres and the blowpipes were horizontally filled with slag during the stop operation. During this recovery attempt 20 complete charges were charged with the coke rate varying from 1000 to 750kg/t.

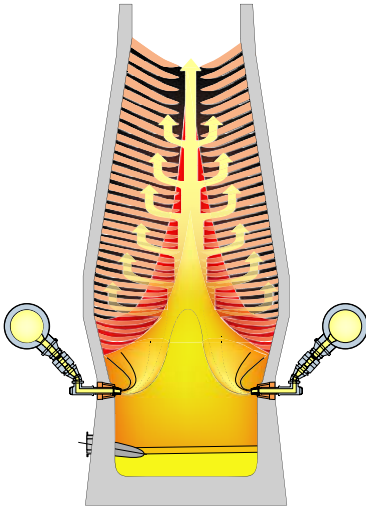
Figure 4 – Situation of the burden inside the furnace at the time of 2nd stop

Figure 4 below shows the burden column at the time of the stop after the first blow in. It was set that the coke rate would be maintained at 1000 kt/ t up to the recovery of the furnace thermal level.
