## REDUCING THE WARPING EFFECT OF HOT ROLLED SAE15B29 FLAT BARS\*

Boron steel is used in the industry due to its great wear and impact resistance. During the hot rolling production of 15B29 steel flat bars it is a recurrent problem that the bars will present warping while on the cooling bed. Control this phenomenon is an opportunity to have better productivity, preventing metallic losses. Through the observation of the macro and microstructure samples produced with different reheating temperatures and cooling rates, it was found the presence of residual stresses and cracks on warped bars macrostructure. The residual stresses appearance suggest that the material cooling is too fast. Billets temperature on the reheating furnace of 1230°C reduced to 1100°C and the production pace slowed down. Bars temperature when arriving the cooling bed was reduced from higher than 670°C to 625°C. The results obtained made it possible to produce the material with better quality, reducing the warping effect at the cooling bed. The major influence on the materials warping was identified as the cooling rate at the cooling bed and the reheating furnace temperature was adjusted to provide a homogeneous

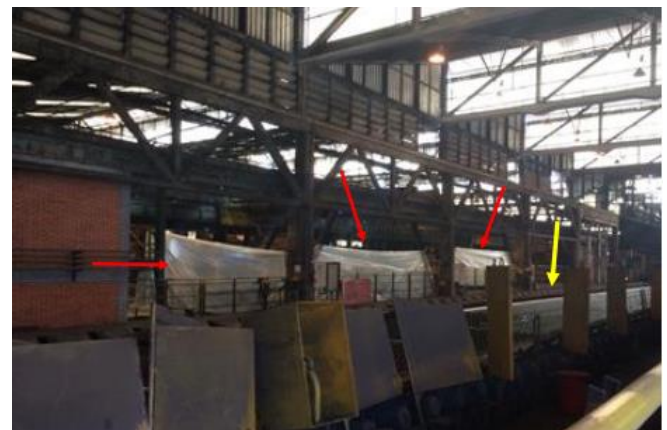
As the main cause of the warp defect is possibly related to the material temperature and cooling rate, it was decided to reduce the reheating temperature. To decrease the cooling rate in the cooling bed a curtain, as seen in the Figure 1, was installed in the cooling bed side to minimize the wind crossflow over the material.

Figure 1 Curtains installed in the cooling bed.

The new parameter obtaining when trying to improve the process was standardized. As future work there is the need of improving the soaking zone of the reheating furnace to make the temperature more homogeneous along the billets. Also, there is a need of installing definitive curtains in the cooling bed to reduce the airflow.

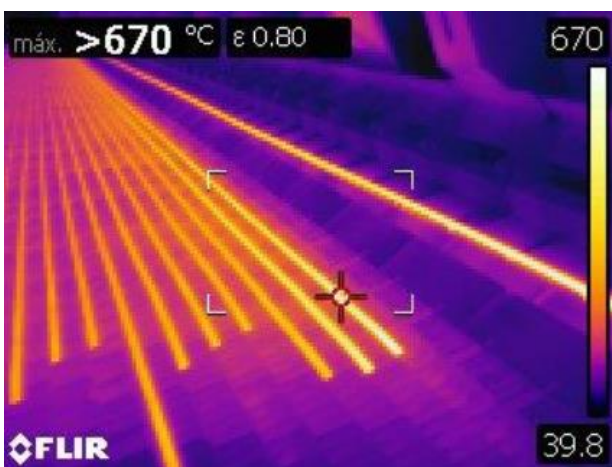
After reaching the cooling process with a temperature around 670°C the material started to warp and the bars tip started to get stuck in the moving rakes, delaying the production process, as it can be seen in the Figure 3 and Figure 4.

Figure 3. Temperature of the bars arriving the cooling bed.

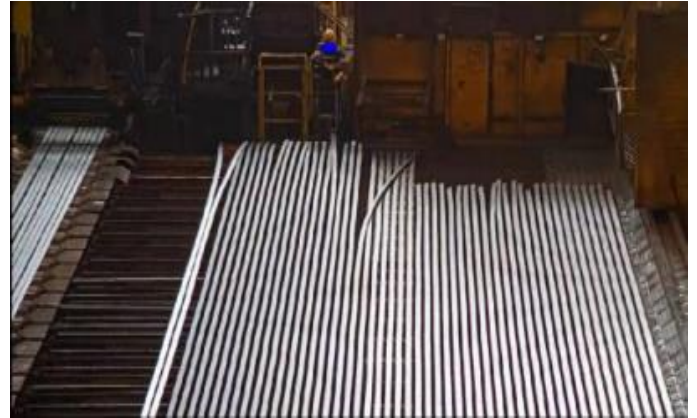
Figure 4 Warped bars in the cooling bed

Probably the causes of this warps can be related to the rolling temperature be too high, forcing the material to have a higher cooling rate that induces tensions in the material making it present the defects. A test was performed reducing the reheating temperatures with the third trio stand pass being around 1100°C. After reaching the cooling bed the bars presented a better aspect when compared to the first test that used higher temperatures in the furnace. The material can be seen in the Figure 5.

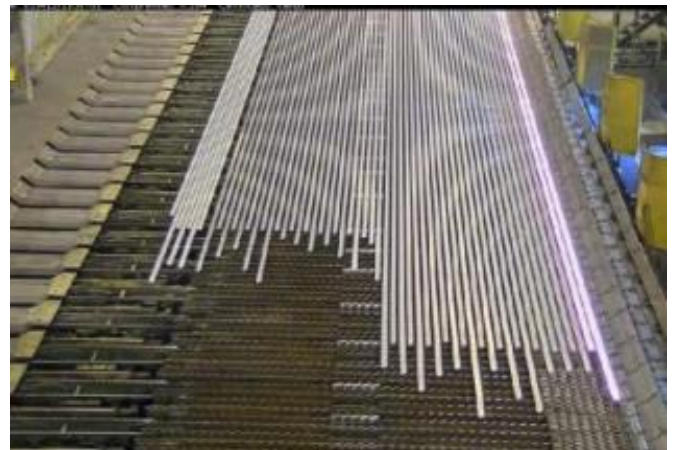
Figure 5 Bars in the cooling bed with the new parameters.

The parameters used were admitted as the new standard due to the material's great aspect when in the cooling bed. The new cooling rate was measured using the infrared pyrometer measuring the temperature every ten seconds during the first minute. Figure 6 shows the results of the temperature measures.

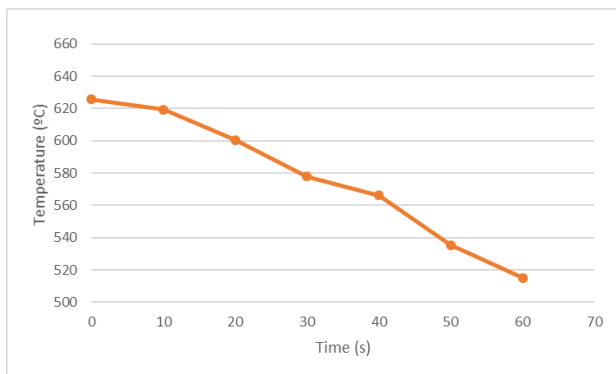
Figure 6 Bars temperature while cooling.

The bars temperature arriving the cooling bed decreased around 45°C and the medium cooling rate measured was of 1,8 °C/s. As it is not possible to detect warp in the bars when using this cooling rate the changes made to the processes were considered efficient.

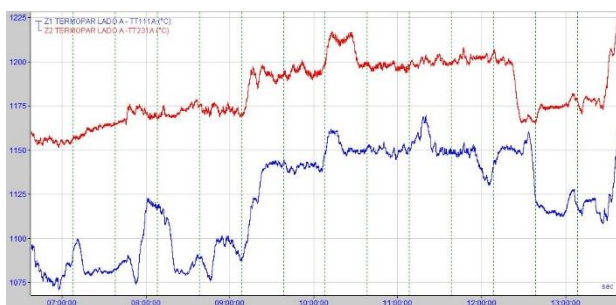
Figure 7 Reheating temperature before training.

Also, to ensure that the process parameters were effective the crew responsible for the reheating furnace control was trained to maintain the set temperature steady. It can be seen in the Figure 7 and in the Figure 8 the temperature data acquired before and after the crew qualification.

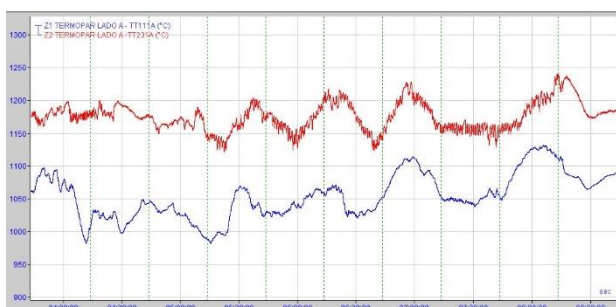
Figure 8 Reheating temperature after qualification.

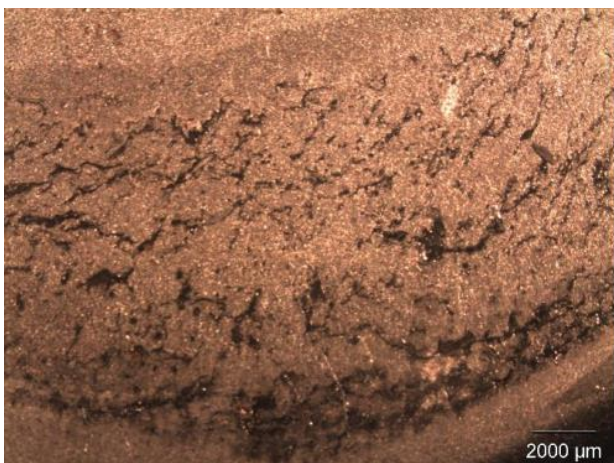
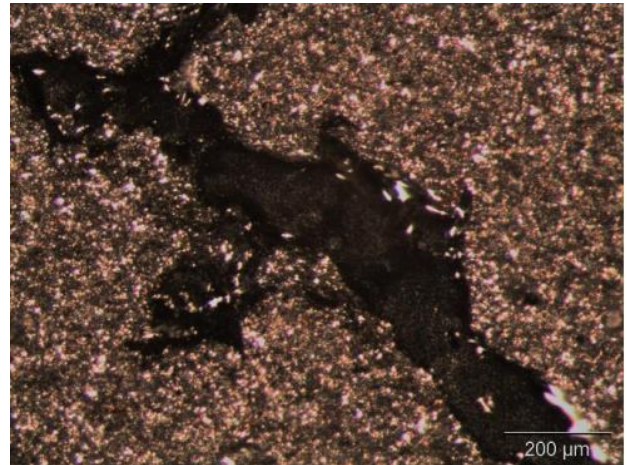
Figure 11 Etched warped sample. 0,7x zoom.

Figure 12 Etched warped sample. 11,5x zoom.

It is possible to see that the warped samples present cracks on the macrostructure. The cracks can be related to the existence of residual stresses in the warped samples and it could be generated as a relief of the stress that could not be eliminated only with the warp effect.

Through the macrostructure analysis it was possible to perceive the presence of small cracks in the bars with the defect. This indicates a relief of residual stresses in the material.
