REDUCTION OF STRIP BREAKS IN TERNIUM PLTCM PLANT*

The Pickling Line Tandem Cold Mill (PLTCM) from Ternium Pesquería started in 2013. It is a line with 5 stands, 6 high; focused mainly on the exposed automotive market, with a wide spread of products with high quality requirements. In addition the operational continuity is very important, for this, one of the greatest challenges is to ensure operational discipline, the order of production, the quality of the input (hot band), operational interruptions, equipment failure, breakage of strip in the mill, among others. In relation to this, it has a strong impact on productivity, customer compliance, damage to equipment, rolls, safety, quality, reprocessing among others. Here is present the results obtained in the project "decrease of strip breaks" which focused on several fronts, discipline in the order of production, previous review of raw material in surface and dimensional defects with automatic inspection equipment in the hot mill, as well as in PLTCM, generation of logic in the redundant systems of alerts and prevention to avoid or minimize strip breaks that were high impact in the past. All these multidisciplinary actions led as a

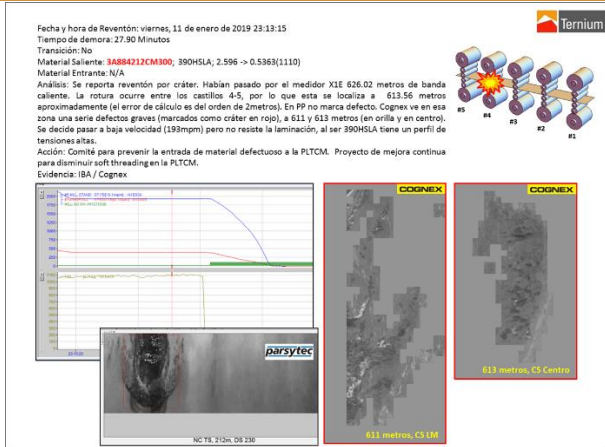
Figure 3. Example of detailed analysis of a substrate defect break.

On the operational side, was focused on generating knowledge by disseminating the causes and origin of breakages through a detailed analysis of each of them with special focus on those generated by operating itself and those related to hot substrate defects.

The procedure established before the event of a break was structured as follows. We proceed to collect the sample from the area where it occurs, the variables that are reviewed in a preliminary way are:

Exact position of the break with an estimated error of 2m. Sample are send to the laboratory if is necessary.

In case of suspicion that the break is due to a superficial defect, the sample is sent to the laboratory for analysis and the results obtained are fed back to the hot or cold rolling mills according to the origin of the defect.
