# OVERVIEW OF HOT BLAST STOVES AFFECTED BY STRESS CORROSION CRACKING <sup>1</sup>

*Friedrich Eschmann<sup>2</sup>  
José Carlos Diniz<sup>3</sup>  
Werner Saffran Rabelo<sup>4</sup>*

<sup>1</sup> *Technical contribution to 62nd ABM - International Annual Congress, July 23<sup>rd</sup> to 27<sup>th</sup>, 2007, Vitória - ES - Brazil*

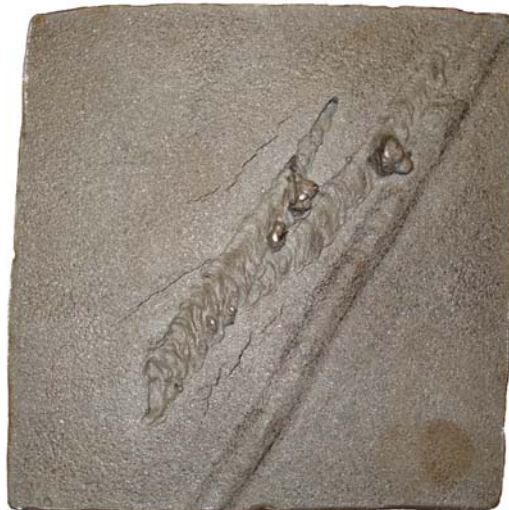
First attempts to overcome the problems by gouging and re-welding or by bandaging the cracked areas with plates or straps soon showed to be no solution. The cracks re-occurred in the vicinity of the repaired area and even faster than before. Figure 1 shows an example of an unsuccessful repair: the exterior of the repair was fairly good the interior however reveals the welding problem and significant cracking on the sides of the weld seam.

**Figure 1:** Steel Shell damaged by SCC - Interior of the repaired area

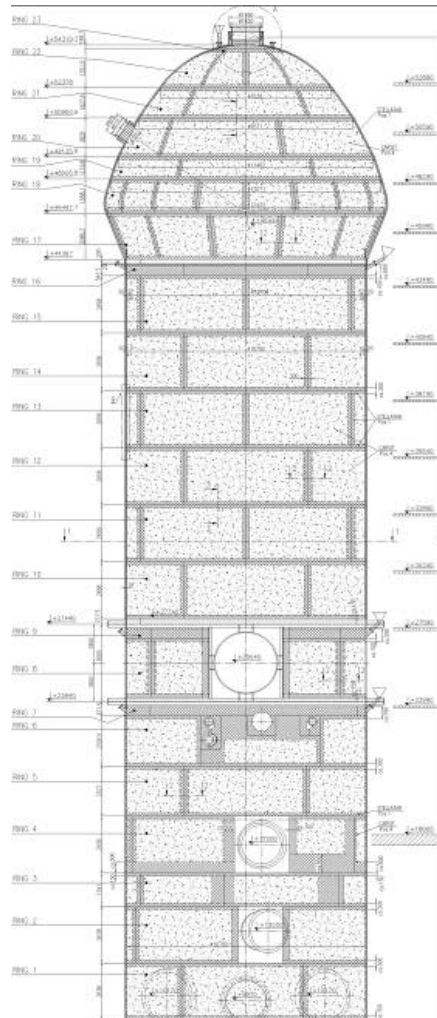
**Figure 2:** Double Shell System on an entire Hot Blast Stove

A distribution of the new shell plates, the location of holding rings and the areas with dry castable and epoxy resin filling of the shell is shown in Figure 2.

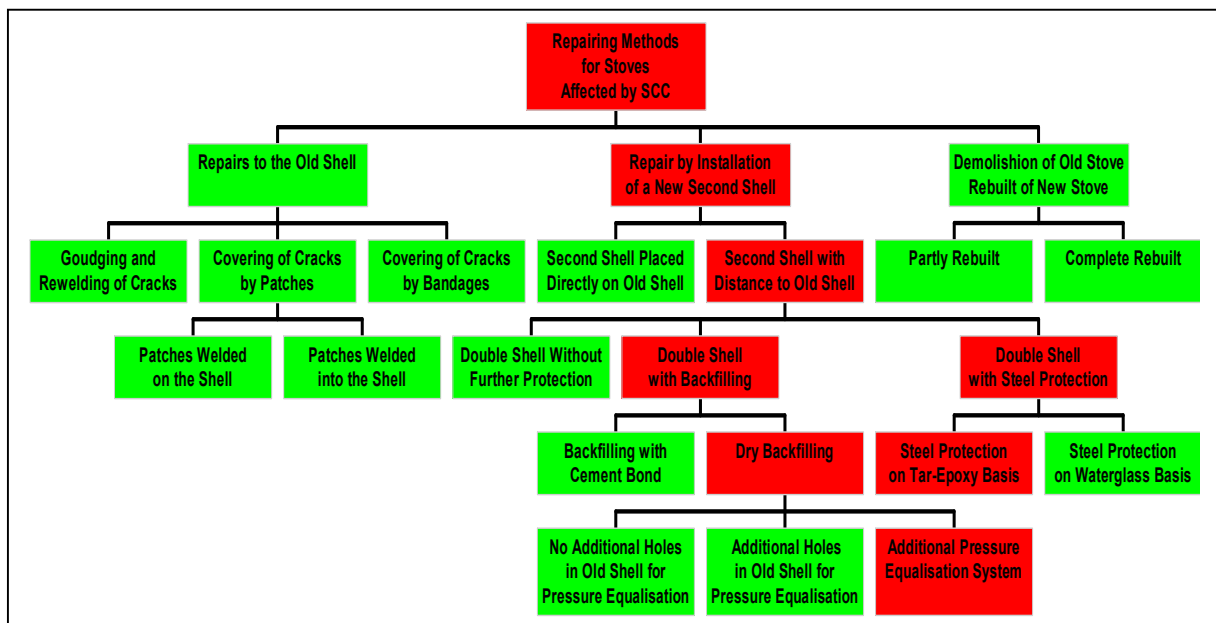
Figure 4: Repair method on hot blast stoves damaged by stress corrosion cracking

Numerous repair process as shown on Figure 4 have been developed, of which, the provision of a double shell in connection with a special protection and backfilling concept has proved to be very effective.

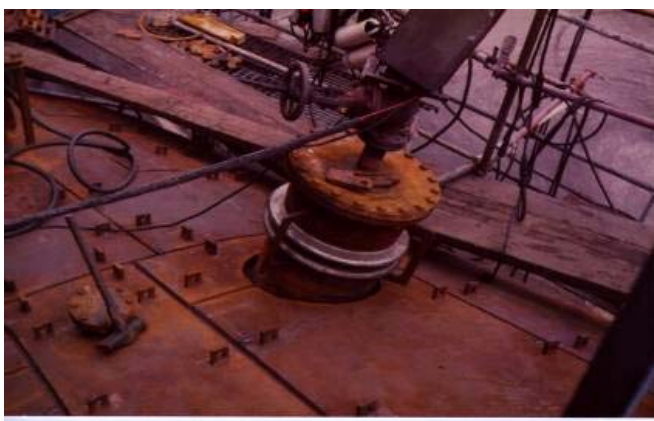
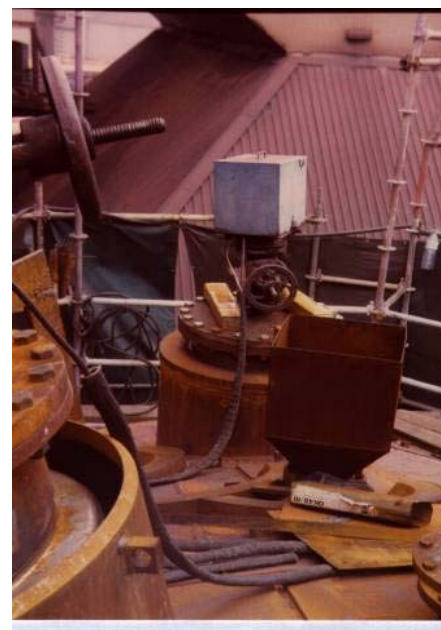
**Figure 7:** Preparation of upper nozzles

2. All stove nozzles will be prepared for later connection to the double shell. In lower areas, nozzles are reinforced only and the double shell is connected to the reinforcing ring. In upper areas, where a differential movement between old and new shell must be expected, a special system using a compensator between old and new shell is installed (Figure 7).

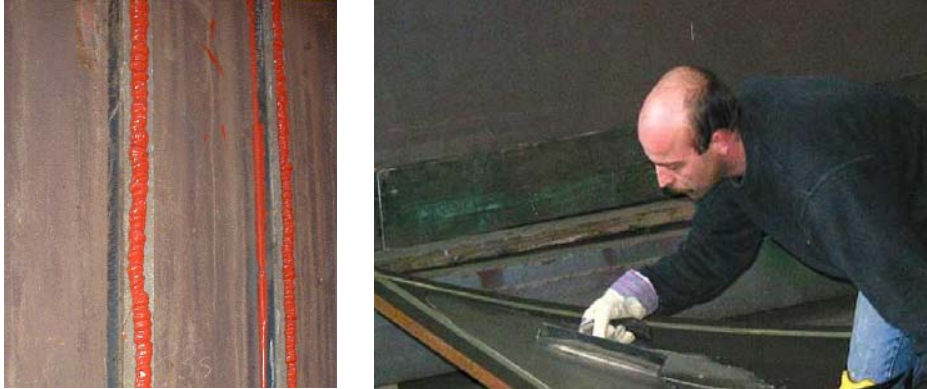
**Figure 8:** Precast Bars and start of plate coating with Stellatar

3. A first course of new plates (preferably 16Mo3) is mounted in a distance of approx. 30 mm to the old shell and welded to the holding ring. The material 16Mo3 has a better resistance in comparison to H II.
4. The new shell plate is coated already with the protective resin, only the welding areas remaining uncovered. Alongside the new welds, precast bars out of the resin are fastened between old and new shell, forming a chamber behind the weld (Figure 8).

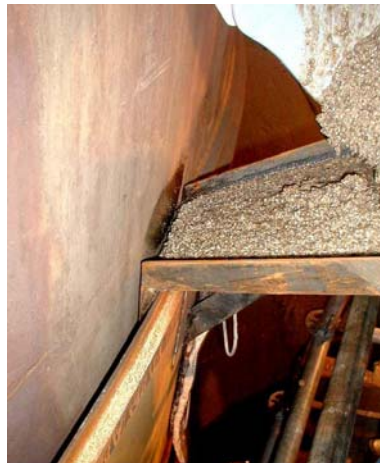
**Figure 9:** Casting of Epoxy Resin Stellatar to Protect Horizontal Weld

5. Epoxy resin is poured into the gap between shells just enough to safely cover the horizontal weld on the bottom of course. The material will soon dry due to the shell temperature (Figure 9).

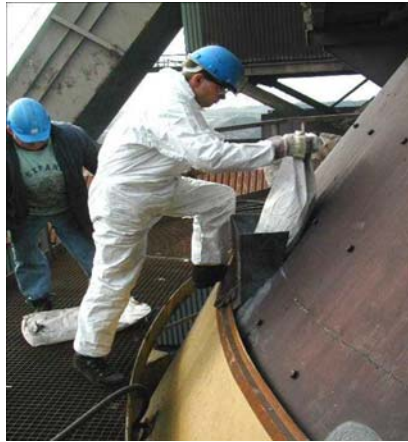
**Figure 10:** Filling of Dry Castable Carsit into Double Shell Gap

6. The gap behind the new plates is then filled nearly to the top with a special high conductivity dry castable, the chamber behind the weld is filled with the epoxy resin. By this, the new weld is fully protected by the resin and the high conductivity castable ensures the temperature difference between old and new shell to be minimized (Figure 10).

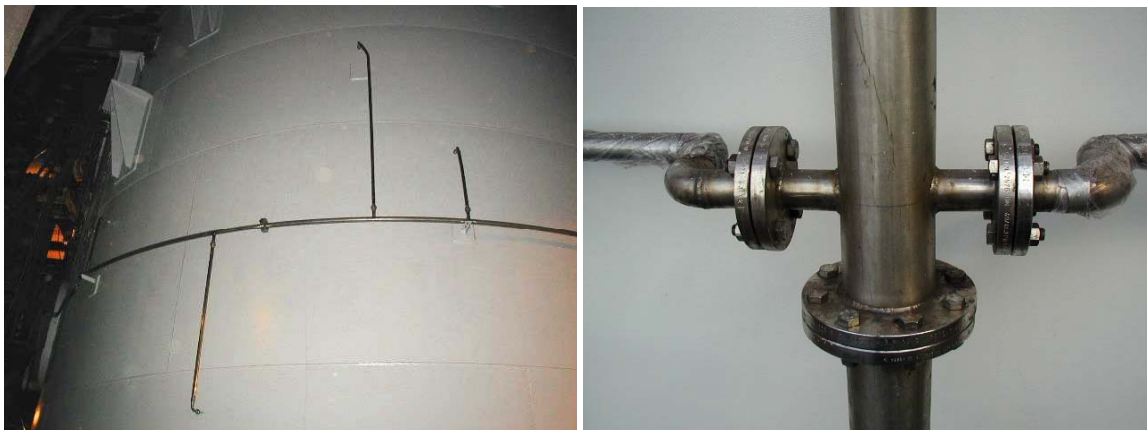
**Figure 12:** The Piping and the Detail of the Pressure Relief System

11. All chambers filled with the dry castable are connected to a pressure relief system designed for the size and operating pressure of the stove and being connected to the cold blast entrance of the stove. This system prevents the old shell from being exposed to outside pressure, which could easily lead to its deformation, to serious destruction or at least to hot spots in the refractory (Figure 12).
