STAVE REPLACEMENT PROJECT – TERNIUM BF 2¹

Abstract

Following some premature damage to staves on the blast furnace number 2 at Ternium Siderar San Nicolás works an investigation of the cause of the problem was carried out. This analysis included for discussions with a number of blast furnace operators around the world. Ternium operational experience in dealing with worn staves proved to be valuable in terms of follow up, damage correction and prevention of damage experienced. This experience was also important in designing the new staves. These concepts are discussed in the paper. The output of the analysis was a decision to replace all rows of copper staves on the Ternium blast furnace. The replacement project was scheduled to be carried out in 2012 during a stoppage of the blast furnace. This paper will review the issues with the original stave performance related to the operation of the blast furnace and the design of the new staves. The paper will also describe the shutdown associated with the stave repair and techniques used to remove and replace the staves. When presented, the paper will discuss the latest performance of the staves on the blast furnace.

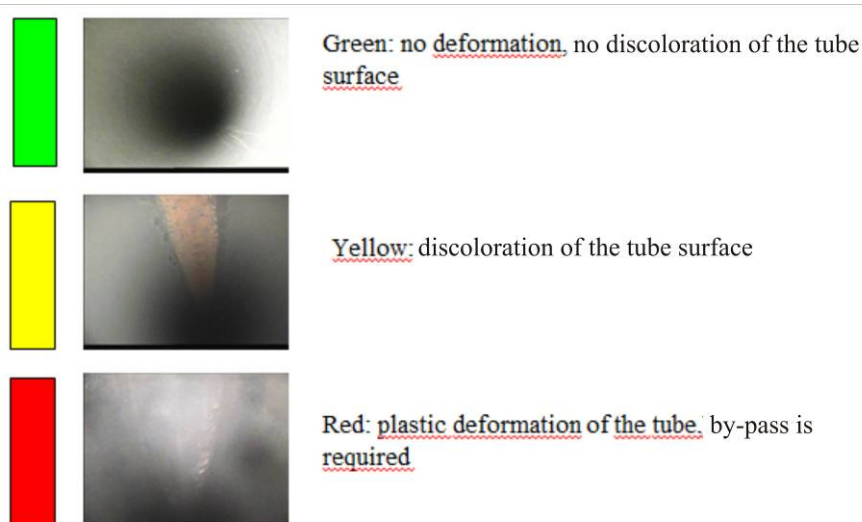
As a preventive measure, inspection tasks were initiated during shutdowns carrying out channel endoscopies, which defined 3 different damage states in the channels, as it is shown in Figure 2. As the channels of the red phase of deformation were found, the by-pass was executed to prevent water ingress to the BF and its shutdown.

Figure 2. References for diagnosis of stove tubes.

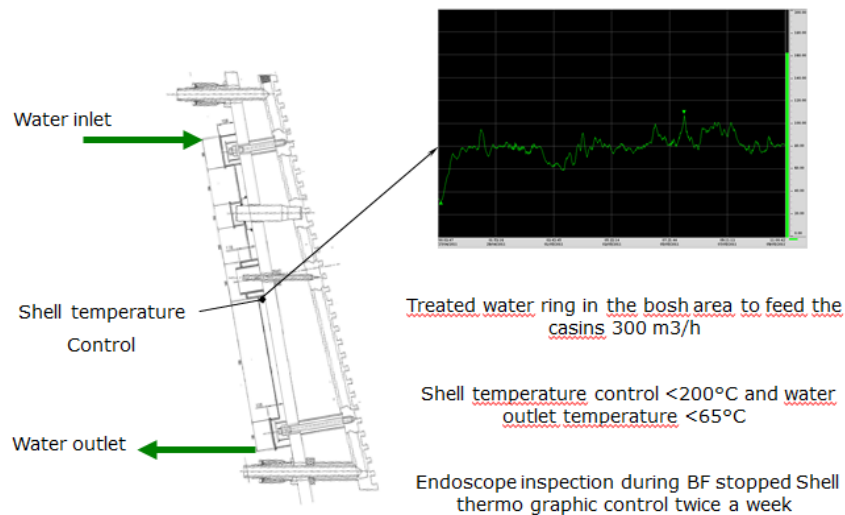
At the same time and in order to protect the shell, it was established that when two consecutive channels were damaged then that area had to be protected by a casing to externally cool the shell and then monitor its temperature so as to prevent shell deformations. Figure 3 shows the casing protecting the shell.

Figure 3. Shell protection (casing).

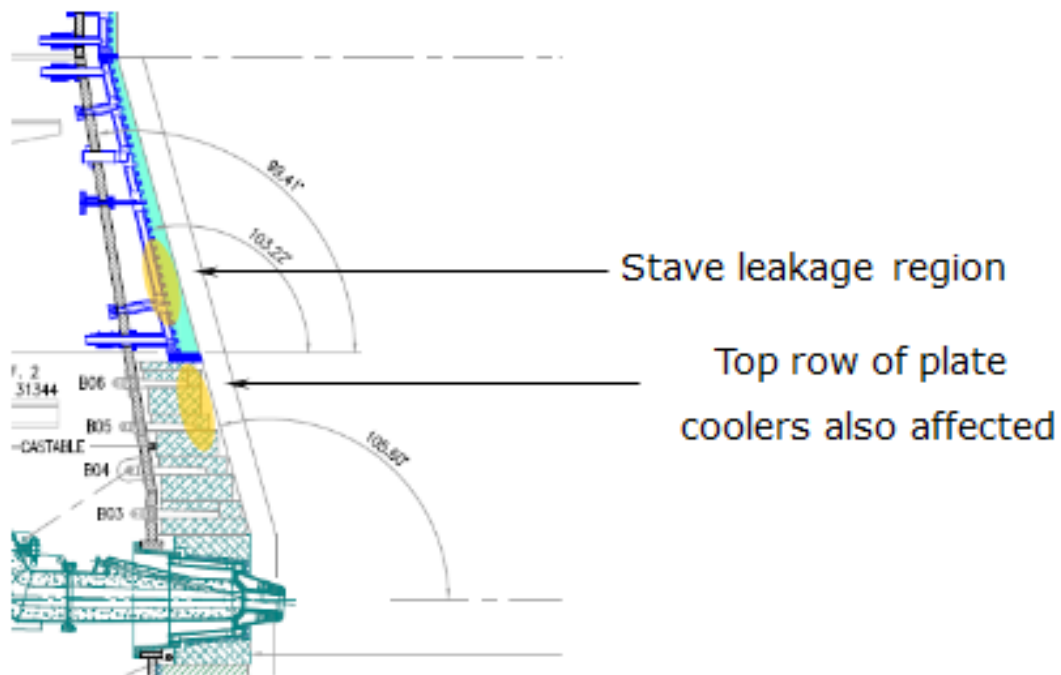
At the beginning of 2012, the process by which damaged channels appeared in the bosh started to speed up. The cooling plates located in the transition area between bosh staves and tuyeres started to become damaged, too (Figure 4).

Figure 4. Area of burnt plates and staves.

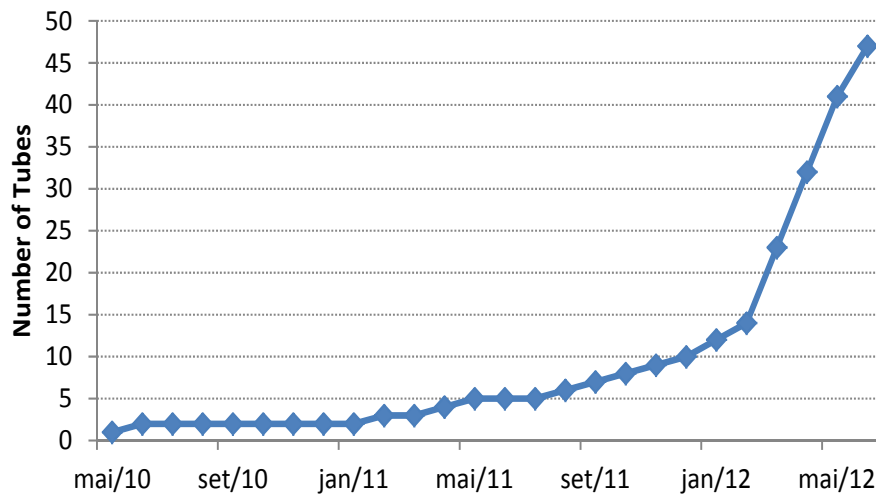
Between June 2010 to June 2012 30 unscheduled shutdowns were carried out because of leakage in cooling circuits; 17 of them were due to the staves; 9 due to the plates and 4 due to the tuyeres. 84 by-passes were performed to stave channels. 43 channels were grouted and 12 cooling casings were mounted. The development of damaged tubes in the staves is shown in Figure 5.

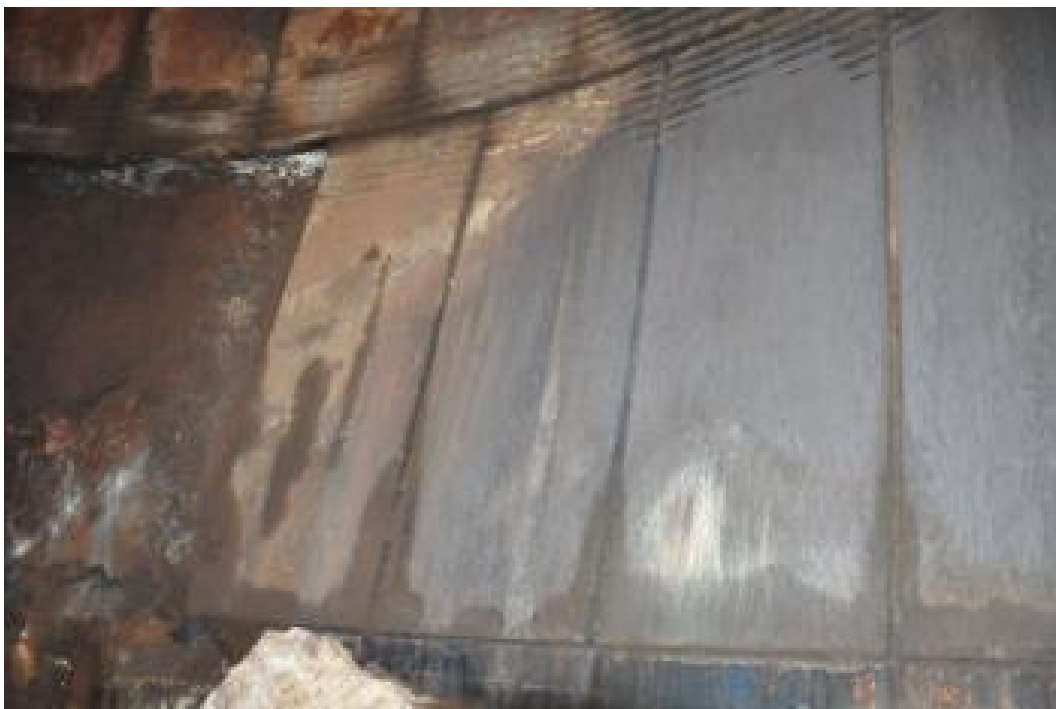
An auxiliary cooling ring and collecting pans were mounted, which were essential to feed the auxiliary systems. As regards the possible causes of premature wear of the copper staves, there are still no definitive conclusions. In July 2012 the blow-down was carried out to change the 5 rows of copper staves. Figure 6 shows their conditions. There was massive copper stave wear, covering the 5 levels and the erosive process of the load on the staves is clearly visible.

Figure 6. Stave condition after the blow-down.

As noted above the repair project comprised the replacement of five rows of copper staves BO1, BE2, S3-S5 all with an improved design. With this philosophy, the
