SUCCESSFUL RELINE AND START UP OF CSN # 2 BLAST FURNACE⁽¹⁾

This paper presents the successful reline and start up of CSN, Brazil, # 2 blast furnace completed in December 2001 to prolong its campaign for 8 more years. The activities of preparation for furnace shutdown and contingency plans are described, focusing on the operation procedures and salamander tapping.

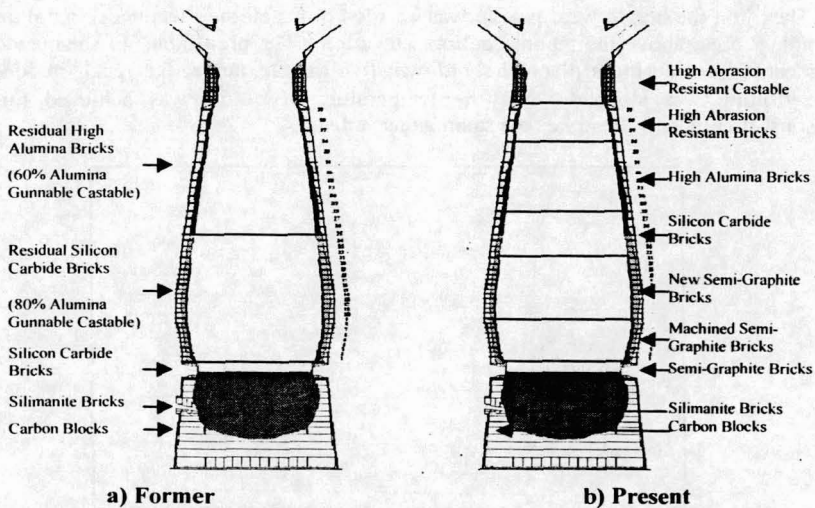
Figure 2 – Former and Present CSN BF 2 Refractory Lining Design.

- Repair of a 105° sector of the hearth refractory lining from the tapholes bottom elevation, including the replacement of the two tapholes.
- Total replacement of the refractory lining from the tuyere to the top.
- Assembling of a new throat armour.
- Assembling of a new gear box.
- Install a new slag runner, repair the slag granulation pits and assemble a tilting runner in the cast house.

Figure 2 shows schematically the former and present CSN BF 2 refractory lining design.

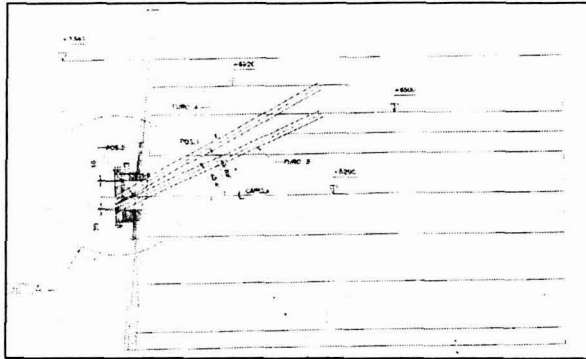
Figure 3 – CSN BF 2 Salamander Holes.

Based on the hearth wear profile was decided to install the salamander spool under the taphole 2 area, above the taphole bottom elevation. The pre-drilling of salamander holes was carried out during a planned shutdown, five months before the repair in June 2000. The drilling was stopped when the temperature of 500°C was achieved for safety reasons[2]. Figure 3 illustrates the salamander holes.

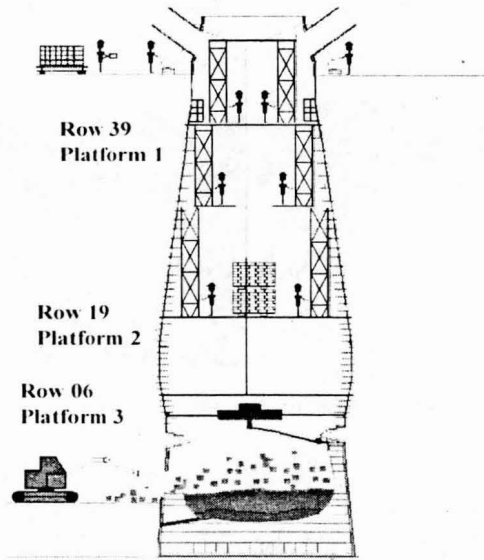
Figure 7 – Location of the Fixed Platforms.

- Platform 1: Throat bottom (at elevation of cooling plates row 39).
- Platform 2: Lower stack (at elevation of cooling plates row 19).
- Platform 3: Bosh (at elevation of cooling plates row 6).

In between the fixed platforms were installed tubular scaffolds (Figure 7). Some special brick rings were also installed (Figure 8) allowing to carry out several re-bricks activities simultaneously.

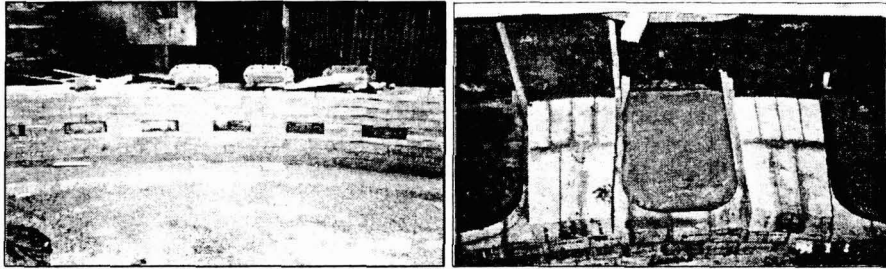
Figure 9 – Area for Bricklayers Training.

In order to guarantee the quality and duration of the refractories activities, all bricklayers (around 250) were trained. A BF shell sector with cooling plates and tubular scaffolds was assembled simulating the true service conditions (Figure 9).

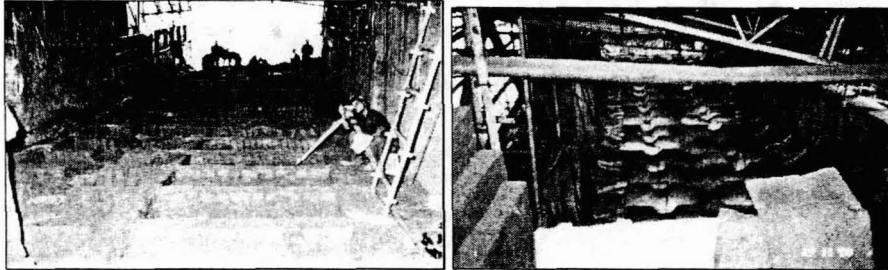
Figure 10 – Salamander Boxes After Excavation (a) and During Drying and Heating Up (b).

The salamander boxes were built in the emergency slag pit by using clay boxes (Figure 10). After compacting the clay, the boxes were excavated. Finally, a thin layer of refractory gunnable castable was applied in the internal surfaces of the clay boxes.

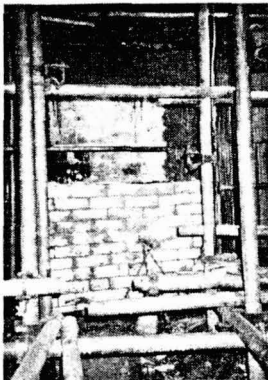
Figure 11 – Taphole Protection Wall.

It refers to the special protection wall built in front of the tapholes before the blow in. The purpose of this wall is to protect the taphole area during the first heats. Figure 11 illustrates the taphole protection wall with fireclay bricks.
