# ANÁLISE DE FALHA EM PROLONGADOR DE PRENSA MECÂNICA PARA COMPACTAÇÃO DE PÓS METÁLICOS: UM ESTUDO DE CASO<sup>1</sup>

## FAILURE ANALYSIS OF AN EXTENSOR IN A MECHANICAL PRESS FOR METAL POWDER COMPRESSION: A CASE STUDY

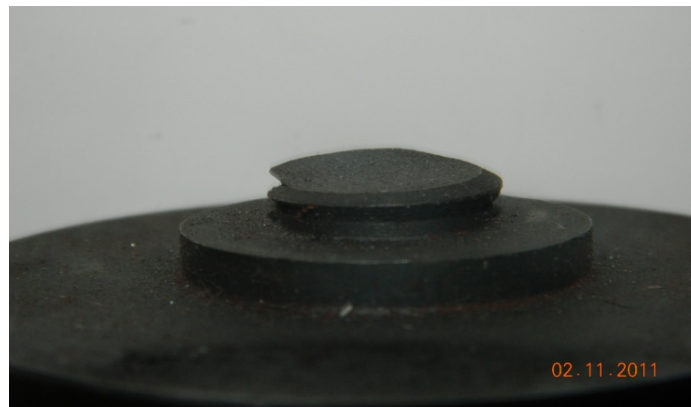
The needle holder failed during service, more precisely during the extraction step. The extraction step is considered the most critical of the process, since it concentrates the highest tensile stress in the interface between the needle holder's thread to the extender's thread .Figure 5 illustrates the needle holder failed.

**Figure 2:** Needle holder failed.

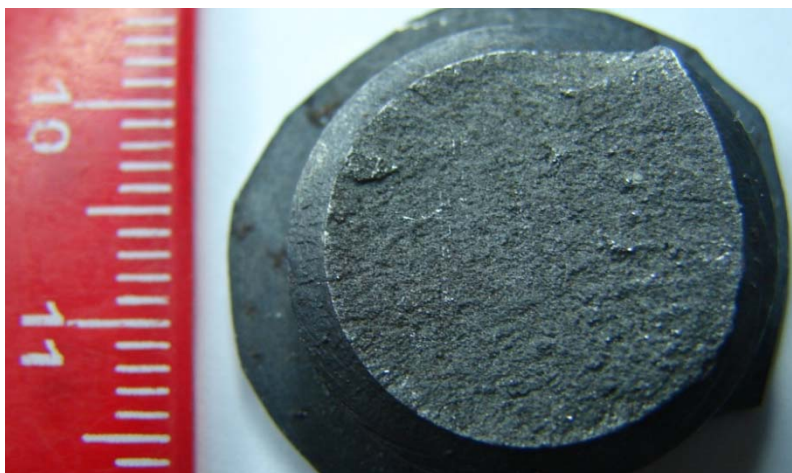
According to Figures 6 and 7, there is no considerable plastic deformation on the surface, characterizing a brittle fracture and there are no signs of torsion loading or beach marks. In the upper region of the fracture surface (indicated by arrows) close to the screw thread, smooth fracture morphology was observed, possible a crack initiation region. This region was subjected to SEM for more detailed analysis.

**Figure 6:** Fractography illustrating a , smooth fracture with little plastic deformation.

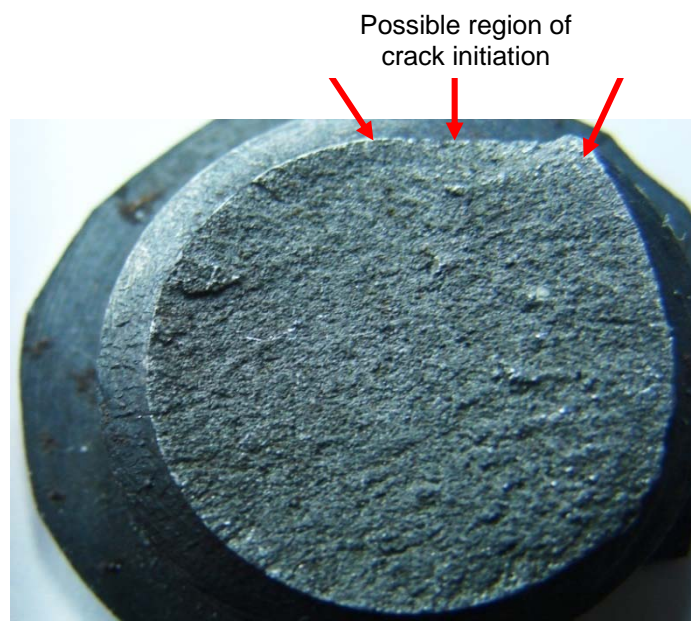
**Figure 3:** Fractography illustrating possible crack initiation.

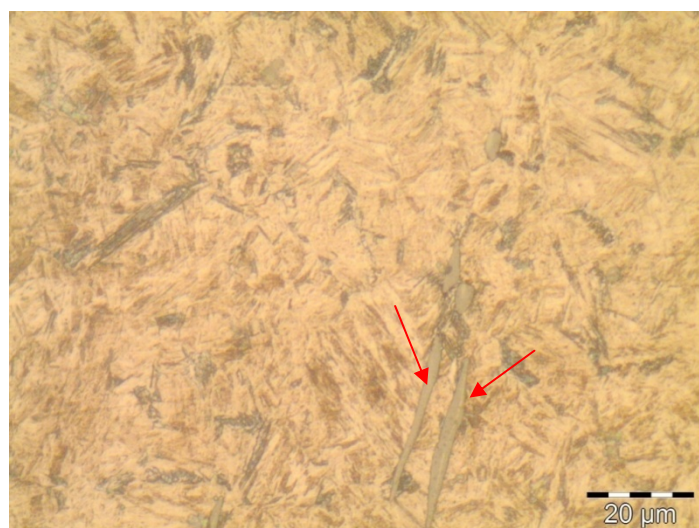
Figures 8 and 9 illustrate metallographic analysis results. It is possible to observe a typical martensitic microstructure and some possible MnS inclusions possibly due to the high manganese content, as shown in Table 1.

**Figure 4:** Typical martensitic microstructure with possible MnS inclusions (indicated by arrows).

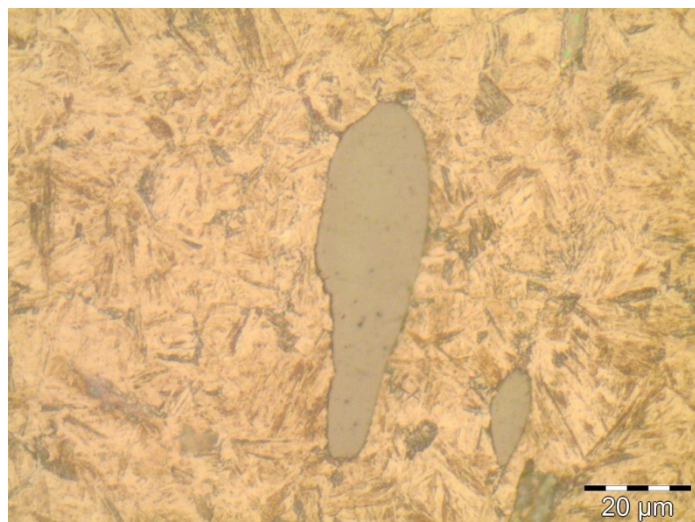
**Figure 5:** Typical martensitic microstructure with possible MnS inclusions.

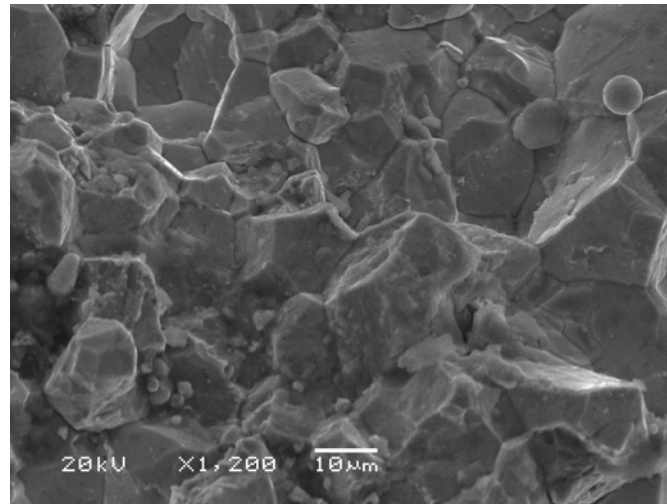
The SEM analysis of the region close to the screw thread, evidenced by arrows in Figure 7, shows that the crack propagation is intergranular. Figure 10 shows the unmistakable intergranular feature. It is evident that some embrittlement of the grain boundaries has occurred. The material high carbon content may lead to the presence of carbides in the grain boundaries due to inadequate heat treatment. Besides, a screw thread is a stress raiser itself, which facilitates nucleation and propagation of cracks, according to Metals Handbook.<sup>(6)</sup> Another possibility to be considered is hydrogen embrittlement, which also leads to intergranular crack failure.<sup>(7)</sup> The possibility of stress corrosion was not considered since the component presented neither any surface corrosion nor intergranular corrosion evidence. One more possibility to be considered is excessive load during assembly, according to the Material Property Data.<sup>(8)</sup> It could be an over stressing agent contributing to the nucleation of surface cracks in the region of the screw thread.

**Figure 6:** Fractography of the region close to the screw thread, where the unmistakable intergranular fracture is seen.

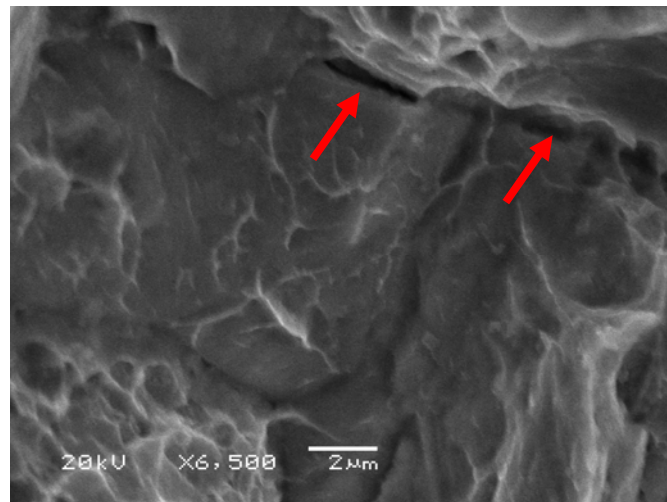
**Figure 7:** Fractography of the region close to the screw thread showing some grain boundary secondary cracks.

Figure 11 illustrates possible microcracks on grain boundaries (indicated by arrows).

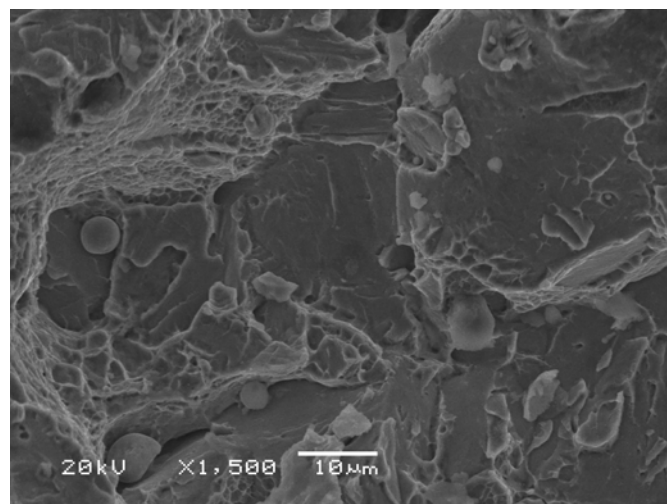
Observing the crack surface in the regions not close to the nucleation crack point one clearly sees that the fracture micromechanism changes. Cleavage facets are seen and also some void coalescence. The considerably small volume of dimpled areas indicates the very limited ductility of the material. Since the component was stressed under tension, one may conclude that cracks propagated until a critical situation was reached that lead to the failure. Thus, failure was initiated in the embrittled region where intergranular fracture occurred and propagated due to the low ductility presented by the high strength material. Figures 10, 11, 12, 13, 14 and 15 illustrate the features found in the crack surface that led the component to fail.

**Figure 8:** Fractography in the central region of the fracture surface showing the fracture micromechanism change. Cleavage facets and regions of shallow dimples are seen.

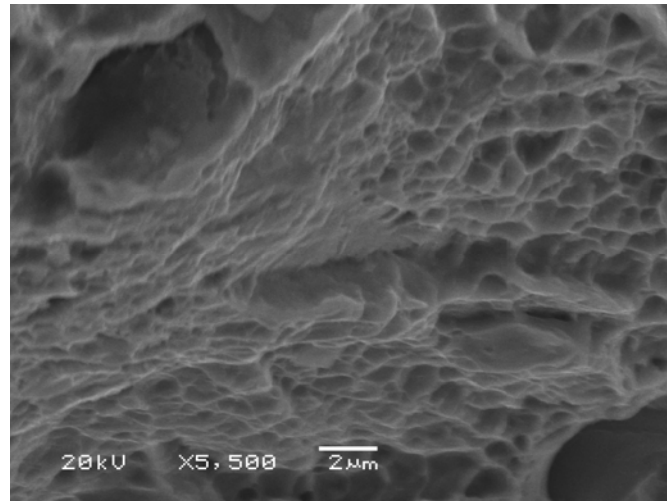
**Figure 9:** The shallow dimples are an evidence of the low ductility of the material.

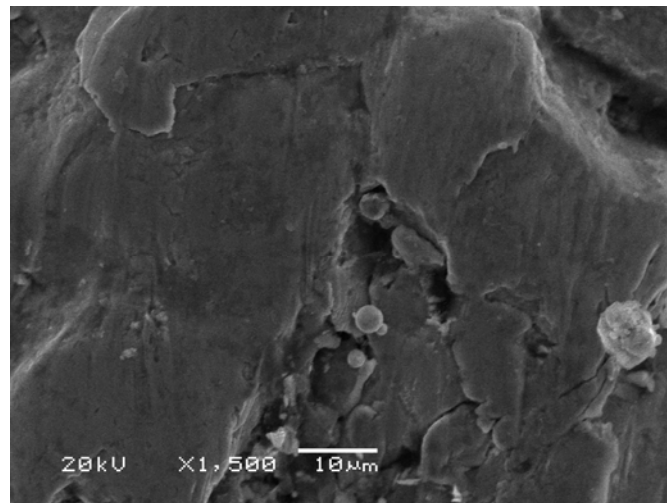
**Figure 10:** The fracture surface in the central region of the specimen shows signs of deformation.

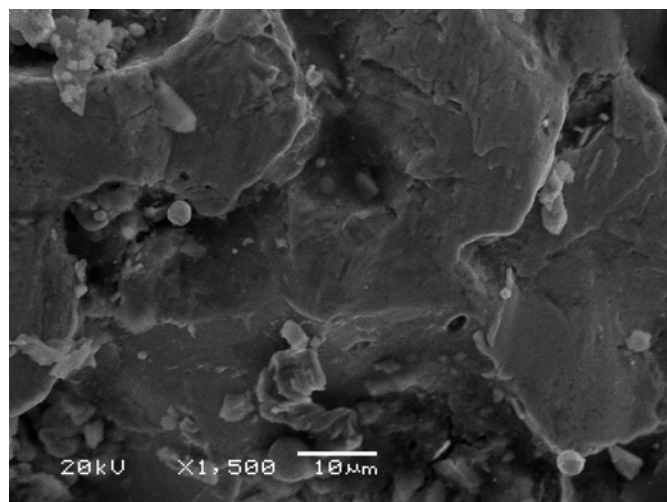
**Figure 11:** A typical cleavage facet in the central region of the fracture surface.
