## EFFECT OF RAIL GRINDING CONDITIONS ON SUB-SURFACE MICROSTRUCTURE AND SURFACE ROUGHNESS OF FATIGUED RAILS<sup>1</sup>

### Abstract

**Keywords:** Rolling contact fatigue; Rail grinding; Head checks.

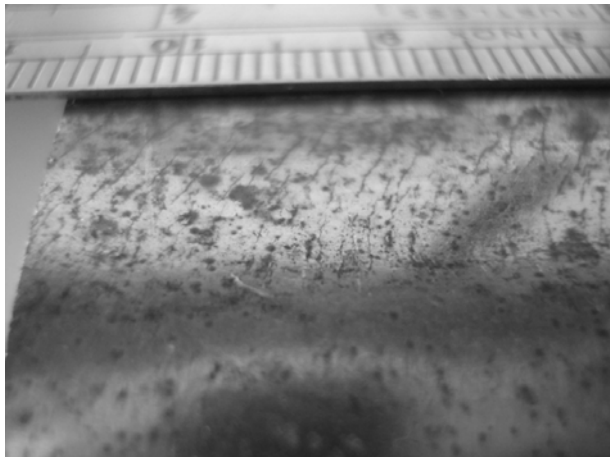
The inspection of fatigued rails revealed the presence of parallel cracks at the surface, which are commonly reported in literature as head checks.<sup>(6)</sup> These cracks grow from inside the rails and in some cases can cause catastrophic rail failures.<sup>(7)</sup> Head checks must be removed by reprofiling and their growth rate defines the “magic” wear rate of the rail, which plays a key role in controlling wear by rail grinding.<sup>(8)</sup> In this case, the inspected rail had an average of 3 cracks per square millimeter (see Figures 3a and 3b for reference). The inspection of the cross section revealed that, on average, the crack depth was 0.5 mm (see Figures 3c and 3d). The angle between the rail surface plane and the cracks was around 35-45 degrees. Some iron oxides were found inside the cracks as a result of the interaction with the ambient. According to these findings and the operator's experience, the grinding procedures were designed to remove 0.5 mm from the surfaces.

a) Head checks on the surface

- Inspection of a commercial fatigued rail showed cracks parallel in the surface (head checks), which were oriented around 36-45 degrees with respect to the traffic direction and had a depth of penetration of circa 0.5 mm.

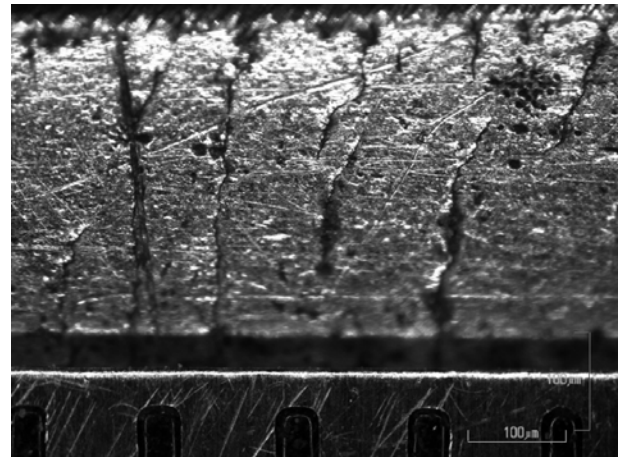
b) Detail of head checks

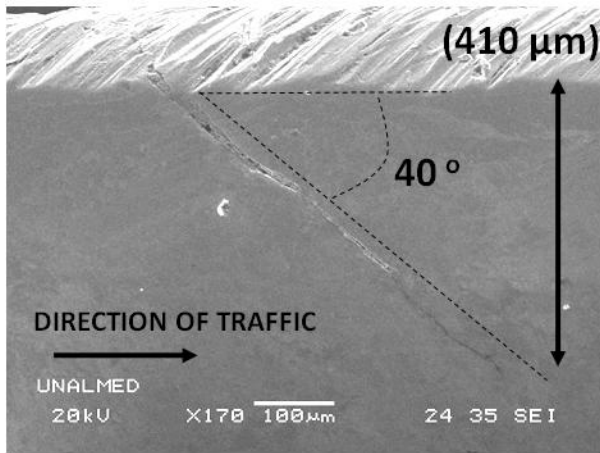
c) Crack observed at the surface

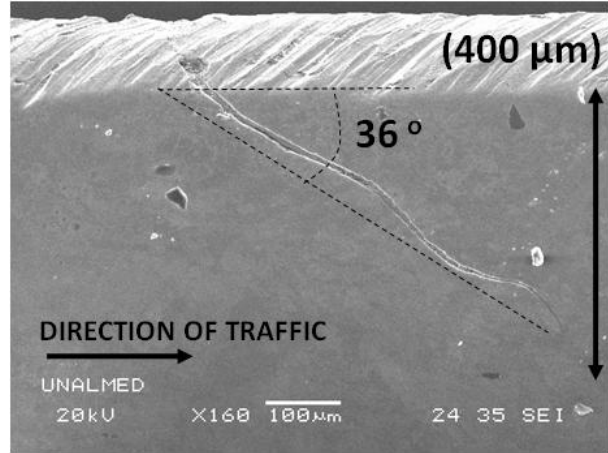
d) Crack observed at the surface

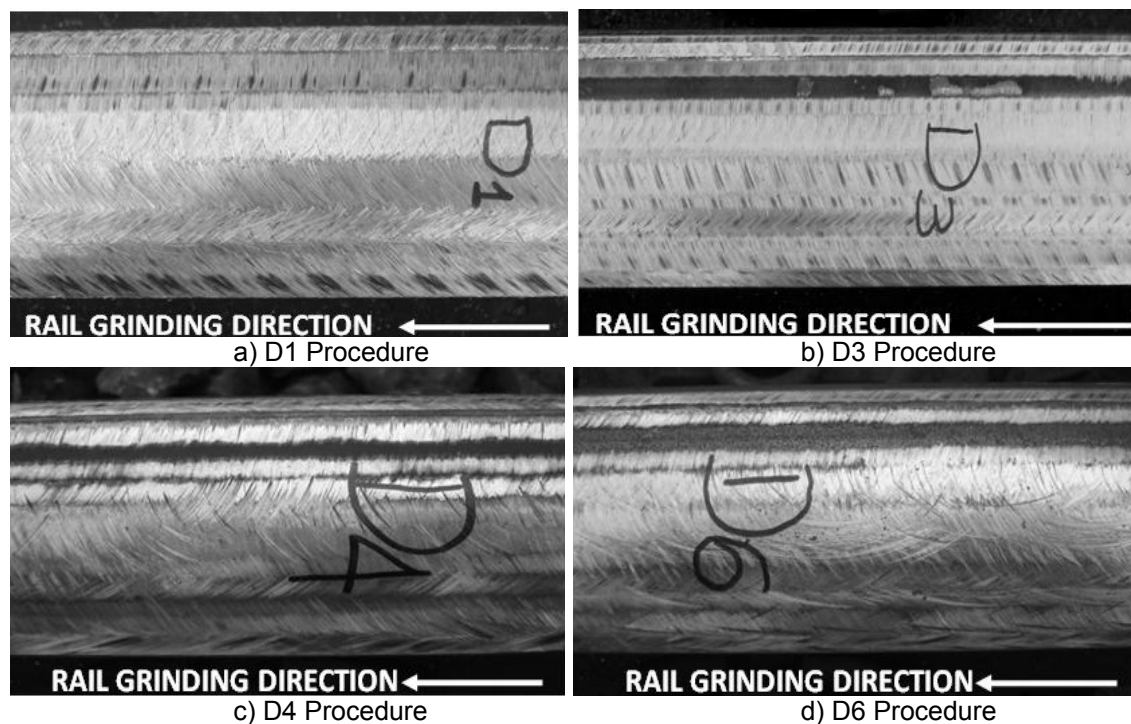
Figure 6 shows the ground surfaces after D1, D3, D4 and D6 procedures. It can be seen that only D1 procedure was effective over the entire rail surface, as opposed to procedures D3, D4 and D6 that left a black zone where the wheels did not grind the rail's surface. On the other hand, the marks seen after the low velocity procedures

Figure 6. Aspect of rail's surface after different grinding procedures. a) D1, b) D3, c) D4, d) D6.

(D1 and D3) were clearly more uniform. According to these results, low velocity grinding is recommended for better results in terms of homogeneity of the surface.

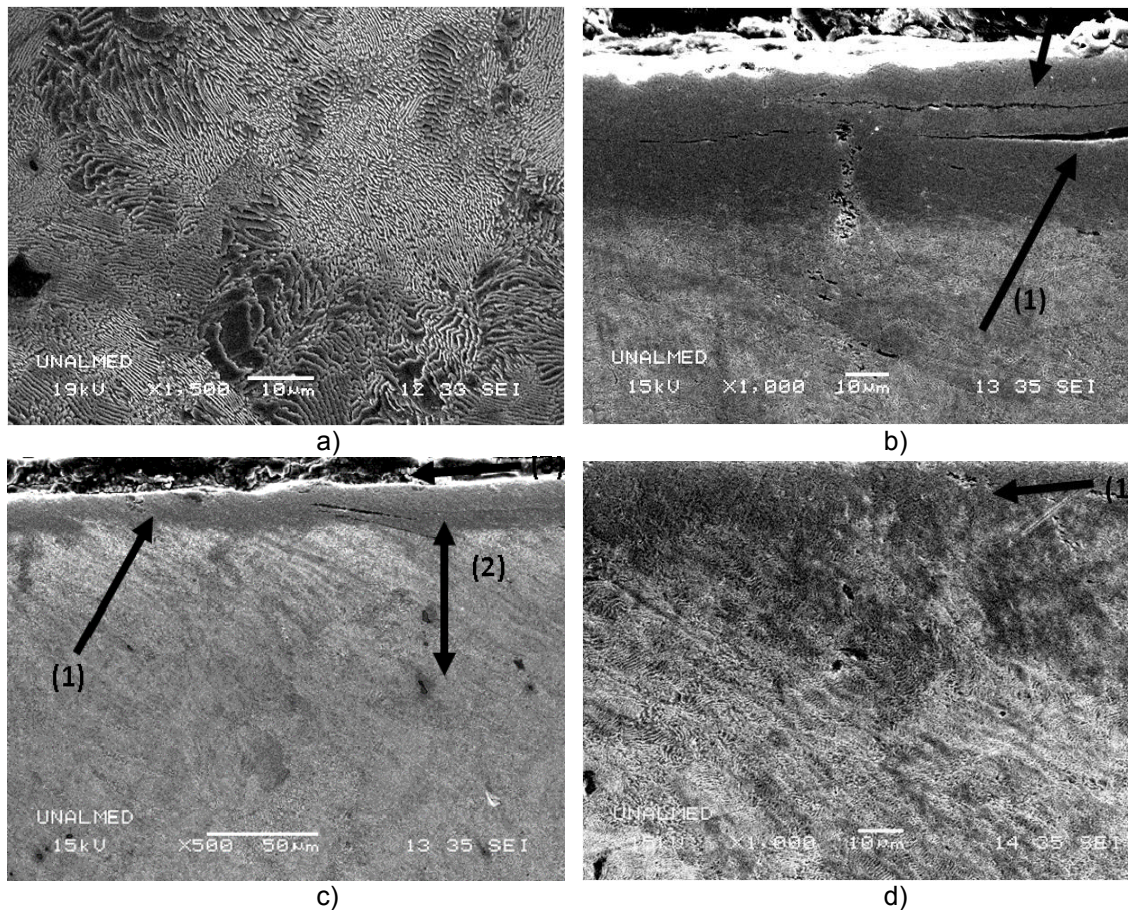
The hard white layer was found in all the inspected rails and it had cracks parallel to the surface (arrow 1 in Figure 7b). Its aspect and the results of hardness measurements (see Figure 8) indicate that it is composed of untempered martensite formed due to localized heating and fast cooling during the grinding procedures, which has been previously reported by Chandrasekar et al.<sup>(10)</sup> Figure 7c shows the white layer (1) and deformed layer (2) after procedure D1 while arrow 1 in Figure 7d shows the hard layer after procedure D4.

**Figure 7.** Rail microstructures for a) Undeformed rail (region far from the contact surface) showing cracks parallel to the contact surface, b) Sub-surface white layer, procedure D1, c) Sub-surface white layer (1) and deformed layer (2), D1 procedure, d) Sub-surface white layer, procedure D4.

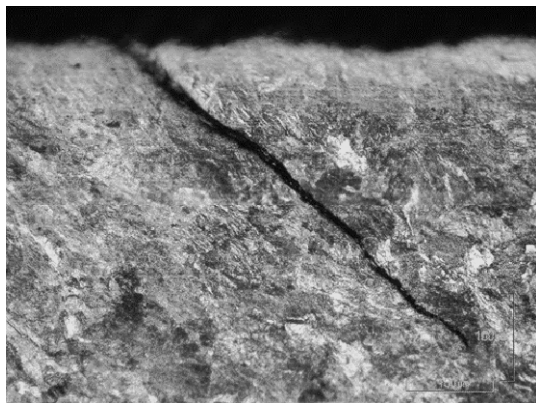
Figure 9a shows the microstructure near the surface before grinding and Figure 9b shows an XRD pattern taken from the ground surface. It can be observed that the grinding procedure effectively changes the microstructure of the subsurface since fresh martensite is formed, and consequently the fatigue response of the rails is presumably affected. In particular, micro-cracks formed at the surface as a consequence of martensitic transformation can act as nucleation sites for fatigue cracks, whose growth notably reduces the fatigue life of the rails. The formation of a hard layer during reprofiling has been recently reported by Kanematsu.<sup>(13)</sup>

a) Microstructure near the surface before the grinding tests
