FAILURE ANALYSIS OF A STAINLESS STEEL STRIP ACCUMULATOR OF AN ANNEALING AND PICKLING LINE*

Alan de Sousa Pereira¹
Antonio Carlos Ataíde²
Andrelino Marcos Ribeiro³
Lucio Ribeiro Camisao⁴
Renato Siqueira Campos⁵

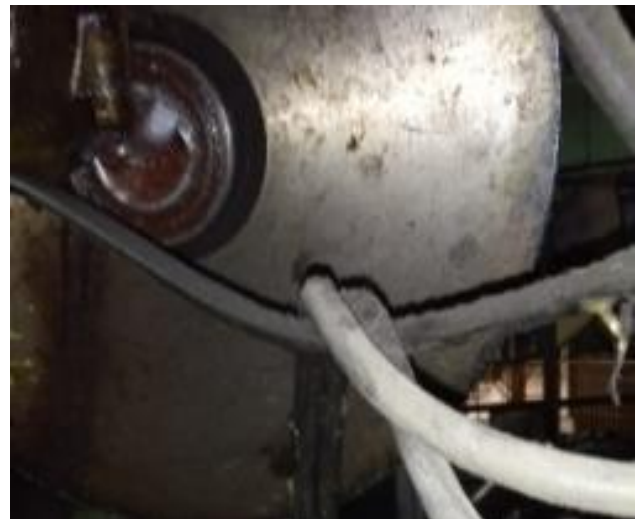
Figura 3. Spindle breakage

On December 10th 2018 occurred the spindle breakage of the pulley carriage of the counterweight belonged to the strip compensation car n.1.

A: Because the shaft was welded to the sheave, which caused the shaft to weaken in the region of the weld in order to break through fatigue.

Action 01: Re-establish the loop car operating conditions.

Action 03: Revise shaft and pulley designs by changing assembly adjustments to interference condition to prevent pulley from moving.

Action 06: To program the replacement of all pulleys and axes of the input and output loops.

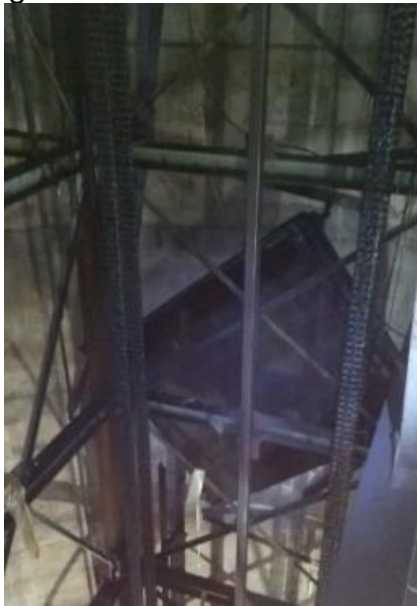
Figure 4. counterweight drop

This break caused the fall of the counterweight on its guides. It caused the plastic deformation of these around the counterweight, in such a way as to make it impossible to move in the positive and

negative direction of y axis. It can be seen in the figure below.

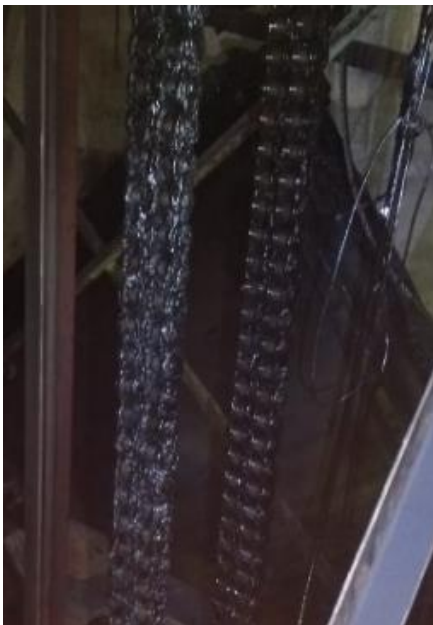
Figure 5. Detail of the counterweight drop

Detail of the counterweight drop on the guides:

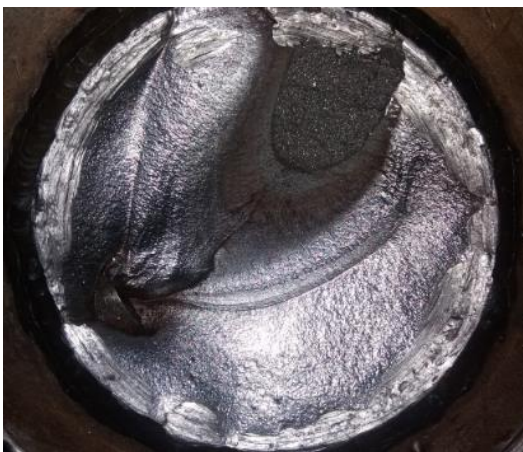
Figure 6. fatigue fracture

The fatigue fracture can be seen in the figure below:

A: Because the weld has generated a tension concentrator so as to core the crack, propagate and fracture the shaft.

It was verified that the fracture by fatigue was by rotary bending [4].

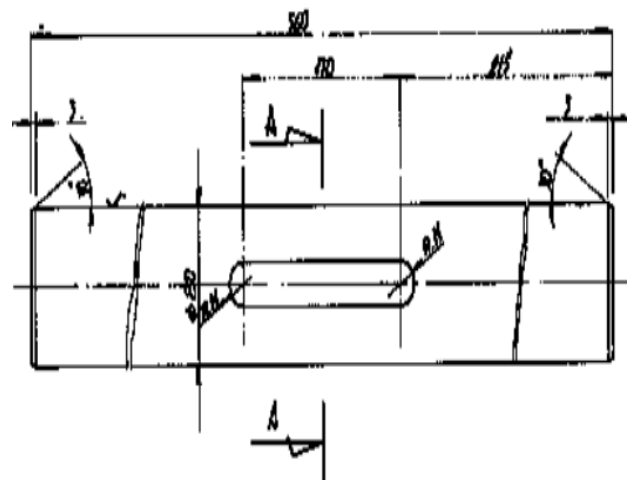
Figure 7. Pulley shaft with open measurement

A: Because the design of the shaft assembly with the pulley does not provide interference fit, which allows the pulley to move against the bearings.

It was soon found that the fact of the weld on the shaft was due to a poor design that did not predict a shaft with interference. As can be seen in the figure below, the 80 mm shaft has an open measurement:

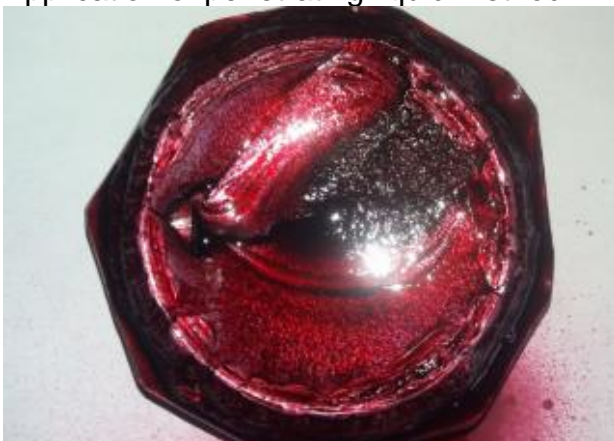
Figure 8. Application of penetrating liquid

Cracks were observed along the entire circumference of the weld after application of the non-destructive test by penetrating liquid.

Application of penetrating liquid method:

Action 02: Perform END on the other axes of the car loop of the input and output.

Action 04: Generate PM to make END on pulley shafts every 4 years.

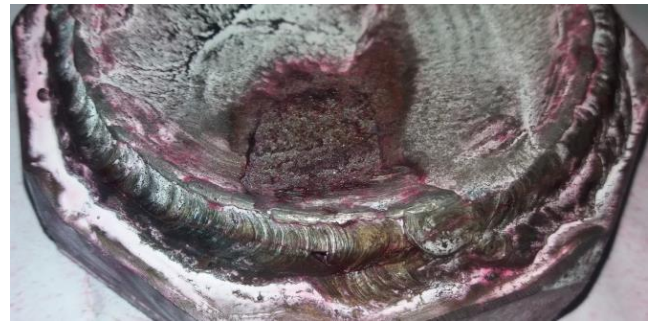
Figure 9. Revealing application

After applying the revealing, it was possible to verify the existence of cracks:

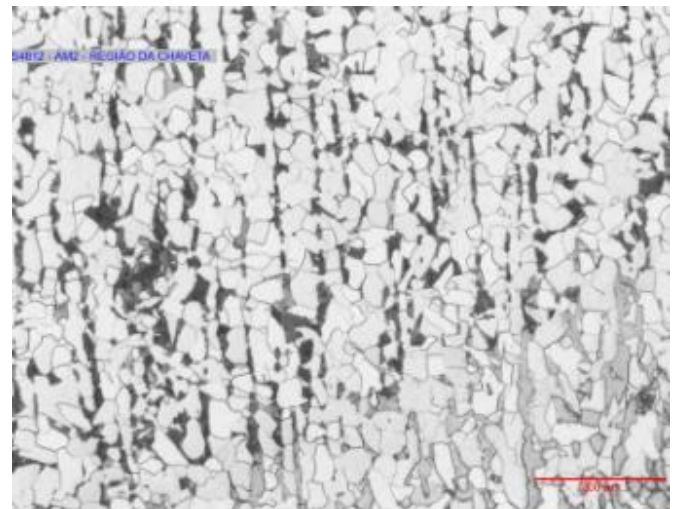
Figure 10. Austenitic microstructure

The first analysis was of the base metal, verifying a predominantly austenitic microstructure:

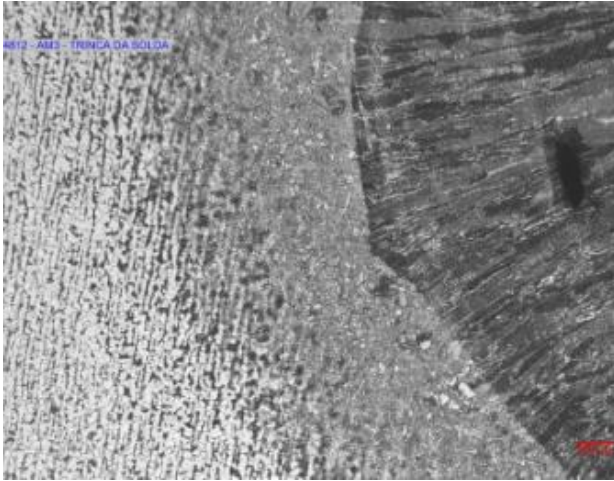
Figure 11. Heat Affected Zone

Then, the analysis of the melted zone and the heat affected zone was carried out in search of martensitic formation:

It was verified the absence of martensite in the heat affected zone, discarding the hypothesis of the microstructure transformation.

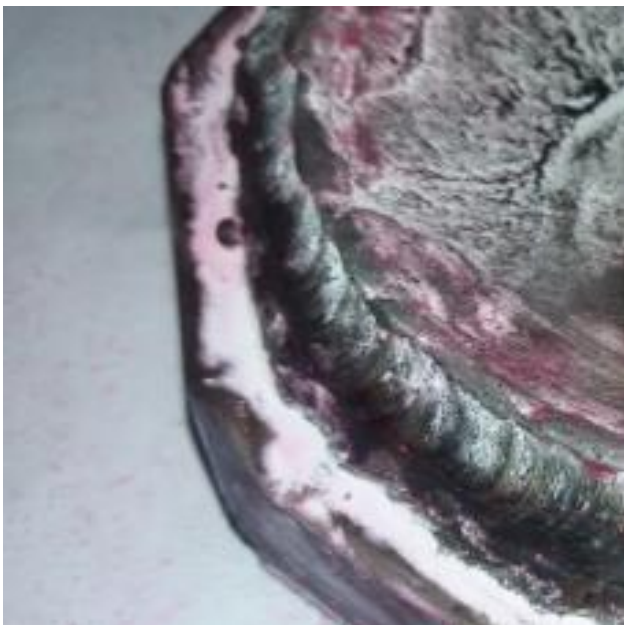
Figure 12. Welding as a tension concentrator

The crack nucleation was verified by fatigue due to the concentration of the stress on the weld bead with an irregular surface. It performed the perfect host for tension concentrators, the main responsible for the nucleation of crack by fatigue.
