## FAILURE ANALYSIS OF ROTARY KILN'S TERTIARY AIR DUCTS \*

Rotary kilns are continuous process equipment used on calcining of nickel ore. The chemical and physical reactions are created by means of heat up the material to predetermined temperatures. Tertiary air fans are attached to the kiln shell to maintain oxidizing/reduction conditions. Special ducts orientate the air flow inside the kiln. In the present work, two types of failure on distinct tertiary ducts mounted on the same kiln are reported. Chemical analysis, hardness test, metallographic and fractographic examinations were carried out. Fabrication related problems and creep were identified as the root causes of damages.

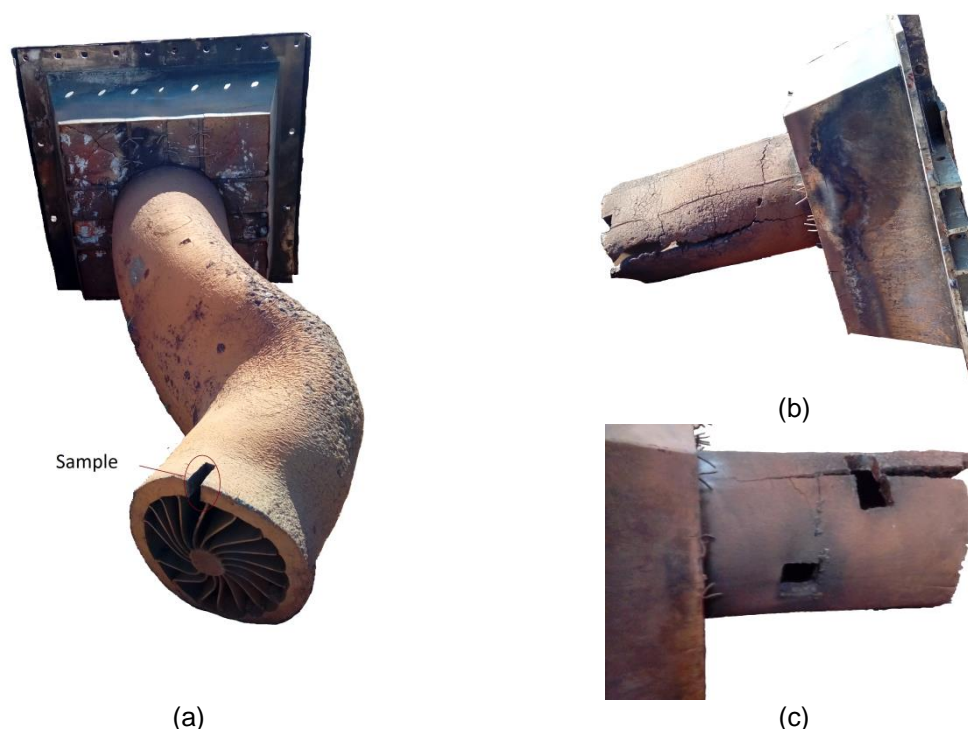
This work presents the failure analysis of the 412-VE-009 and 412-VE-010 ducts, shown in Figure 2. Both failures were detected in 12/27/2016. The results of tests and examinations reported here are based on [3].

**Figure 2.** Tertiary ducts: (a) 412-VE-009; (b) and (c) 412-VE-010.

The plastic deformation observed in the warped duct (Figure 2.a), is considered to be a consequence of creep under high temperature effect. Creep strength and oxidation resistance are critical properties in refractory or heat-resistant alloys. Keep air flowing inside the ducts is of primary importance for a long service life.

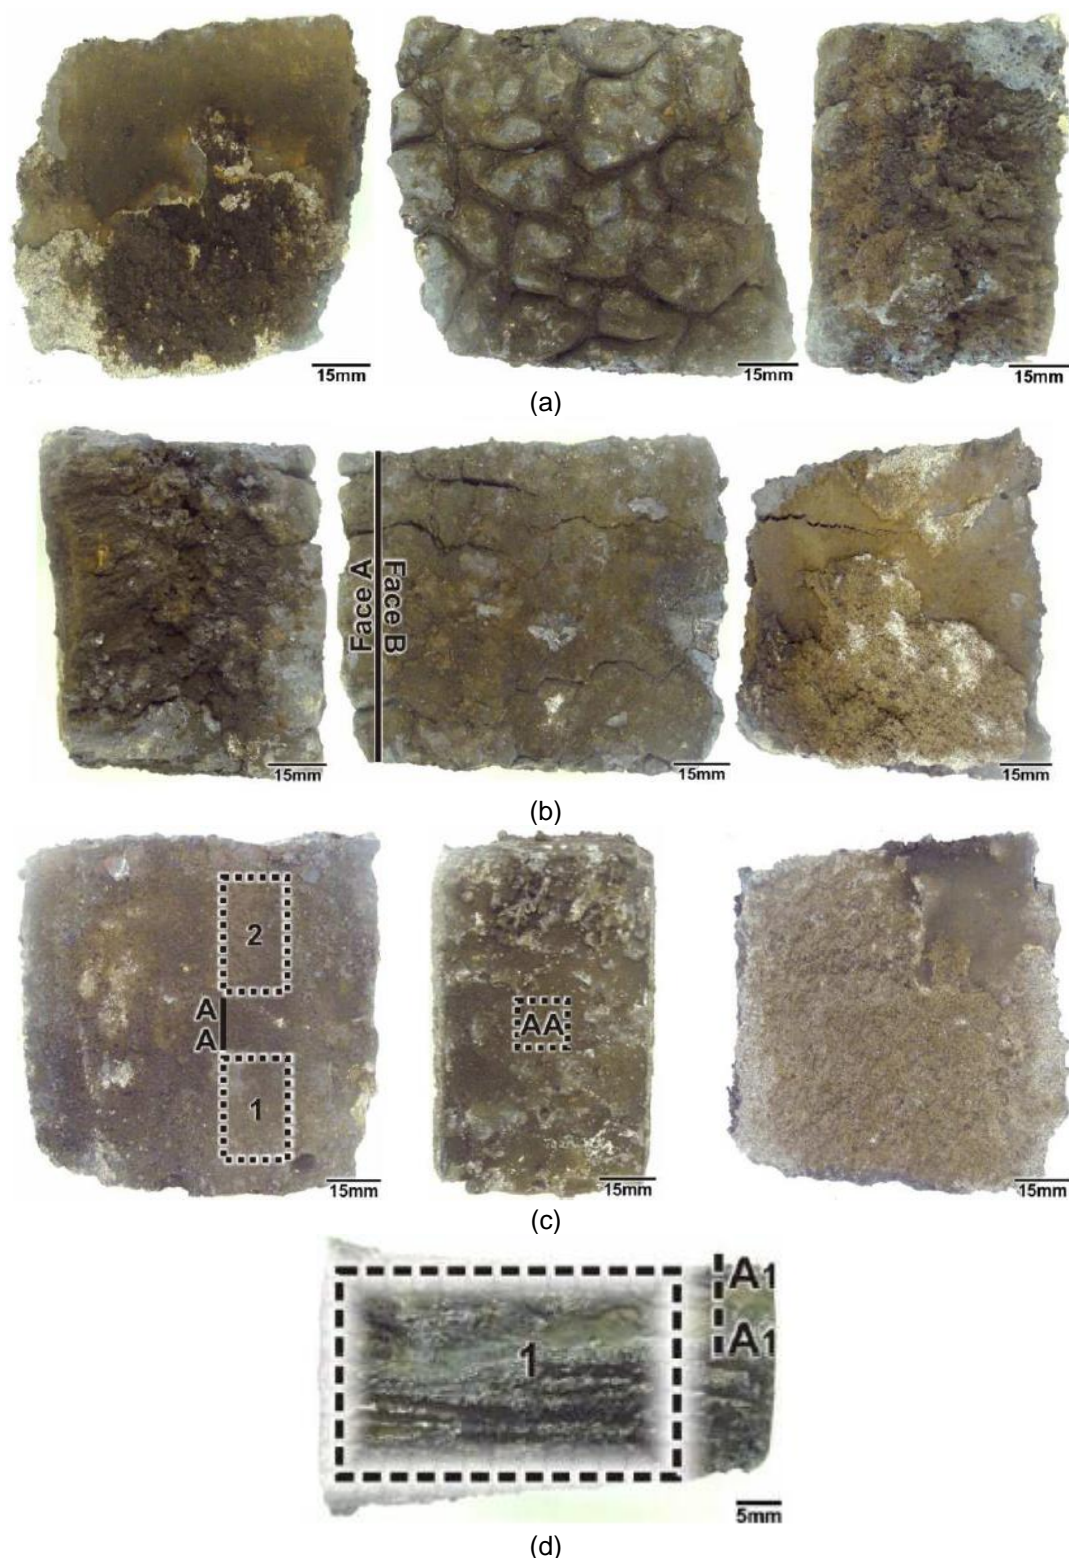
**Figure 3.** (a) Sample #1; (b) sample #2; (c) sample #3; (d) sample #4. After [3].  
**Table 2.** List of tests and examinations with the respective samples, regions and sections considered for analyzes and test specimens' identification.

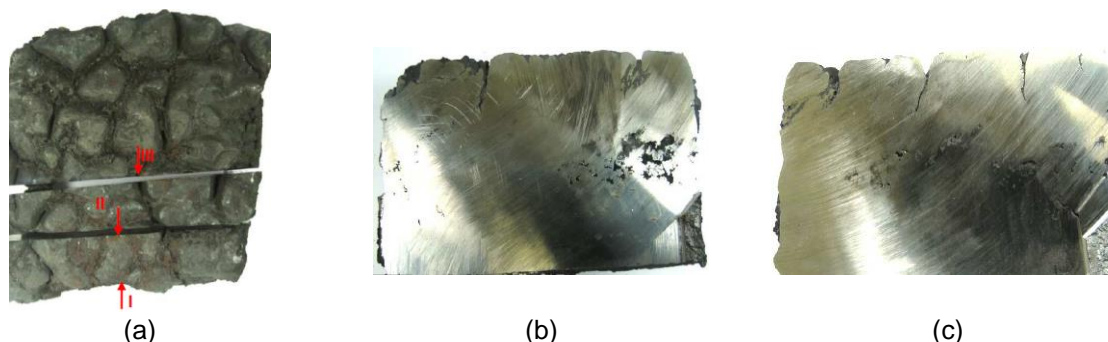
The surface aspect of samples #1 and #2 (Figure 4.a and 5.a) is compatible with damage caused by oxidation at high temperature.

Figure 4.a shows the sample #1 sectioning plans. The arrow I points to the fractured surface, while arrows II and III point to the sectioned surfaces presented in detail in Figures 4.b and 4.c, respectively. The sections revealed cracks and the presence of voids in the central region of the sample. The morphology and position of these voids indicate a casting defect known as shrinkage, resulting from the liquid-solid contraction that the material underwent during solidification.

**Figure 4.** (a) Sample #1; (b) and (c) sections indicated by arrows II and III respectively. After [3].

In the Figures 4 and 5 one may observe the metallurgical defects (shrinkage) that caused the premature fracture of the duct. The extension of these defects decreased the creep strength of the duct causing its premature failure.

The failure analysis presented in this paper led to a series of actions aimed obtaining a longer service life for the tertiary air ducts. A simulation of the casting process (filling, solidification, cooling and feeding system) was commissioned in order to prevent metal casting defects. Creep tests to identify the parameters that dictate the behavior of the specified duct material were also performed. These parameters were used in numerical simulations to compare the predicted life of the original duct with one manufactured with an H-type alloy [9]. Optimization of the duct geometry is in progress. The results of these studies will be published opportunely in a future article.

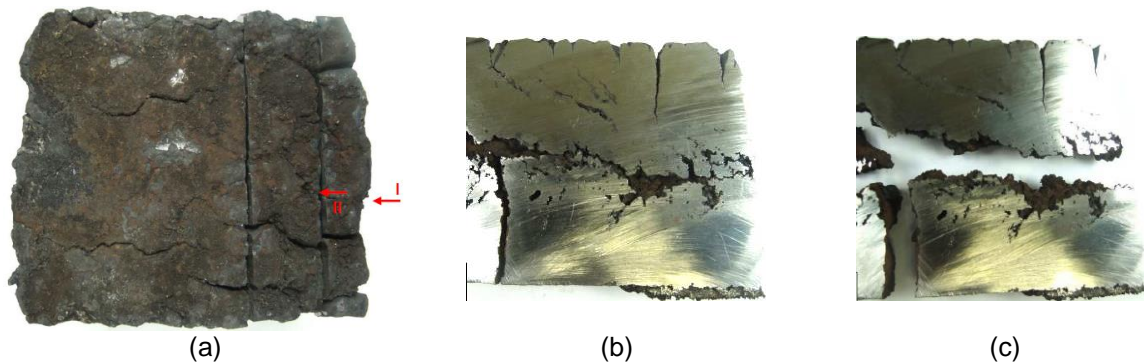
Figure 5.a shows sectioning plan of sample #2. The arrow I points to the fractured surface. The arrow II points to the sectioned surface presented in Figure 5.b, in which can be observed cracks, high temperature oxidation regions and shrinkages in the central region. These voids are larger than those observed in sample #1. The extent

of the defect was so great that a small impact load in the sample was sufficient to fragment it into four parts (Figure 5.c).

**Figure 5.** (a) Sample #2; (b) section indicated by arrow I; (c) the same section after a little impact load. After [3].

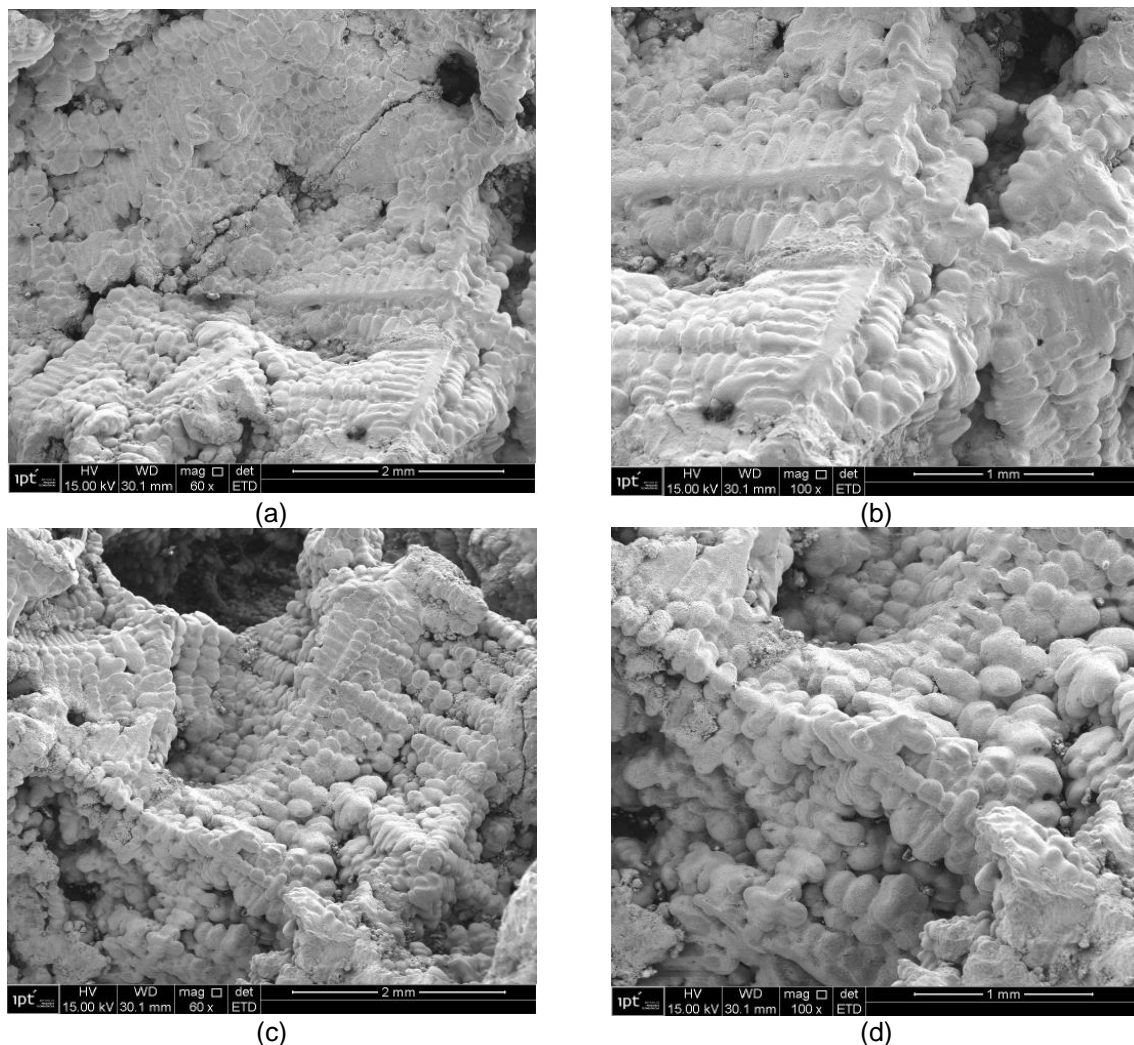
Specimens taken from the regions with voids of sample #2 were subjected to observation on the SEM. The results are shown in Figure 6. It can be seen dendrites resulting from the solidification and confirmed that defects in the extracted samples of the fractured duct are shrinkages.

**Figure 6.** Surface topographic appearance of the voids observed in sample #2, specimen M4719-3: (a) and (b) region 1; (c) and (d) region 3. After [3].

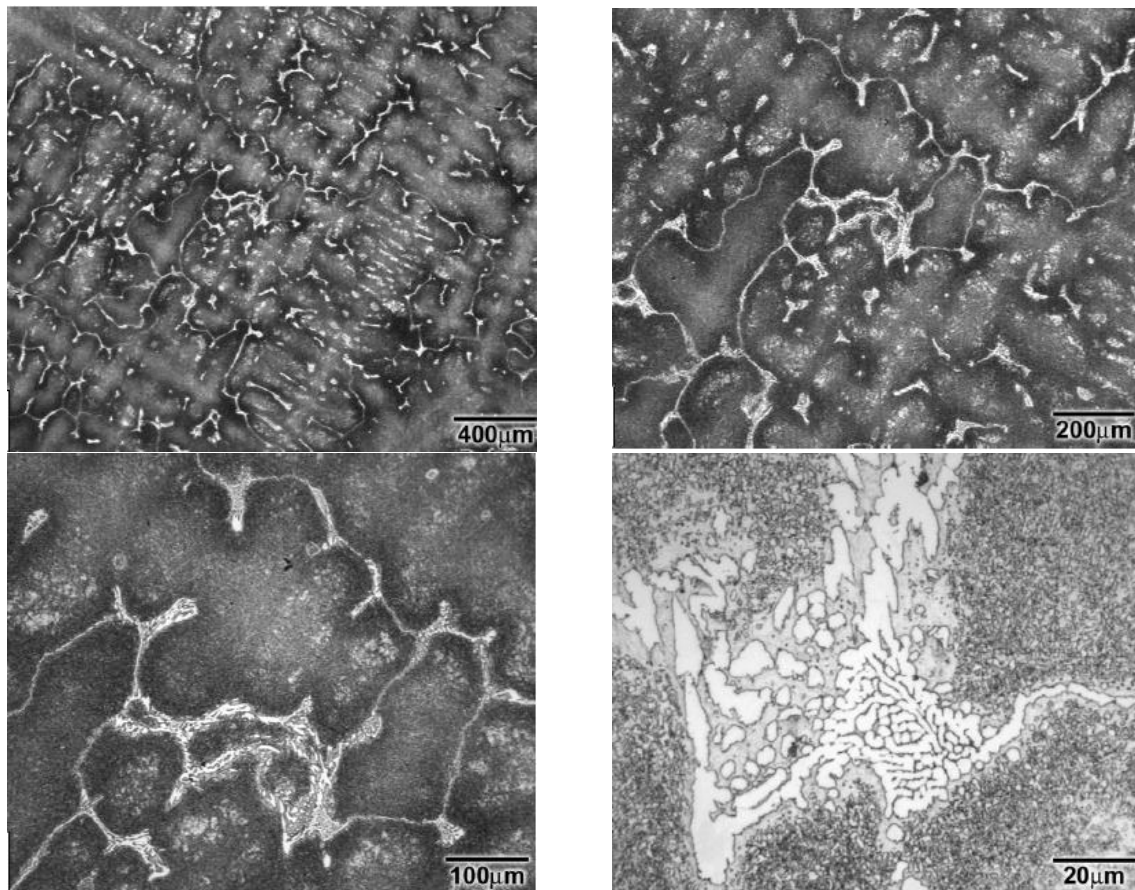
The metallographic analysis of the fractured duct material (sample #3) revealed characteristic microstructure of a cast hypoeutectic ferrous alloy, showing carbides in interdendritic regions and secondary carbides precipitation in the matrix (Figure 7). The chemical composition and the ferromagnetic nature observed in the alloy indicate that the material has a ferritic matrix. The same test specimen for the results of Figure 7 was observed on the SEM. Figure 8 shows backscattered electron images and secondary electron images of the microstructure of this material.

**Figure 7.** Test specimen M4719-4 microstructure observed with increasing magnitudes. After [3]

reaction is expected with the formation of the  $M_7C_3$  carbide and this carbide undergoes decomposition for  $M_{23}C_6$ . The carbides observed in interdendritic regions (Figures 7) are probably the carbides  $M_{23}C_6$ .

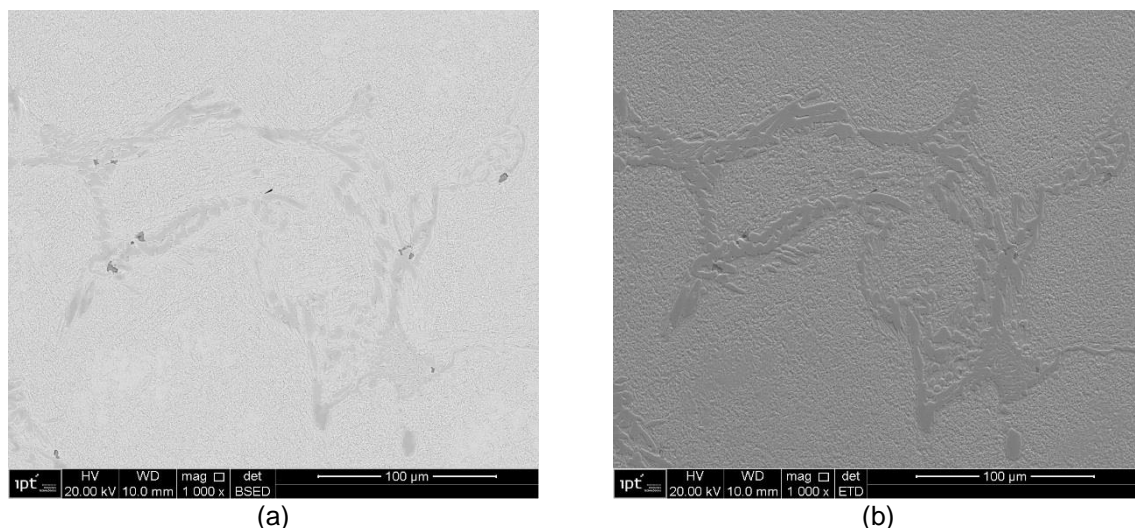
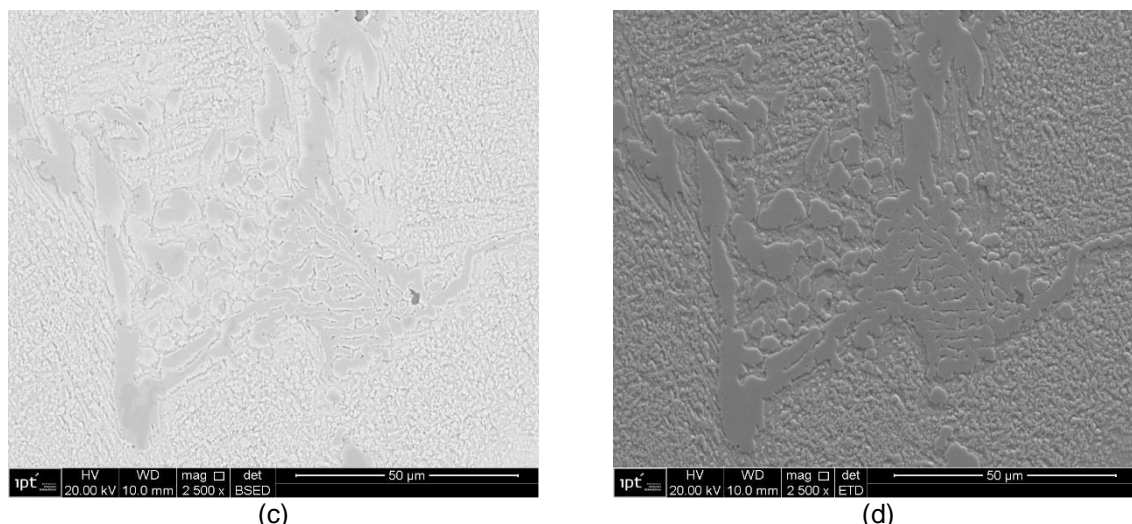
**Figure 8.** (a) Image of backscattered electrons showing the interdendritic eutectic region; (b) the same region of (a) observed with secondary electron image; (c) backscattered electron beam showing the interdendritic eutectic region with the highest magnification; (d) the same region of (c) observed with secondary electron image. Sample #3 - test specimen M4719-4. After [3].

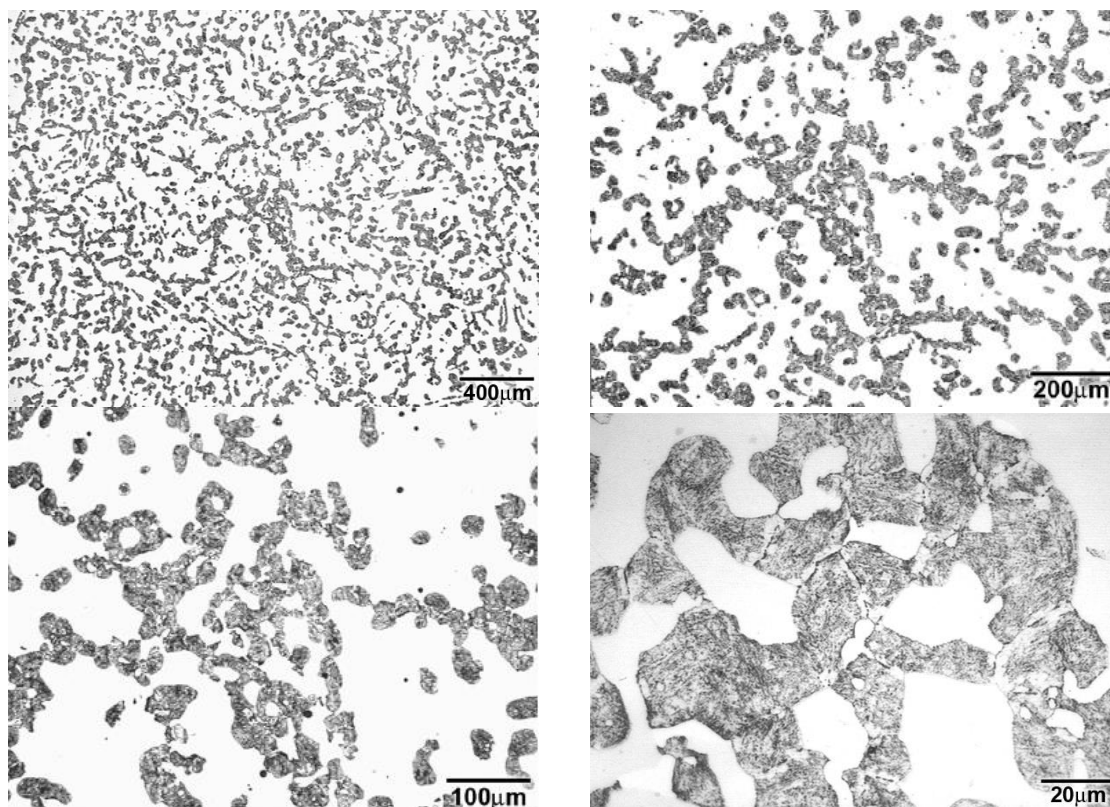
Microstructural analysis of the warped duct material (sample #4) revealed microstructure of a cast ferrous alloy (Figure 9). In this sample the presence of eutectic microconstituents was not observed. The morphology of the dark microconstituent suggests being precipitates resulting from reaction in the solid state known as discontinuous precipitation. The same test specimen with respect to the results of Figure 9 was observed on the SEM. Figure 10 shows backscattered electron images and secondary electron images of the microstructure of the material.

**Figure 9.** Aspect of sample #4 – test specimen M4719-6 microstructure observed with increasing magnitudes. After [3].

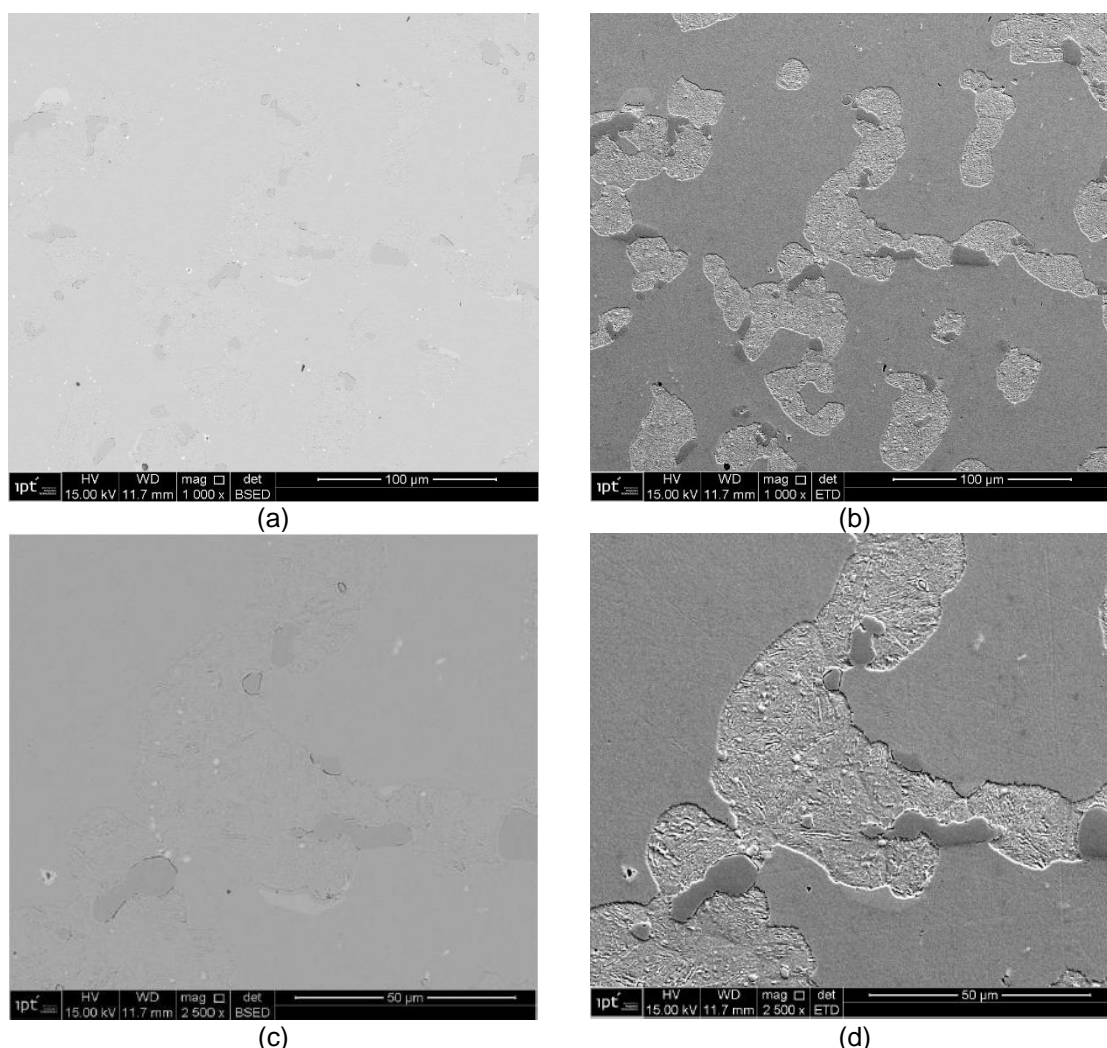
The lamellar nature of the carbides is clearly observed in Figure 10.d; this is a typical characteristic of as discontinuous precipitation.

**Figure 10.** (a) Backscattered electrons image showing areas with different shades of gray; (b) same region of (a) observed with secondary electron image; (c) backscattered electrons image showing the same region of (a) with higher magnification; (d) same region of (c) observed with secondary electron image. Sample #4 – test specimen M4719-6. After [3].
