IMPROVEMENT OF THE PERFORMANCE OF THE BOSH COOLING SYSTEM OF ROGESA NO. 5 BLAST FURNACE*

Walter Hartig¹
Franz Reufer²

Abstract

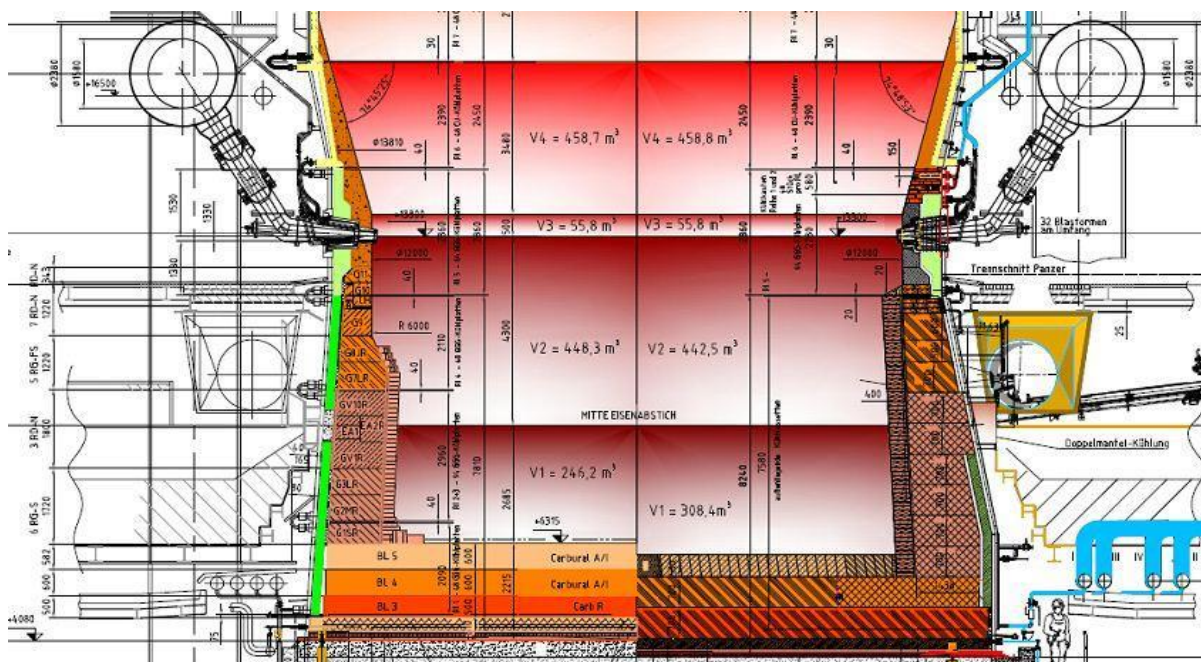
Fig. 1. Old and new design of the hearth

Fig. 1 shows the comparison of the old (left) and new design (right).

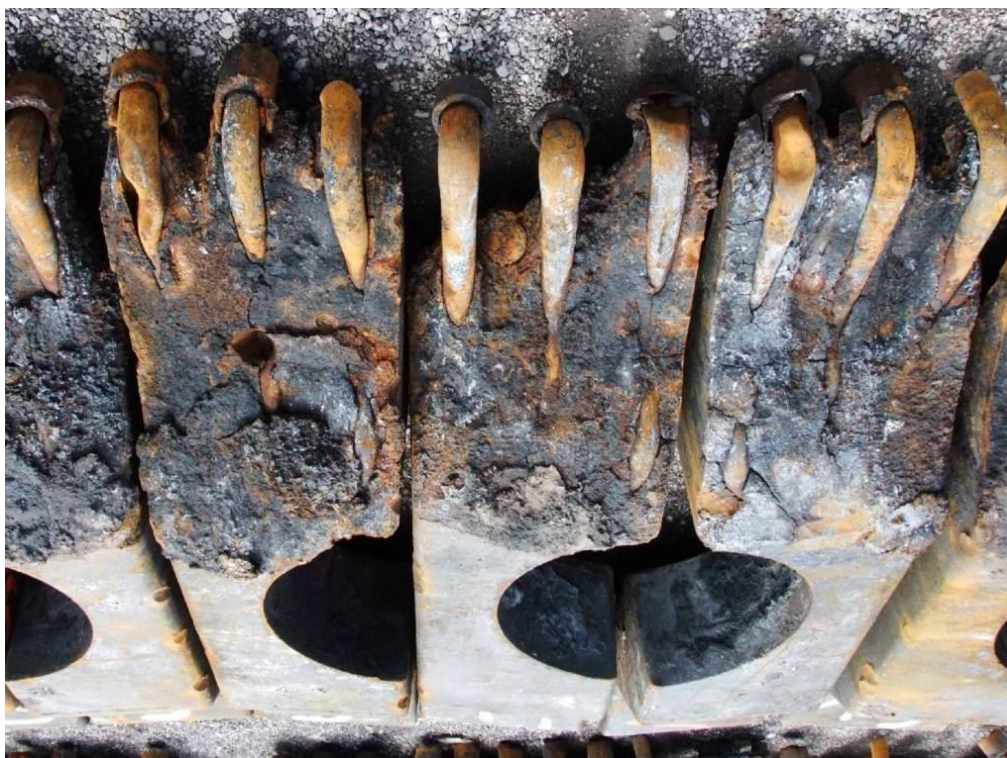
This interim repair in 2005 had to be performed in an emergency situation because of the accelerated progressive wear of the hearth walls and the cast iron staves in the bosh leading to hotspots after 8 years of operation. Also after the interim repair the wear of the tuyere staves continued and in consequence the reline had to be done in 2010. The main cause for the wear was the use of low quality coke [2].

The „weak point“ of the cooling system of the furnace was above the tuyere level where also a breakout occurred in March 2010 which caused a three day stop of the furnace for repair. Fig. 2 shows the tuyère staves after the dismanteling after the 2nd campaign.

Fig. 2 Worn out tuyère staves after dismanteling

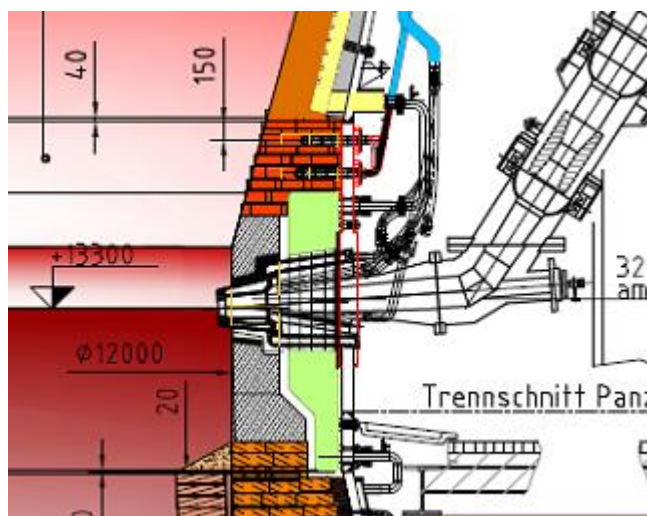
Fig. 3. Cooling system at tuyere level and bosh.

The new concept for hearth cooling and lower bosh was chosen in order to improve the efficiency of the cooling and also to give a maintenance friendly construction in the case of the failure of the cooling boxes. (Fig. 3)

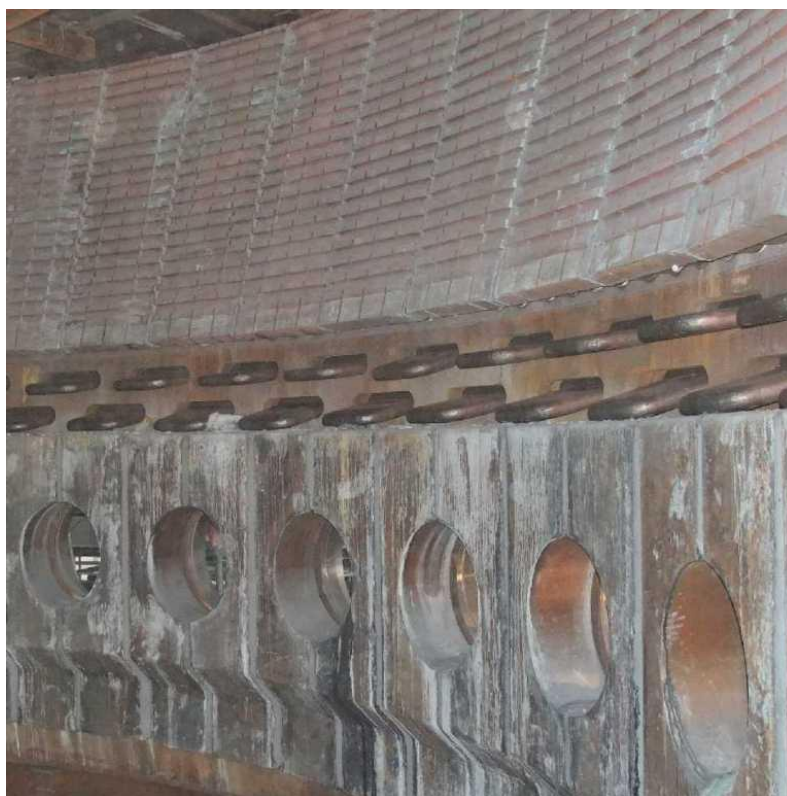
Fig. 4 Tuyère staves, cooling boxes and bosh staves during before refractory installation

Fig. 4 shows the area of the cooling boxes before the installation of the refractory brickwork.

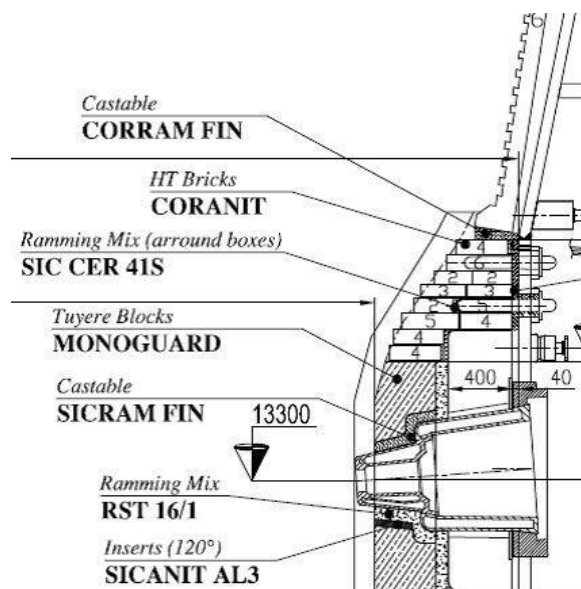
The installation of the refractory brickwork was made with bricks and ramming mix at the joints between the bricks, the cooling boxes and the shell. The refractory quality was high alumina nitride bonded material identical to the ceramic cup. (Coranit) (Figure 5).

Fig. 5 Brickwork of the area of the cooling boxes

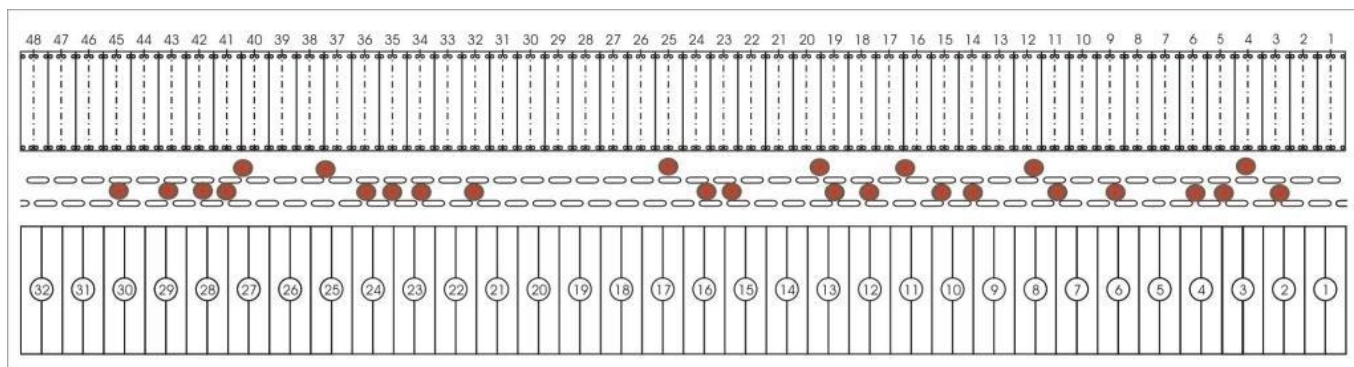
During the months after commissioning the PCI-rate was on a medium level of 150 kg/t HM and the productivity of the furnace was also on a moderate level between 6000 and 6500 t HM/d. In spite of these moderate conditions hot spots occurred at the shell between the cooling boxes caused by gas flowing between the brickwork and the shell. The first hot spots occurred in the area of the assembly opening of the shell, afterwards around the whole furnace. Fig. 6 shows the locations of the hot spots.

Fig. 6 Locations of the hot spots after commissioning

The intensities of the hot spots increased over the time, consequently a package of measures had to be taken in order to avoid a breakthrough of the shell like it

happened in 2010. In the case of the appearance of hot spots the following countermeasures were taken:

- Switch off of the coal injection in the affected area
- Forced cooling by compressed air or waterspray
- Reducing of the productivity

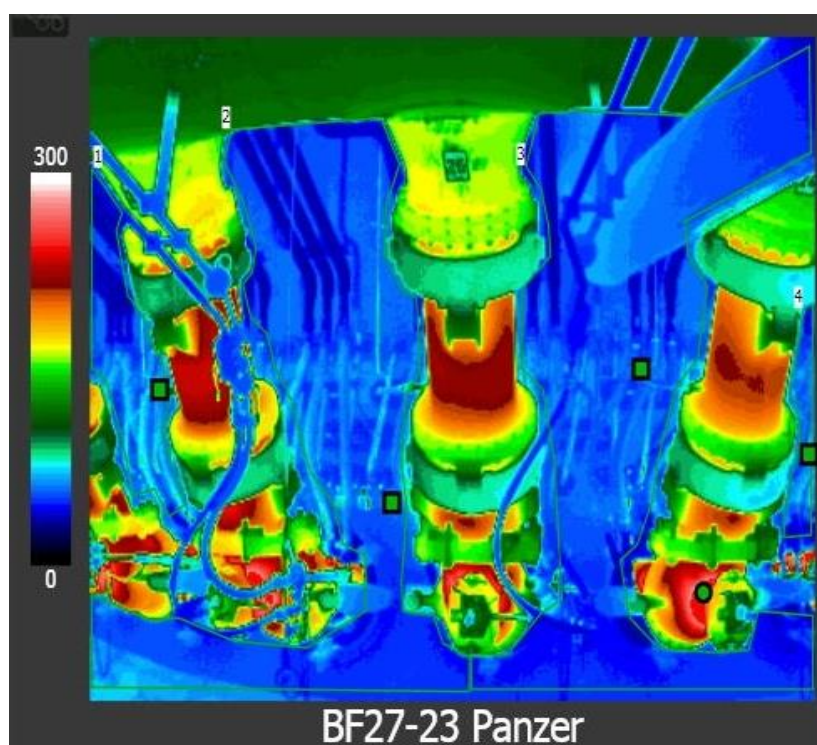
- Installation of Infrared cameras on the tuyère platform (Fig. 7)
- Injections of refractory castable at stoppages.
- Installation of longitudinal thermocouples on the shell
- Measurement of the temperature of the cooling water of the cooling boxes.

Fig. 7 monitoring by IR camera

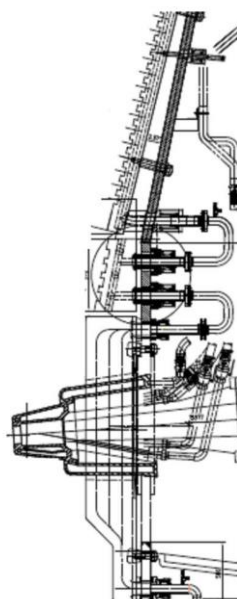
During the year 2012 the PCI-rate was increased from 160 to 180 kg/ t HM, which resulted in a higher heat load in the bosh area with consequently more frequent occurrences of hot spots. The observations during stops of the furnace showed that the complete refractory brickwork had disappeared. Because of this reason it was decided to make an intermediate repair and to replace the cooling boxes by staves.

Fig. 8 New construction of the bosh cooling by staves

Fig. 8 shows the new construction: the two rows of cooling boxes were replaced by one row of 48 short copper staves. The cutouts in the shell for the cooling boxes could be reused for the attachment of the staves, so that no new borings or cutouts had to be made. The water supply for the new staves was integrated in the existing shell cooling, whereas the cooling boxes had their own water supply which could be put out of service. The construction of the new stove is compact with one waterchannel inside like a serpentine the water supply inlet and outlet and a bolt as assembling aid.

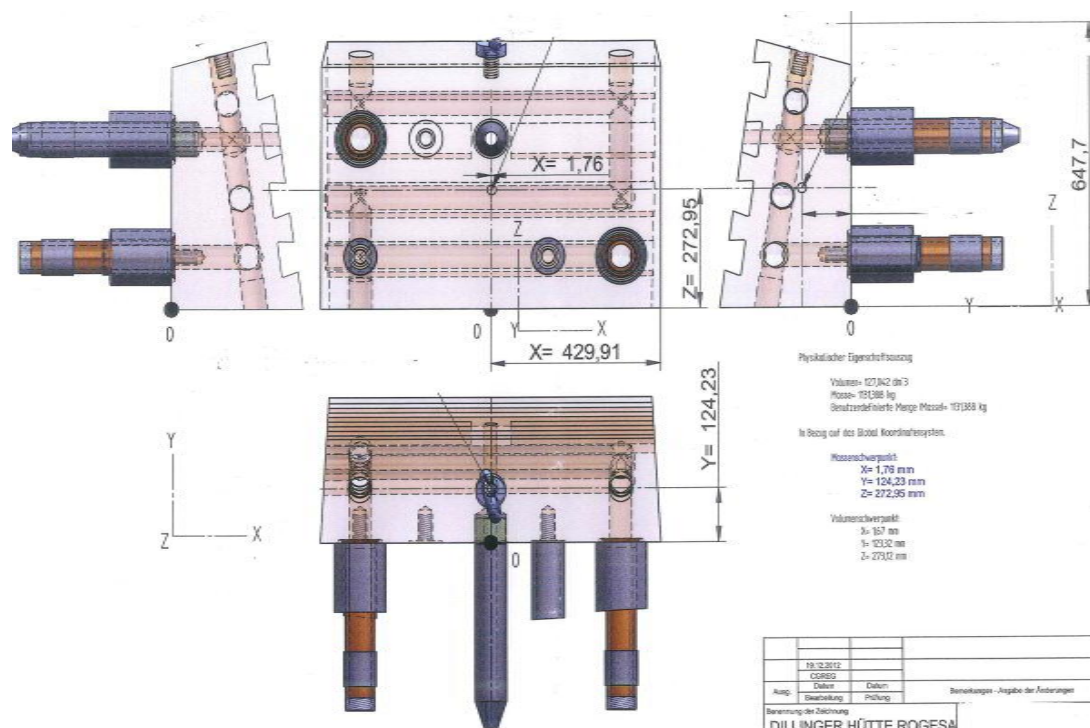
Fig. 9 Drawing of the new bosh stove

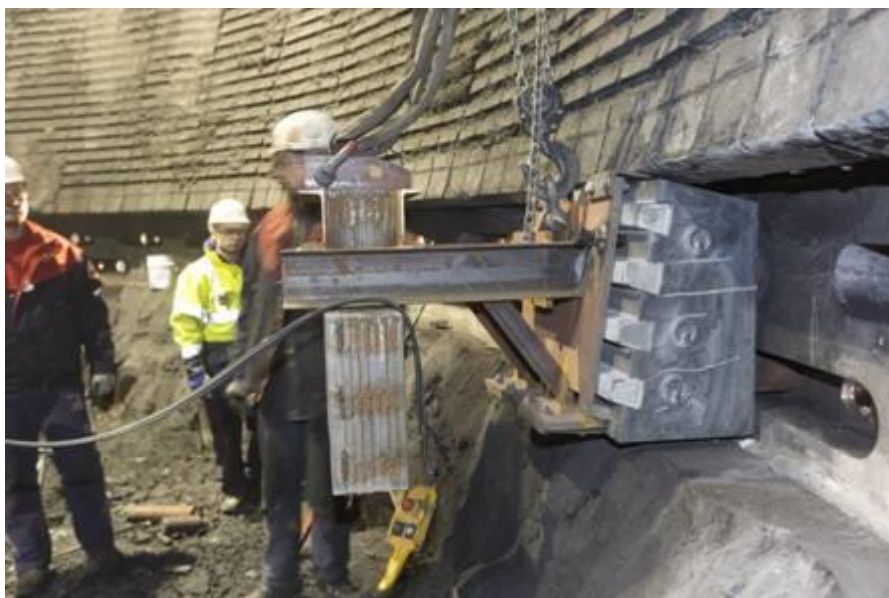
One week before blowing down a special burdening pattern was set, in order to clean the shaft. Therefore the shaft was free of accretions, so that almost no cleaning had to be made. Tanks of the concrete cover the work inside the furnace could be done without breathing protection measures. The table shows that the project was realized in the scheduled time and also without major incidents. Fig. 10 shows the installation of the first copper stave with a mounting suspension.

Fig. 10 Installation of the new copper staves between tuyère stave and bosh

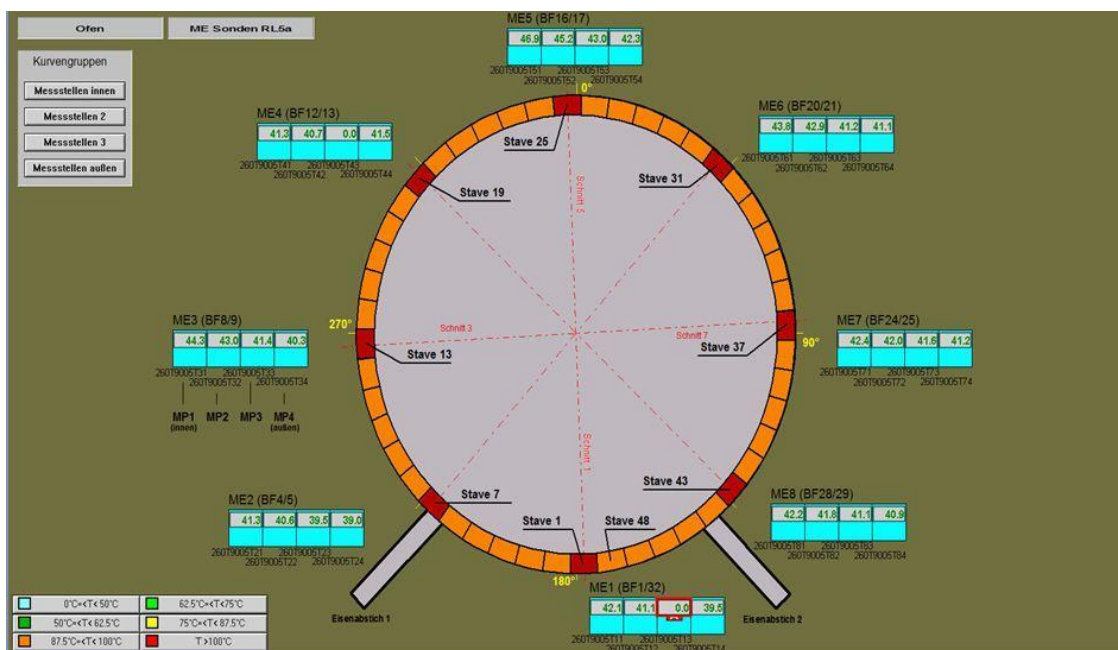
Each 6th of the new built in 48 copper staves is equipped with a multiple temperature measurement of four thermocouples with different depths of 100 mm distance. By this lay-out the temperature gradient inside the staff in radial direction can be monitored. The readings of the temperature measurements show that there can temporarily occur temperatures up to 190 °C resp. a heat load of 150 kW/m². It is also interesting to notice, that the heat load is the higher the better the furnace is working. Fig. 11 shows the temperature of the inner thermocouple the may 14th to 22th

Fig. 11a. Multiple Thermocouples in the new bosh staves.

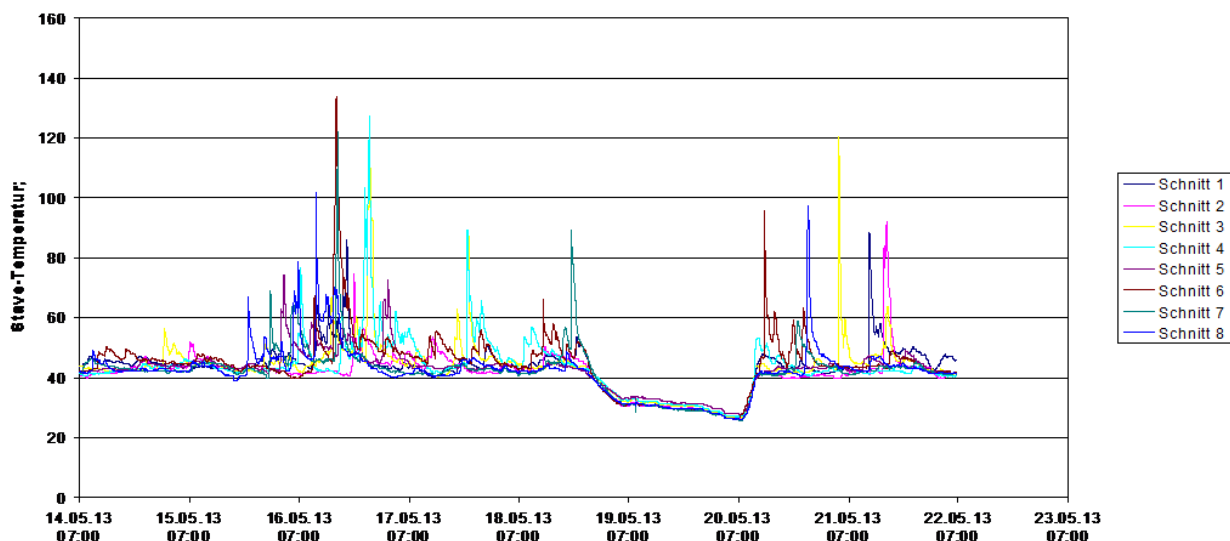
Fig. 11b Temperatures of the new bosh staves
