## PERFORMANCE ANALYSIS OF GALVALUME STEEL SHEETS FOR METALIC ROOF TILES\*

### **Abstract**

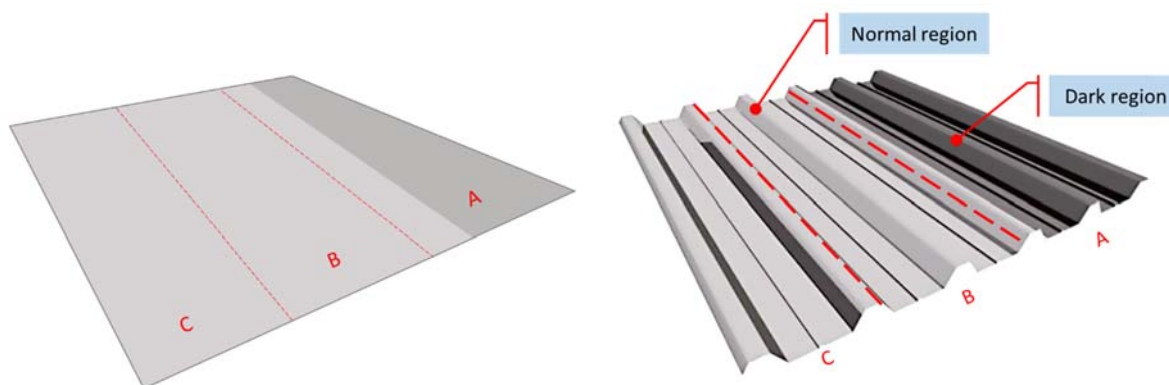
Figure 1 summarizes, graphically, what it was described formerly. The localization of this region in the coils is near one of the mill's edge. This band is contained in the samples identified as "A", according making on the furnished samples. The mentioned surface characteristic normally is not visible on plates before forming or processing by straightener/flattener/leveler equipment.

**Figure 1.** Left: galvalume/aluzinc sheets representation of the regions sampled. Right: representation of the problem and the association with the regions sampled.

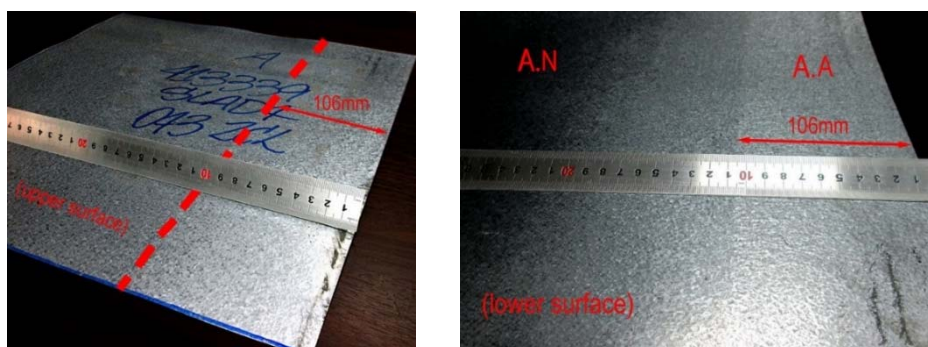
Figure 3 shows the visual aspect of the sample 43A. It was the only sample, among all received, with a slight surface difference visible even to the naked eye. In the Figure 3, it can be noted an abnormal “bright band” near the mills edge of the sheet (sample) 43A. This region was identified as “43A.A” and has an approximate size (width) of 106mm. That region is more prominent in the lower surface of the sheet (inner side of the coil) than the upper. The remainder of the surface, named as “43A.N”, is very similar to the other’s samples surfaces (43B and 43C).

**Figure 3.** Abnormal “bright band” on the mill’s edge of the sample 43A. The characteristic is more visible on lower surface.

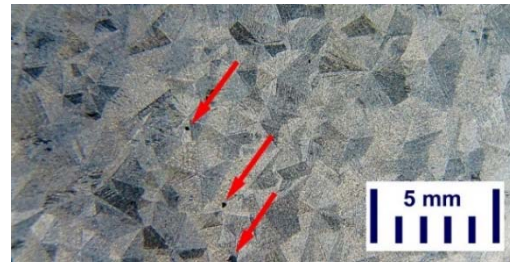
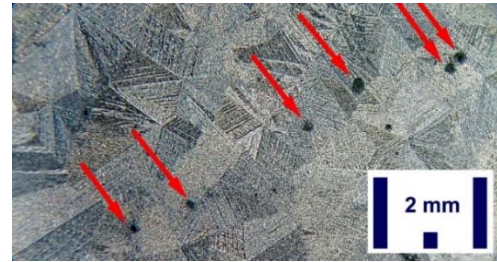
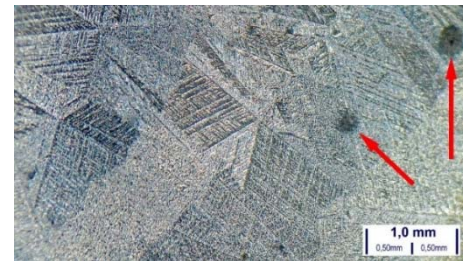
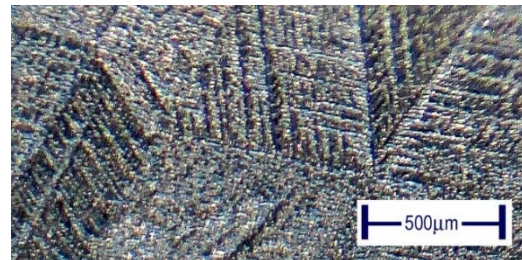
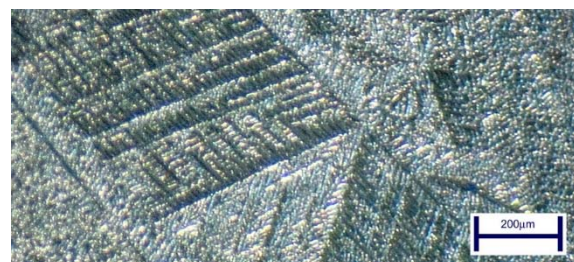
**Figure 4.** Normal (N) and abnormal (A) surfaces on sample 43A as seen by light microscopy.

It can be noted by the photos taken by stereo microscope (Figure 4) that the bright region is formed by a coarse deformation pattern on aluminum-zinc-silicon alloy (galvalume/aluzinc layer), which is more easily seen at magnifications of 200X. Whereas the galvalume/aluzinc layer is homogeneous, it seems that the steel substrate deforms more intensely in the 'abnormal' region (A.A) than in the other

(A.N). This difference deformation of the steel substrate can generate the coarse-like deformation structure of the aluminum-zinc-silicon alloy crystals as viewed on surface (Figure 4 at 200X).

Moreover, it is noted that there are 'dark spots' on abnormal (43A.A) surface, many of them visible on lower magnifications (10X and 20X). Figure 5 shows one of these spots with more details and reveals that these stains are a kind of localized oxidation that occurs preferably between the walls of the aluminum-zinc-silicon alloy crystals.

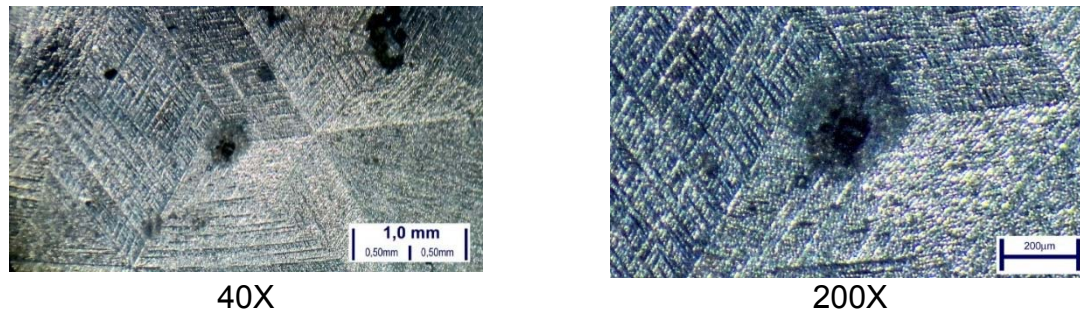
**Figure 5.** 'Dark spot' viewed on surface of the sample 43A.A, as seen by light microscopy.

The dark spot/stain observed is very similar to the feature known as "wet storage stain". In this case, galvalume/aluzinc has excellent durability in the atmosphere because of the protective, air-formed oxide that forms on the surface. However, if there is no free access to dry air and if water or moisture is present, a faster type of corrosion by the forming of hydrated aluminum oxide ( $\text{Al}_2\text{O}_3 \cdot 3\text{H}_2\text{O}$ ) occurs. Under these conditions, due to the lack of an inhibiting oxide fil, degradation of the surface appearance of Galvalume sheet can occur in as little as 24-48 hours.

In the present case, it is possible that the tension/deformation imposed by the straightener/flattener/leveler equipment on customer facilities had promoted sufficient deformation on galvalume/aluzinc layer, on surface 43A.A, in order to generate tiny cracks. These small apertures, mainly on crystals interfaces, permits air moisture to enter producing dark oxidation ( $\text{Al}_2\text{O}_3 \cdot 3\text{H}_2\text{O}$ ) in a mechanism very similar to the "wet storage stain". Obviously, with more intense deformation (like that used during tile forming) more microcracks are formed. These microcracks are paths through the layer, which moisture enters producing wet oxidation and so darkening the obtained surface.

- In mild cases, a solvent (such as mineral spirits or turpentine) applied with a soft rag has been known to effectively remove the stain. This method is also used to remove stain from pre-painted Galvalume sheet without damaging the paint.
- For more advanced cases on unpainted Galvalume sheet, it is impossible to remove the stain without also affecting the good coating under and around the stained area. The amount of damage to the coating during removal will depend on the method used. In this case, storage stain can be removed from bare Galvalume sheet with a mild household cleanser and a wet sponge or rag (as they used for aluminum home objects cleaning). Industrial products may also be used, but are more aggressive to the coating.

In all cases, the Galvalume/Aluzinc sheet/tiles should be thoroughly rinsed with water after the stains have been removed.

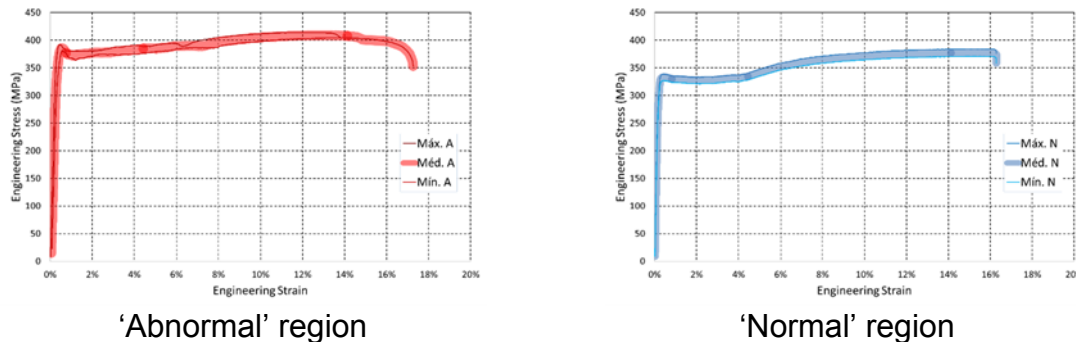
The stress-strain curve obtained from ‘abnormal’ indicates that the steel in that region has undergone a process of strain aging. As described by supplier representative (see Figure 1) and as well measured in this work (see Figure 3), the verified strain aging occurred in a very specific region, near one of the mill’s edge. This scenario indicates that some kind of treatment of misprocessing operation occurred over 106mm (or 4.1 inches) from one edge of the analyzed coils.

**Figure 8.** Tensile stress-strain curve from ‘abnormal’ (A) and ‘normal’ (N) regions of the received sheet samples.

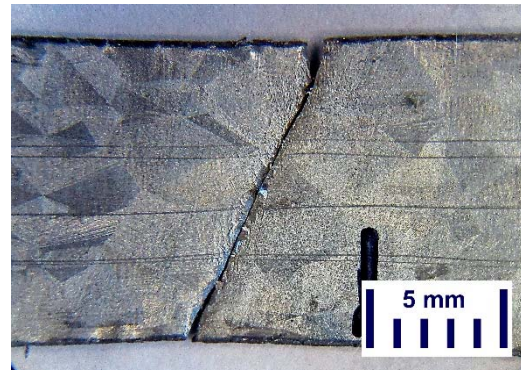
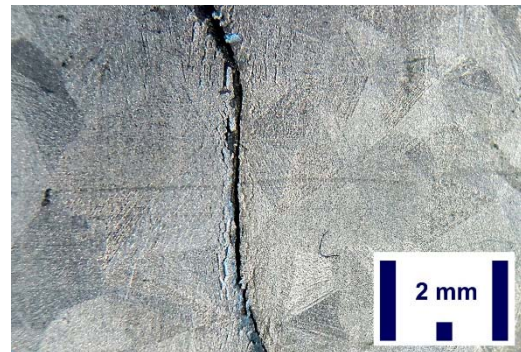
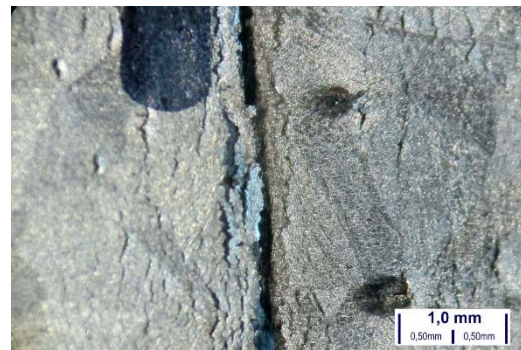
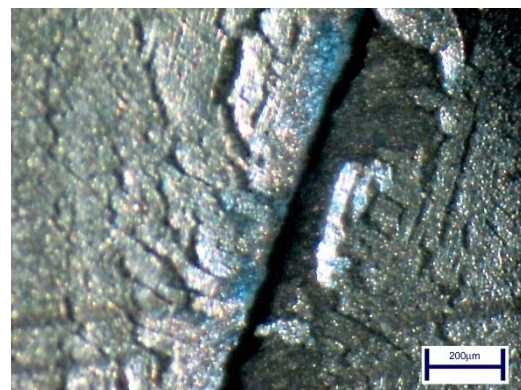
The surfaces of the tensile test specimens showed a remarkable difference in terms of the galvalume/aluzinc layer aspect. While normal samples behaved as expected, with steel and layer deforming together, samples obtained in the abnormal regions do not. A 'fish scale' feature was observed at galvalume/aluzinc layer near fracture on each tensile specimen from abnormal region. Figure 9 illustrates this difference pointed out by stereo microscopy surface photos.

The same cause that produced the detected strain aging can be associated to a more fragile behavior of galvalume/aluzinc layer in the 'abnormal' region of sheet. A more fragile layer, produced by an unwanted thermal treatment, can aid to explain the different feature observed on 'abnormal' (A) and 'normal' (N) surfaces. Depending on type of thermal cycle submitted on the analysed coils, it can produce both strain aging and layer fragilization.

**Figure 9.** Tensile test samples surfaces as viewed near fracture with increased magnifications by stereo microscopy.

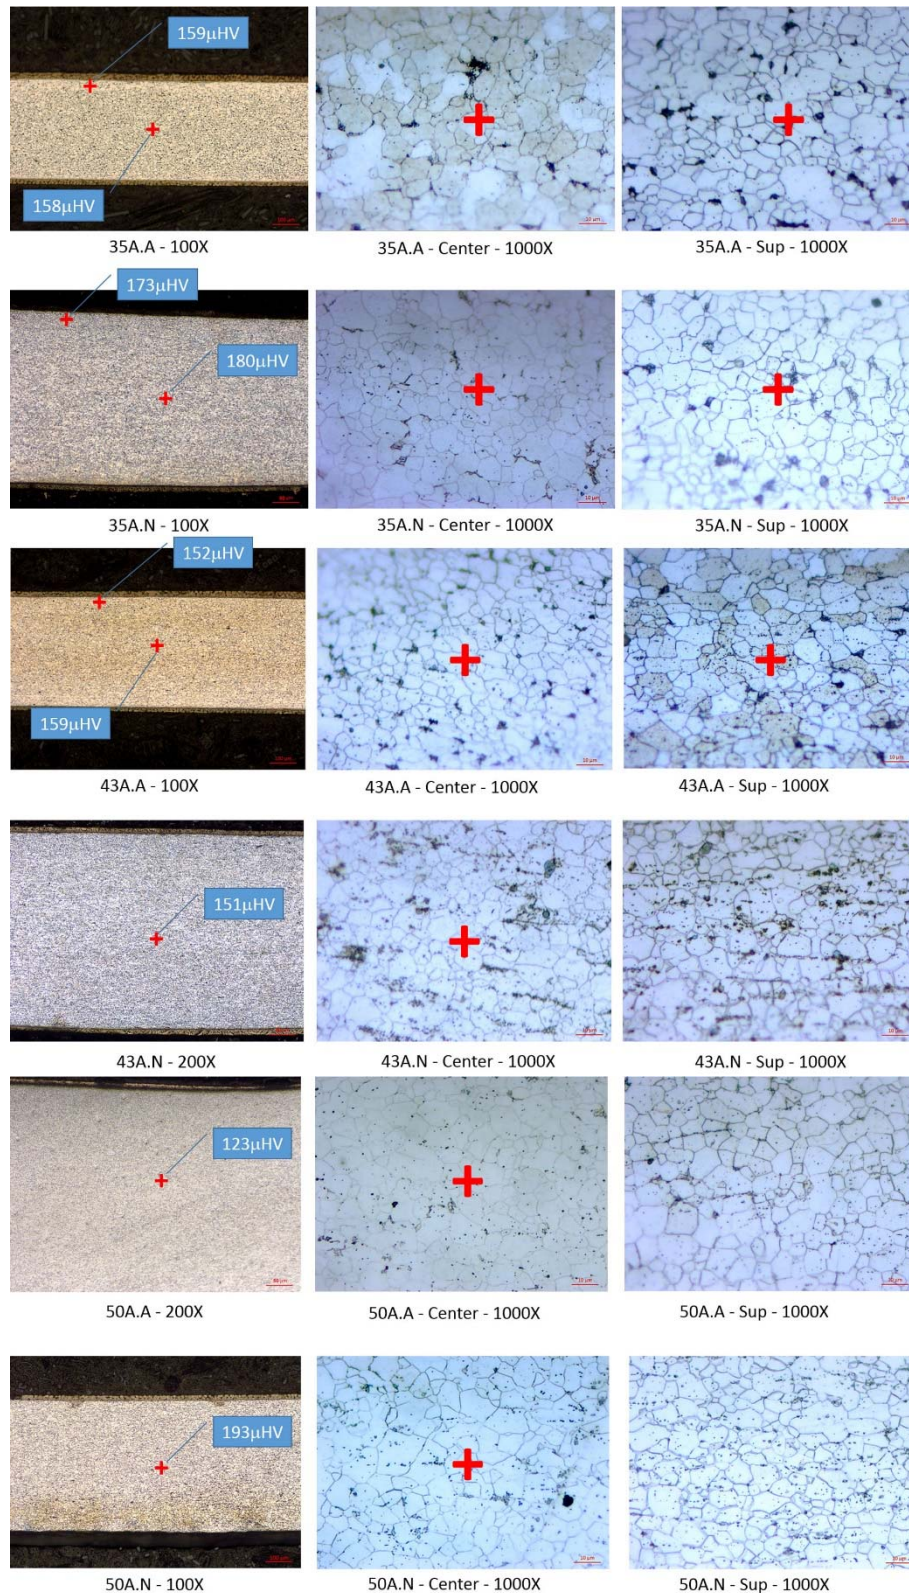
Microhardness measurement shown that abnormal samples have a little less hardness ( $150\mu\text{HV}_{50}$  general average) than normal ones ( $174\mu\text{HV}_{50}$  general average). Considering that penetration hardness depends on the plastic behavior of the samples, one can conclude that one set of samples (abnormal) possess a different mechanical behavior than the other set (normal).

**Figure 10.** Microhardness ( $\mu\text{HV}_{50}$ ) measurement positions on samples and values obtained. (Transversal sections).

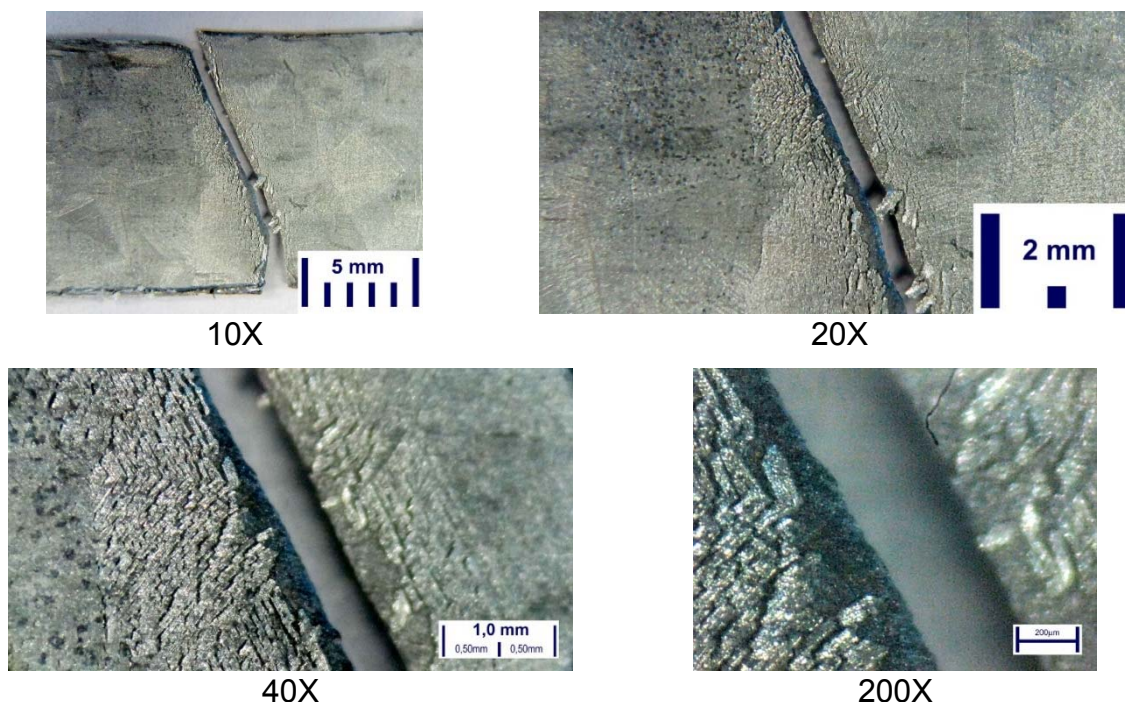
Some of these samples was submerged for 24 hours in brine, a solution of salt (sodium chloride) in water. After this period, the samples were observed by optical microscope and all treated samples presents an dark surface due oxidation. Figure 15 shows a comparison between the treated samples and non-treated samples. The treated sample presents a dark colored surface in the cracked areas of the

galvalume/aluzinc layer, whereas the non-treated show a bright aspect with no dark areas.

**Figure 15.** The same tensile test sample but with the right side obtained directly from test and the left side after treatment by submersion on brine during 24 hours followed by 48 hours exposed in fresh air.

The dark aspect observed on the coils surfaces can be associated to hydrated aluminum oxide ( $\text{Al}_2\text{O}_3 \cdot 3\text{H}_2\text{O}$ ) which has a yellow-brown-dark color. Tensile test samples were used to demonstrate this scenario. As the dark aspect observed on the coils surfaces can be associated to hydrated aluminum oxide ( $\text{Al}_2\text{O}_3 \cdot 3\text{H}_2\text{O}$ ), then it's possible to point out some practice to avoid or minimize the problem.
