RELINING HOT BLAST STOVE #1 OF COMPANHIA SIDERÚRGICA NACIONAL (CSN) BLAST FURNACE # 2 ¹

¹ *Technical contribution to the 3rd International Meeting on Ironmaking, September 22 – 26, 2008, São Luís City – Maranhão State – Brazil*

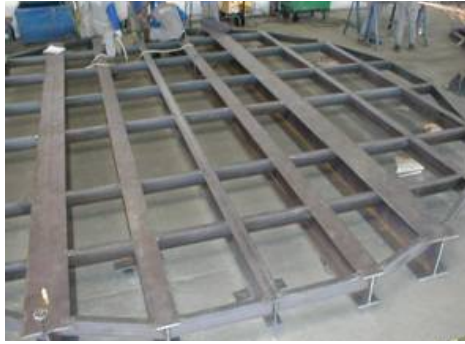
Figure 1 shows pre-assembly of stationary platform and dense refractory lining of Dome.

a) Pre-Assembly of Stationary Platform.

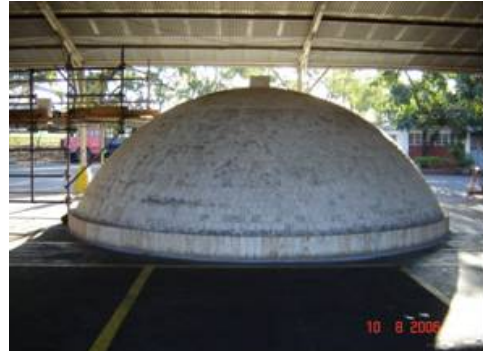
b) Pre-Assembly of Dome Roof.

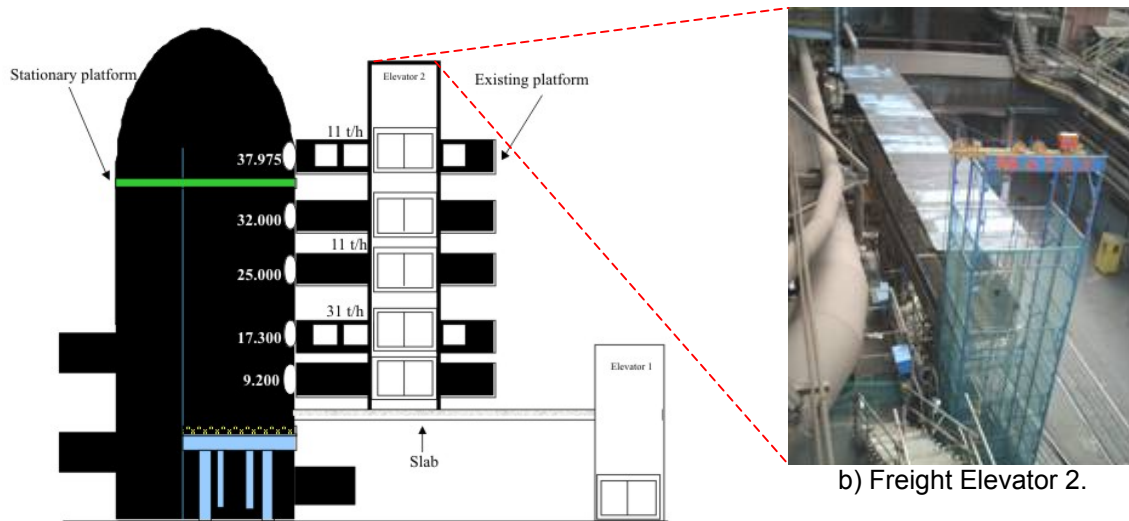
Figure 2 – Materials Supply System.

Owing to layout physical constraints in the Hot Blast Stoves area, it was decided to use 2 freight elevators, transfer tables, 5 platforms, 1 winch and to torch cut 4 new manholes at different elevations, as schematically shown in Figure 2.

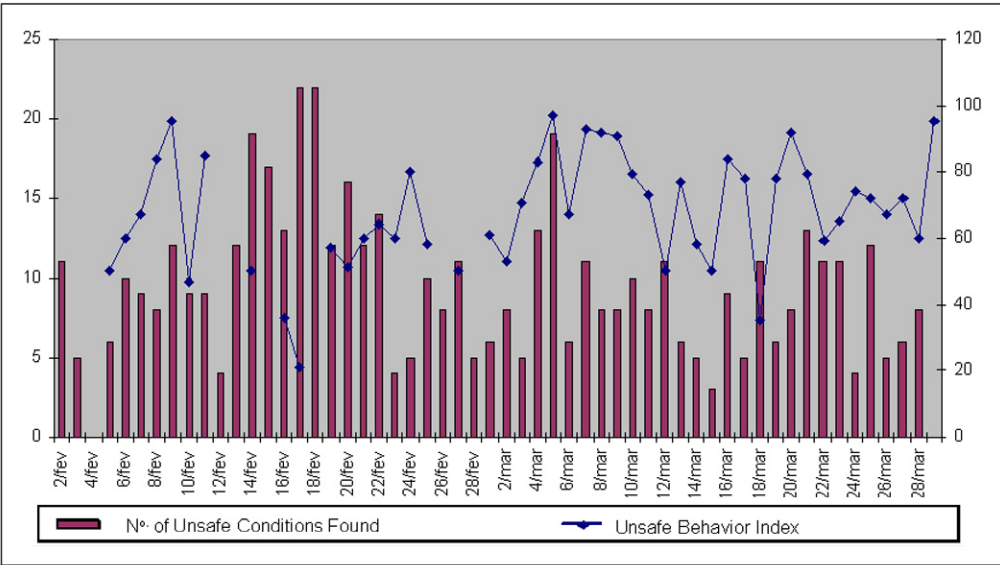
Figure 3 – Number of Unsafe Conditions Found and Unsafe Behavior Index (Period of time: Feb.-Mar./2007).

Over the course of the project, Safety Teams made rounds in all work shifts to identify and immediately eliminate Unsafe Conditions. Safety Audits were also conducted to track Unsafe Behavior Index in connection with the main Safety Instructions, i.e., monitoring CO, confined spaces, work at high places etc. (Figure 3). Safe Behavior Index is the percentage relationship between non-complied safety standards and the total number of audited standards.

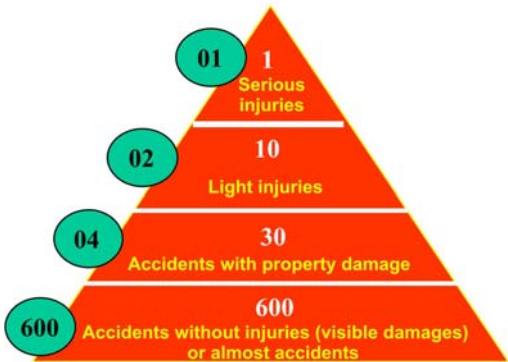
Figure 4 – Main Safety Occurrences.

Bird Pyramid	Occurrences Reported
1. Accidents involving no injuries (visible injuries) or almost accident: 600.	- Unsafe conditions found by Safety Team while making rounds.
2. Accidents involving property damage: 4.	- Damage to safety platform floor. - Movable platform off balance. - Diatomaceous silica board falling down. - Pellet moving sideways in the elevator.
3. Non-disabling injuries: 2.	- Finger getting stuck. - Back pain on moving pellet.
4. Disabling injuries: 1.	- Finger impact on handling checker brick.

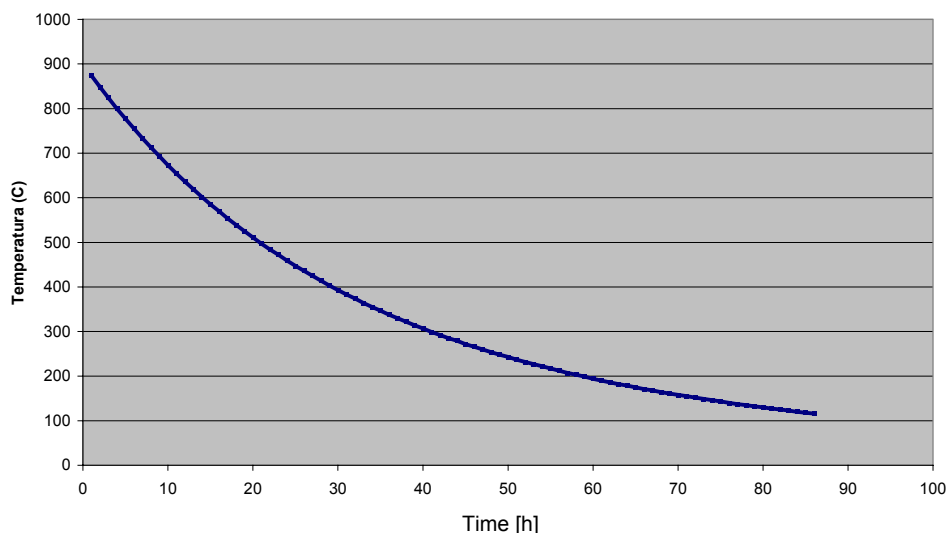
Figure 5 – Accelerated cooling down curve.

As refractory lining would have been torn down anyway, without it being reused, no particular care needed to be taken regarding cooling down. Ideally, it ought to be done as quickly as possible. Thus, an accelerated cooling down curve was formulated, aimed at just 86 hours (3 days and 14 hours) – Figure 5, blowing cold air and spraying water mist in the lower temperature range. A ventilation system was installed at Checker Brick bottom (cold air entry side) as well as thermocouples at the temporary chimney exit side, in order that temperature drop might be tracked (Figure 6). Cooling down was successfully completed in 4 days and 6 hours, i.e., 18 hours ahead of schedule (5 days).

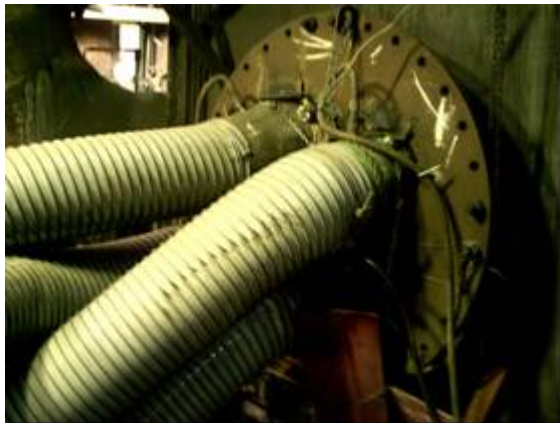
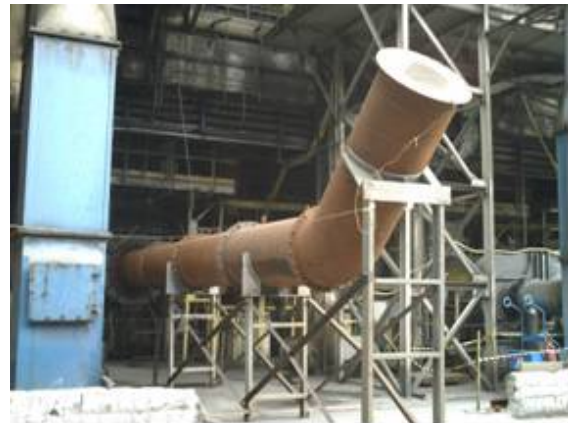
Figure 6 – Accelerated cooling down.

a) Ventilation System

b) Temporary Chimney

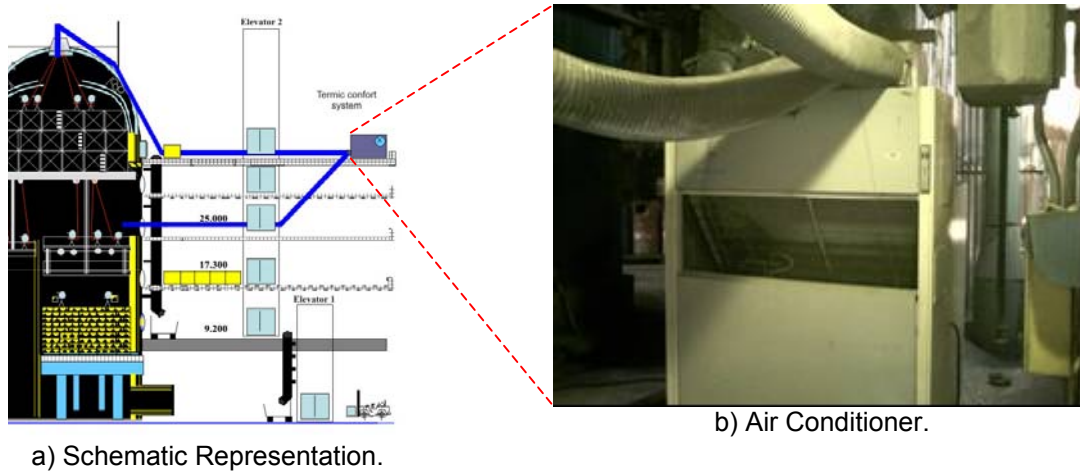
Figure 7 – Air Conditioning System (Thermal Comfort)

Good working conditions are absolutely necessary if one is to secure a high productivity level. In this specific case, special care was taken as the services were supposed to be performed in confined spaces – job site inside Hot Blast Stove, separated by multi-storey platforms, to be done in Brazilian summertime, under pretty high temperatures. In view of this fact, an air conditioning system and a dedusting system were installed to ensure fresh, recirculating air on every work front (Fig. 7).

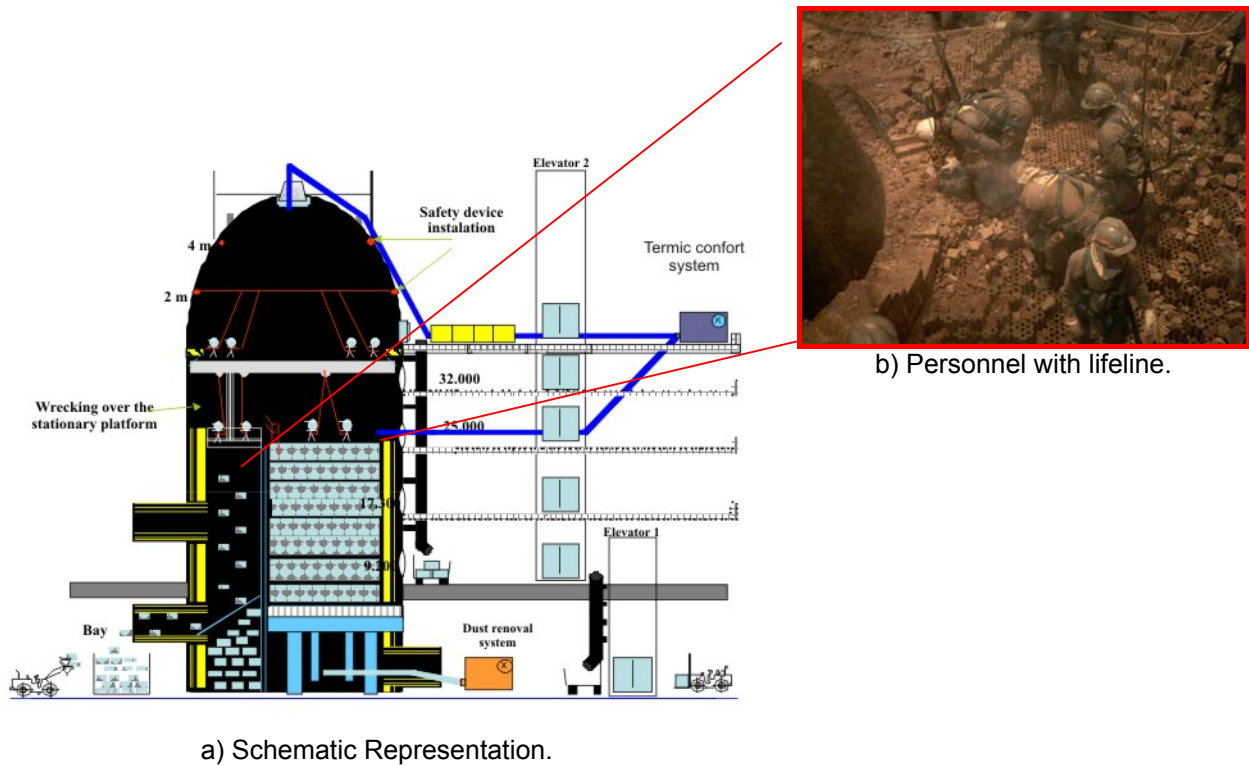
a) Schematic Representation.
Figure 8 – Demolition of Refractory Lining and Dome Assembly.

Demolition services started outside by opening dome central flange. Body protecting equipment and rope guides were installed on Hot Blast Stove top to secure personnel safety. Air conditioning and dedusting systems were also installed prior to people's were given permission to walk into the equipment. Upon dome demolition, a movable platform was set up in the Combustion Chamber area (Platform 1, P1). Checker Chamber and dividing wall were torn down with workers standing on checkers while Combustion Chamber was demolished by using movable platform. At elevation 32.600, services came temporarily to a halt, so that the stationary platform (Platform 2, P2) and brick rings might be set up. This also aimed at dome erection work being conducted concomitantly with demolition of equipment lower part. The Combustion Chamber movable platform, P1, was reinstalled underneath stationary platform, P2, and the demolition services continued on, as indicated earlier, down to equipment bottom . Fig. 8 shows the demolition services.

Demolition was completed in 11 days and 16 hours, i.e., 16 hours behind schedule (11 days). The main causes leading to delay were as follows:

- Baffle plate deformation, undersized (1/2").
- Bottleneck in exiting materials owing to lining not being demolished at burner opening and flange torch cutting.
- Lack of fitters to quickly respond to required changes – baffle plate, bay and torch cutting.
- Unskilled hammer workers.

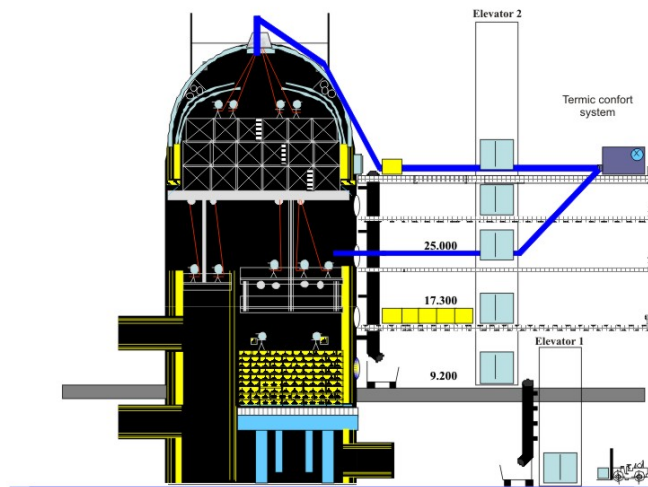
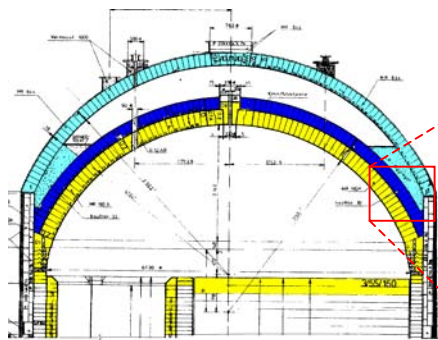
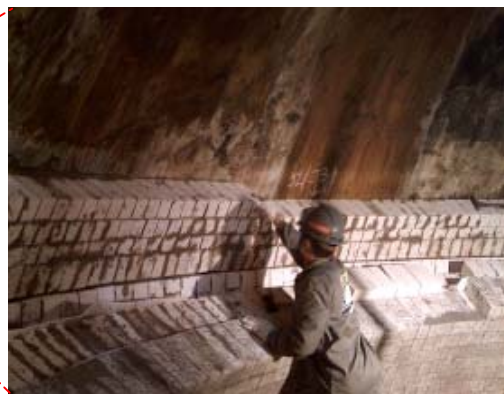
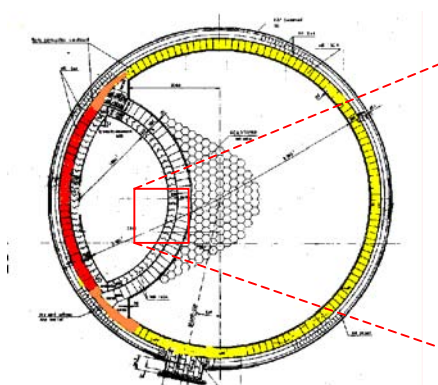
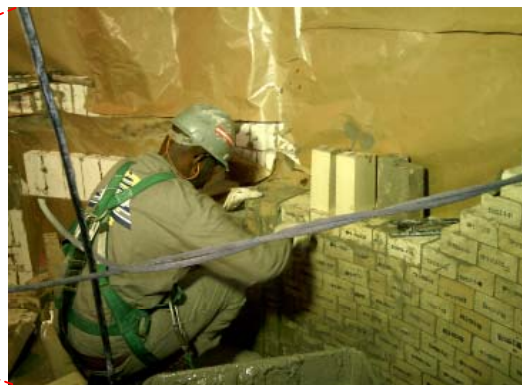
Figure 9 – Concomitant Assembly Services

parked at a new elevation, thus allowing for Job Sites 2, 3 and 4 to run in parallel. At the same time, the supplying manholes, which were cut open in the shell, were welded up and dye penetrant checked. Figure 9 shows Job Sites 1, 2, 3 and 4 assembly services running in parallel.

a) Schematic Representation

b) Dome Assembly

c) Combustion Chamber Assembly

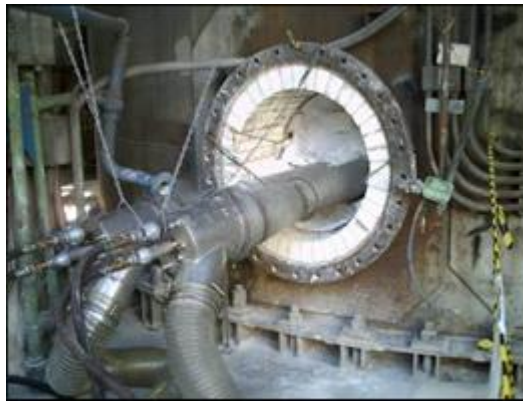
Figure 10 – Convection heating up system.

The convection heating up system picked (Figure 10) aimed at minimizing the temperature gradient between the various points of the equipment.^[3] Thermocouples in tandem were installed on dome roof dense lining hot side and cold side as well as

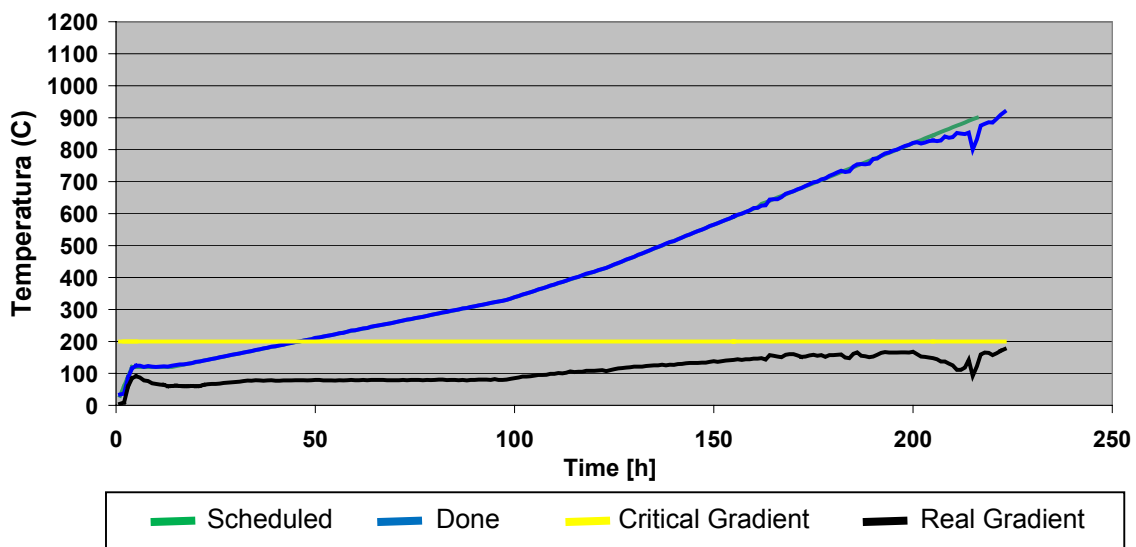
Figure 11 – Heating up Curve.

underneath cast iron grate for temperature tracking purposes. Figure 11 shows the planned x actual heating up curves, totaling 9 days and 7 hours (223 hours).

The heating up phase, including mechanical services to clear Hot Blast Stove was completed in 9 days and 22 hours, i.e., 50 hours ahead of schedule (12 days).

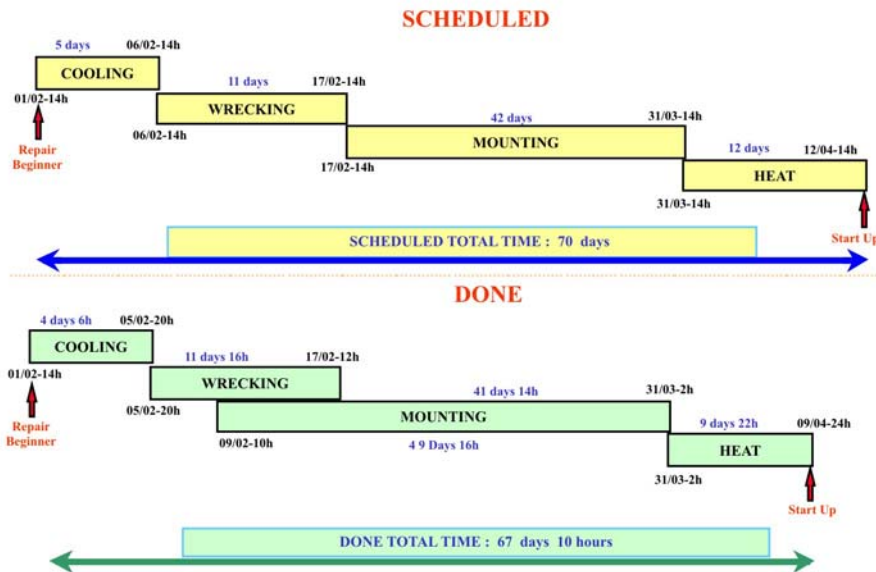
Figure 12 – Time Schedule of CSN # 2 Hot Blast Stoves Reline.

The project was completed in 67 days and 10 hours, that is, 2 days 14 hours earlier than originally planned (70 days). The introduction of new technologies, coupled with innovative building methodologies, have played a major role in shortening Hot Blast Stoves reline time (Figure 12).

REPAIR/YEAR	REPAIR TIME
Blast Stove BF#2 Décadas de 80 e 90	120 days
Blast Stove # 3 2002	89 days Cooling: 15 days Wrecking: 17 days Mounting: 43 days Heating: 14 days
Blast Stove # 1 2007	68 days Cooling: 4 days Wrecking: 12 days Mounting: 42 days Heating: 10 days

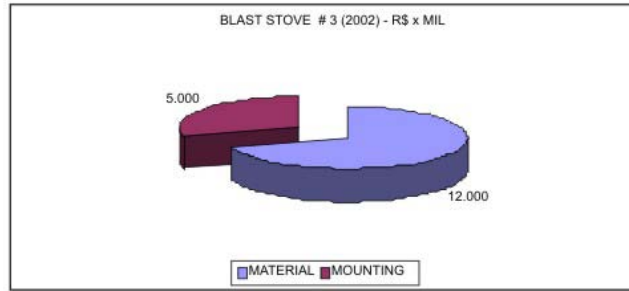
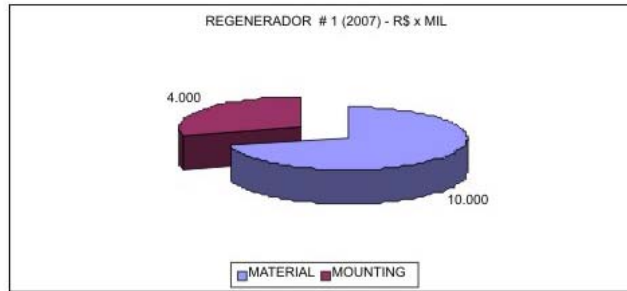
Figure 13 – Cost of reline BF # 2 Hot Blast Stoves.

The total cost for Hot Blast Stove # 1 was R\$ 14 million – R\$ 3 million less than that of Hot Blast Stove # 3 conducted in 2002, on an emergency basis (Figure 13). This fact clearly shows the benefits arising from monitoring and planning adequately the campaign of such equipment.
