# BLAST FURNACE TROUGH AND RUNNERS: TECHNIQUES FOR MINIMIZING THE WORKING LINING OXIDATION PROCESS<sup>1</sup>

<sup>1</sup> *Technical contribution to the 3<sup>rd</sup> International Meeting on Ironmaking, September 22 – 26, 2008, São Luís City – Maranhão State – Brazil*

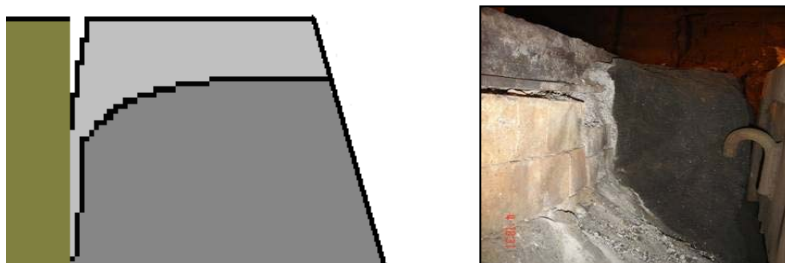
Figure 2. Oxidation process through working lining and safety lining interface

Many times a gap between the materials occurs as a result of different thermal expansions. In this way, the air penetration through the main trough wall is facilitated. The Figure 2 shows the mechanism.

In this case, the oxidation process is faster than the first case and can be detected during the repair process. When the layer with slag and pig iron incrustated is removed with a cutting machine to apply a new material; a big portion of the material falls down due a crack through the oxidized and, consequently, weak interface. Thus,

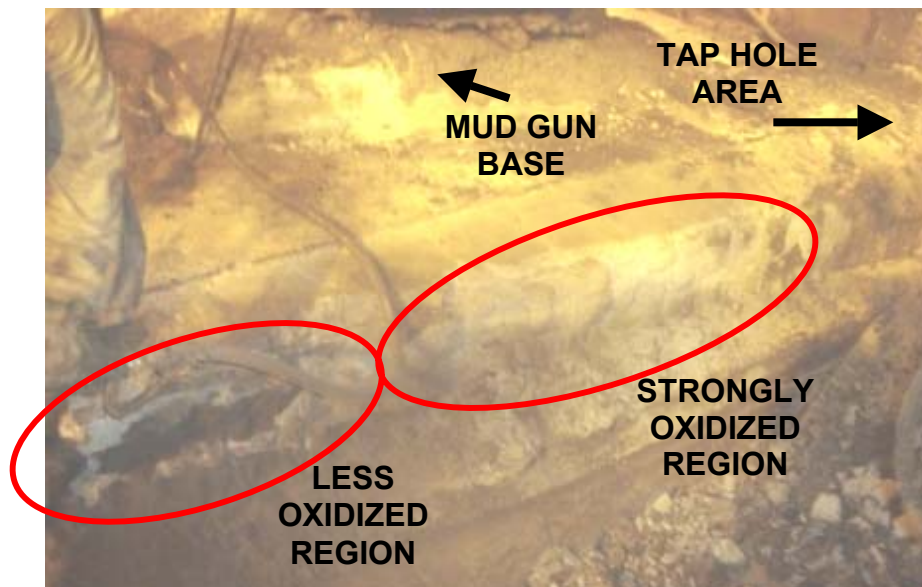
Figure 3. Strong oxidation region caused mainly by water steam

The Figure 3 shows a trough region with strong oxidation in the slag line after a campaign mainly caused by water used for mud gun cooling.

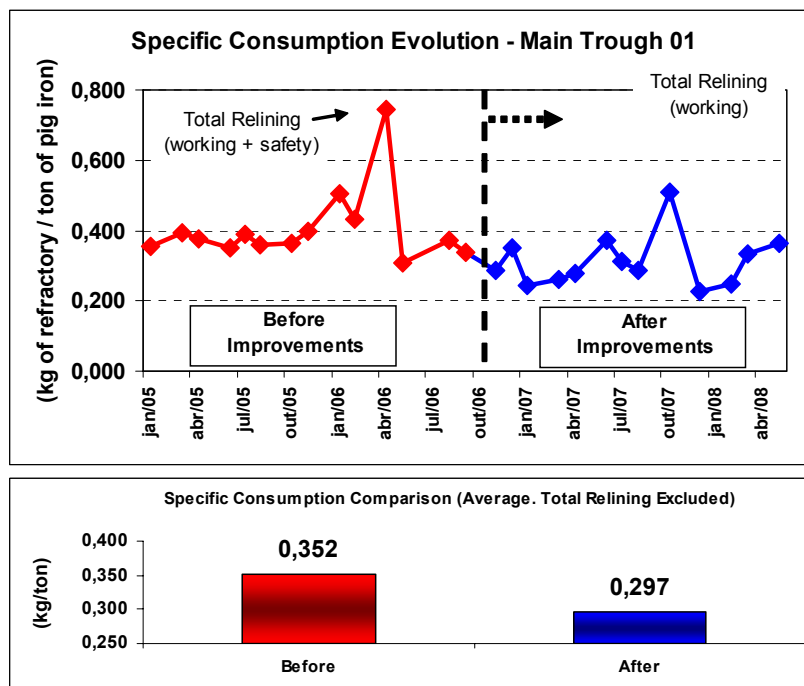
Figure 7. Specific consumption evolution of main trough 01

As it can be seen in the Figures 7, 8 and 9 the specific consumption (kg of refractory material / ton of pig iron throughput) could be reduced after the total relining (working and safety lining) and the other techniques to minimize the oxidation described above.

The Figures 7 and 9 clearly show that the total relining is a good way to reduce the specific consumption.

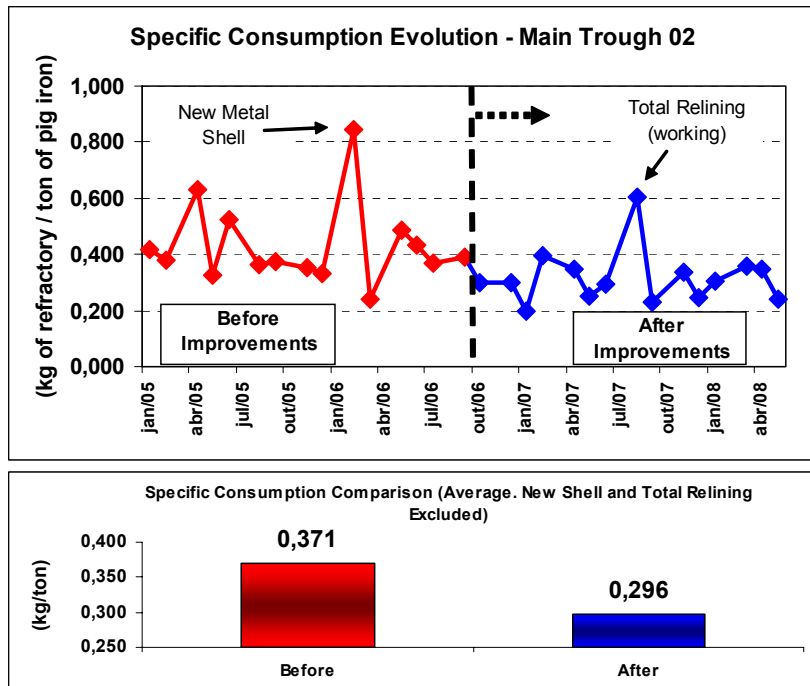
**Figure 8.** Specific consumption evolution of main trough 02

In case of the main trough 02 (Figure 8), the techniques of zone lining material, metal shell adaptation as well as the coating application, shows that they are important ways to reduce the materials consumption.
