## EDDY CURRENT INSPECTION RESULTS ON WORK ROLLS FOR FINISHING STANDS OF HOT STRIP MILL\*

### **Abstract**

**Key Words:** Work roll; Eddy current system; Bruise signal; Roll redressing.

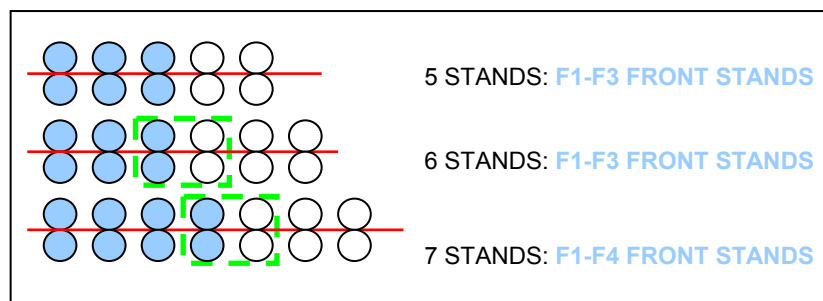
**Figure 1** Finishing group configurations in a HSM

Mills that had adopted fully HSS rolls in the earlier stands are moving their use also in the intermediate stands where the wear resistance is a crucial problem (Figure 1). In these stands the roll material has to guarantee a sufficient wear resistance to carry out the rolling program without generates any problem to the strip in terms of profile and surface quality. The working temperatures and the friction phenomena typical in these stands require roll material with excellent high-temperature strength. In the first stands also the damaging due to thermal fatigue influence the roll life because it contributes in establishing the roll surface quality with all the consequences on campaign length and redressing procedures. The use of HSS rolls makes possible, in many situations, to perform longer campaign (or multiple) in comparison with HCrI rolls. HSS rolls show an optimal attitude in profile retain that together a low roughness of it assure excellent roll performance.

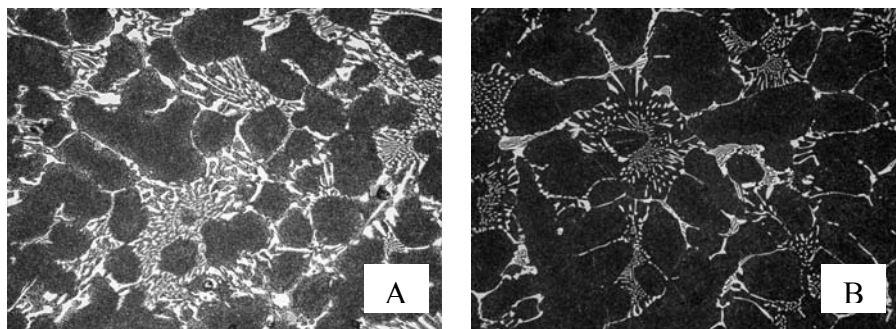
**Figure 2** A – High Chromium Iron B – High Speed Steel (100x)

optimizing. Figure 2 outlines the microstructures of these materials (see next page – carbides in white, matrix in dark).

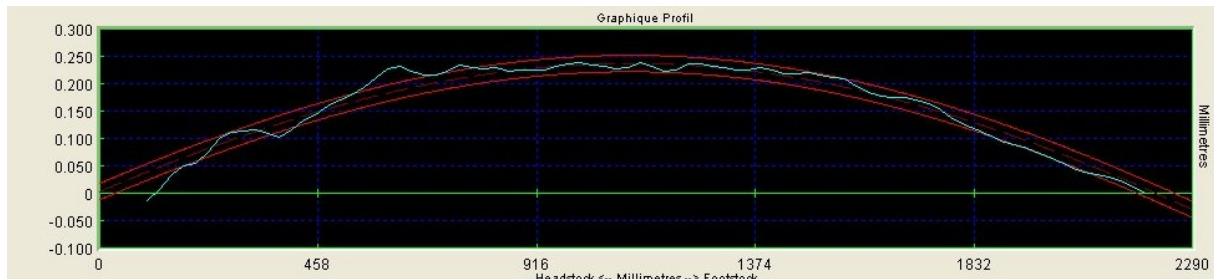
**Figure 3** Wear profile of top roll after 2533ton in F1

A hard dark scale covers the roll surface. The pattern of firecracks, due to thermal fatigue, appears clear on both rolls. The pitting seems to be heavier on the bottom roll. Pitting severity mainly influences the value of the roughness. At the end of campaign the rolls don't show wear (Figure 3). A description of the state of the roll after a campaign in F1 is in Table 6.

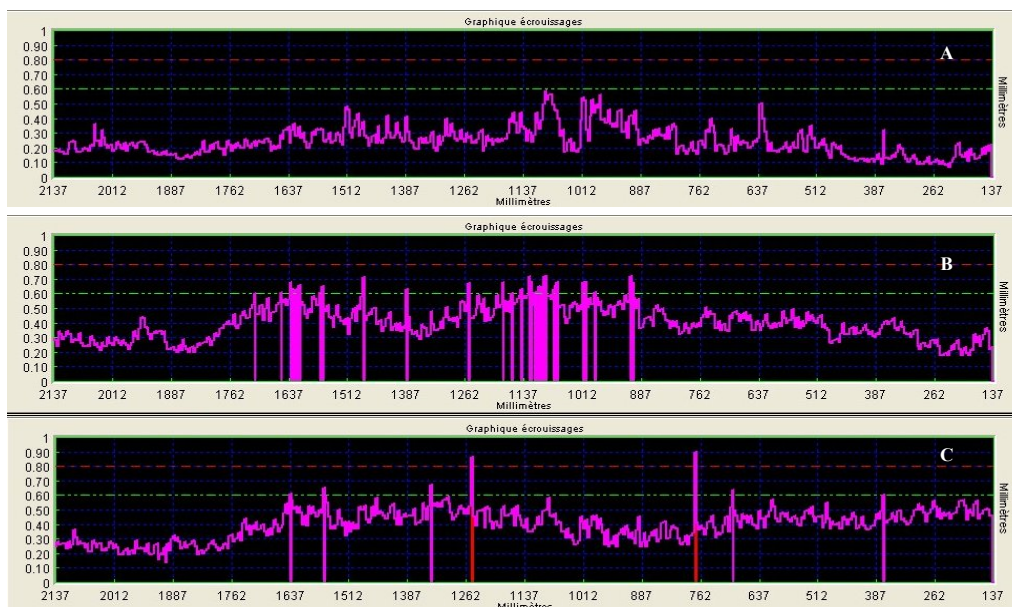
**Figure 4** Bruise signal on F1 top roll surface

Figure 4 shows the maps of the bruise signal of the EC system:

- A. roll surface without removal grinding material – pitting is covered by the scale;
- B. roll surface after a stock removal of 0.12mm (midpoint of the barrel like reference) – circumferential bands with diffuse pitting (area of the pits about 0.5x0.5mm);
- C. roll surface after a stock removal of 0.19mm – isolated pits (area < 0.25x0.25).

EC results don't point out the very fine pattern of firecracks due to thermal fatigue. The rough grinding passes can generate a raising of background noise takes itself very closely to the fixed thresholds (see case C in Figure 4).

1. Stand F1-F2
  - The automatic EC control isn't able to reveal the firecracking of the roll surface generated to thermal fatigue.
  - The automatic EC control is able to measure the level of the pitting.
  - The automatic EC control doesn't show difference like background signal between roll surface with scale or without (peeled-off).
2. Stand F3-F4
  - After the normal campaigns the main problem is the wear of the rolls (more pronounced in stand F4). The level of extra-grinding it's consequence of the level of wear profile uniformity. The scratches associated to the abrasion phenomena aren't so marked and then the roll surface appears free of defects after very light grinding passes.

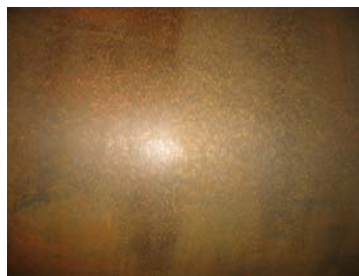
**Figure 5** Surface aspect of the top roll after 2141ton in stand F2 ( $R_a=3.5\mu$ m)

In respect to the situation of stand F1, in stand F2 rolls show, with higher frequency, bands where the scale is peeled off. The presence of these areas without scale doesn't change the wear rate of the roll but worsen the roughness that can reach level of 5-6 $\mu$ m in terms of Ra. The two figures that follows show the roll surface and roll profile respectively while Table 7 summarized the state of the roll at the end of a typical campaign.

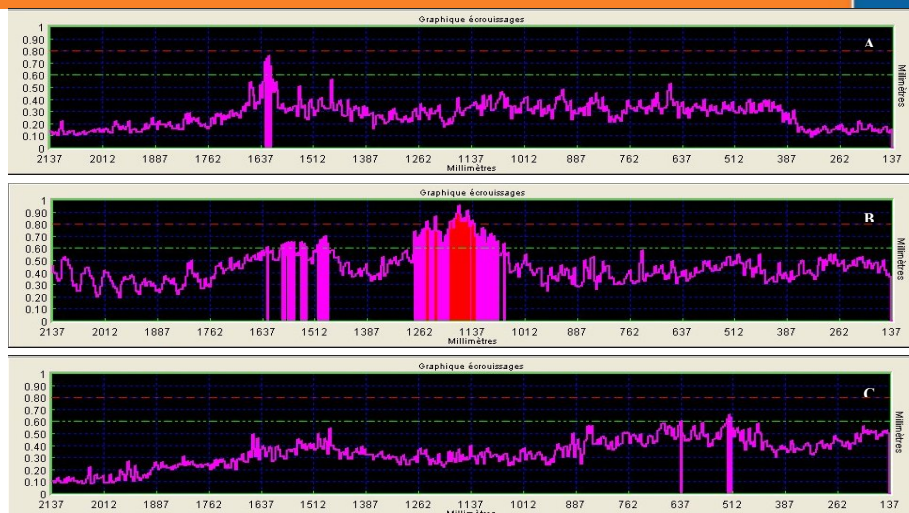
Figure 7 Bruise signal on F2 top roll surface

Figure 7 shows the maps of the bruise signal of the EC system:

- A. roll surface without removal grinding material – it's clear the region of the roll barrel affected from damaging;
- B. roll surface after a stock removal of 0.14mm – circumferential bands with diffuse pitting (0.5x0.5mm) where signals exceed the thresholds;
- C. roll surface after a stock removal of 0.27mm – no visible pits are present (size < 0.15x0.15mm). The roughness on the right side of the barrel is 1.75 $\mu$ m while to the opposite side is 0.9 $\mu$ m: these differences could be responsible of the different levels of background noise in the map.

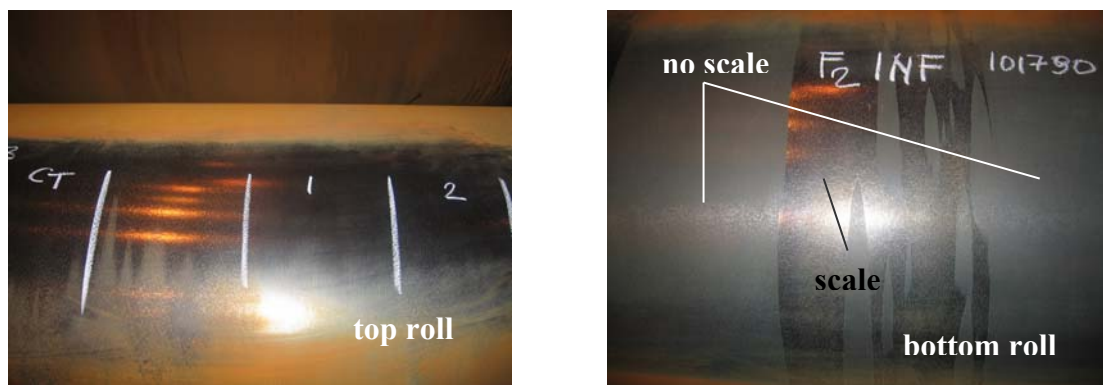
Figure 8 Surface aspect of the rolls after a campaign in stand F2

The Figure 9 shows the roughness profile of several bands damaging in different way (see the top roll in Figure 8). The scale still presents on the roll surface is abraded in different manner so to influence the roughness. In case of heavy peel of the roll scale (see the bottom roll in Figure 8), it possible to find a worsening of the quality of the surface but this doesn't create an appreciable change about the surface profile (Figure 10).

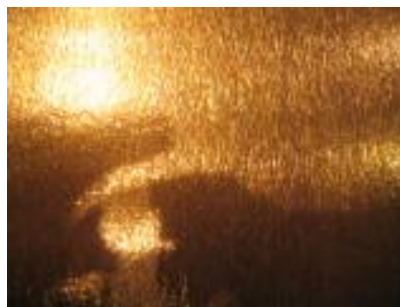
**Figure 14** Bottom roll surface ( $R_a=3.5\mu\text{m}$ )

Rolls in stand F4 show an important level of loss material during the campaign (higher in the bottom roll) and the wear profile appears several times irregular (Table 9). The amount of machined roll material is imposed from the roll consumption. In Figure 14 the surface aspect of a bottom roll after a campaign of 2561ton.

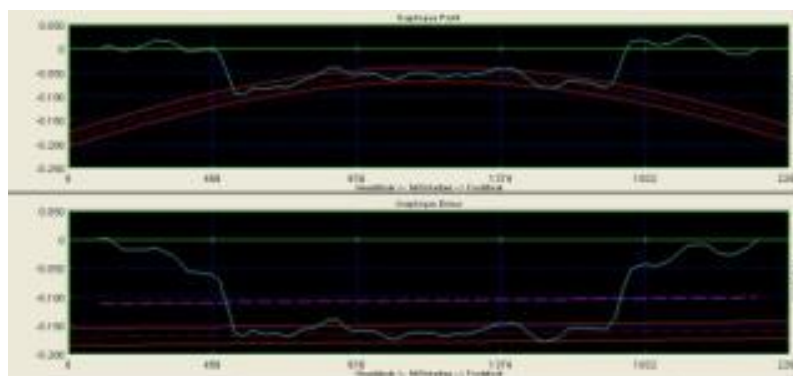
**Figure 15** Wear profile of bottom roll after 2561ton in F4

The wear profile showed in Figure 15 underline the typical level of consumption of a bottom roll in this stand. The principal scope of redressing procedures, for rolls working in F4, it's to rebuild their profile for the next campaign: done this also the roll surface it'll be ready for rolling (Figure 16).

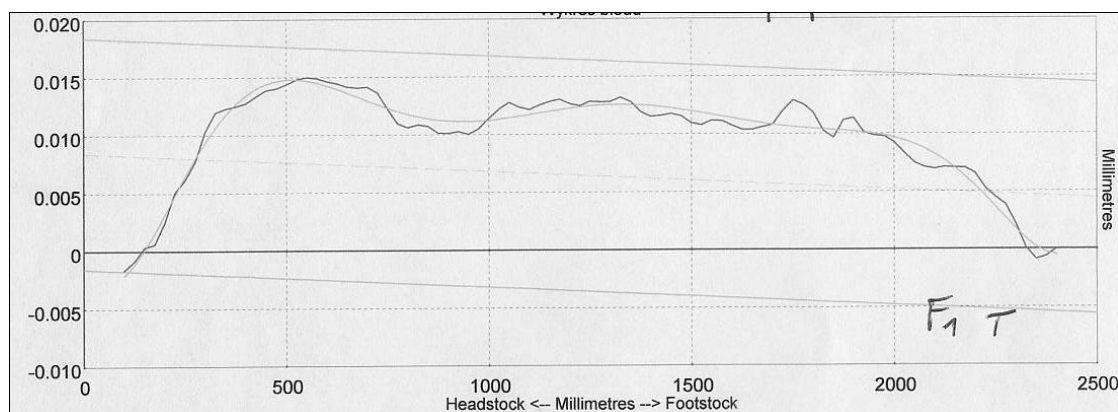
Figure 17 Wear profile of top roll after 5550ton in stand F1

In this mill in the first two stands are in use HSS rolls. In these stands campaigns are in the range of 5000-6000ton. Rolls, at the end of campaign, show thermal fatigue and pitting; wear is practically zero (Figure17). EC control results can be used to follow the level of roll surface damage during grinding. Figure 18 shows an example of EC signal sensitivity to the surface damaging of the roll (thermal fatigue plus micro pitting in Figure 19).
