# FRICION CHARACTERISTICS OF STEEL PISTONS FOR DIESEL ENGINES<sup>1</sup>

Dallwoo Kim<sup>2</sup>  
Akemi Ito<sup>2</sup>  
Yasuhiro Ishikawa<sup>3</sup>  
Katsuyuki Osawa<sup>3</sup>  
Yoshiyuki Iwasaki<sup>3</sup>

<sup>1</sup> Technical contribution to the First International Brazilian Conference on Tribology – TribobR-2010, November, 24<sup>th</sup>-26<sup>th</sup>, 2010, Rio de Janeiro, RJ, Brazil.

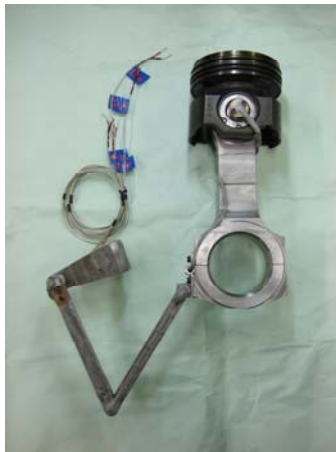
**Figure 4.** Diagram of linkage device.

To determine piston secondary motion, four inductance type clearance sensors<sup>[4]</sup> per piston were attached to the thrust and anti-thrust sides, as shown in Figure 3, and clearance between these sensors and the cylinder wall was measured. Here, the position of the clearance sensors attached to each piston was set identical to the center of the piston pin, where the copper wires of the clearance sensors were routed out of the engine using a linkage device, as shown in Figure 4. Any harmful after production was not added on the piston as shown in the detail of the piston in Figure 4.

Thirteen J type thermocouples per piston were installed, to investigate piston temperatures under engine operating conditions as shown in Figure 5. Here, the positions of the thermocouples in each piston were the same as the positions for the clearance sensors, and the thermocouples were also directed outside through the same linkage device, as shown in Figure 4.

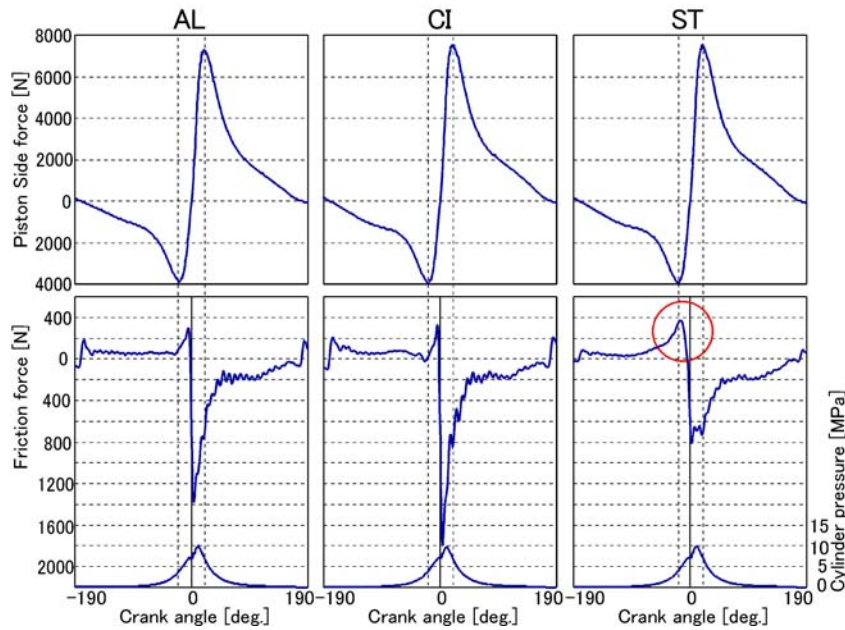
**Figure 7.** The relationship between Piston side forces & Piston friction forces (1000 rpm,  $P_b=100$  kPa).

Piston friction force was measured under constant conditions where engine speed was set at 1000 rpm, cylinder temperature was 100°C, oil temperature was 90°C, and with boost pressure set at both  $P_b = 0\text{kPa}$  and  $P_b = 100\text{kPa}$ . Figure 6 shows the measurement values of friction forces and the calculated values of piston side forces of each of the AL, CI and ST pistons without boost pressure. Figure 7 shows those measurements with boost pressure.

Figure 7 shows the friction forces of each piston when the boost pressure ( $P_b$ ) was increased to 100kPa. Here, the CI piston shows an even larger friction spike around compression top dead center, due to a higher boost pressure, which suggests a further boundary lubrication condition. In addition, the ST piston shows a lower friction spike around top dead center than any of the other pistons, as is the case without boost pressure. Among all of the test pistons the ST piston demonstrates the optimum capability to maintain proper lubrication. As shown in Figure 2, the ST piston was configured such that the skirt and crown were divided to facilitate better oil supply provision to the area of the piston rings, unlike the other pistons. Also, The frictional force of Firing-TDC was smaller though  $h_1$  of the top ring is larger than AL. It seems to be a good supply of lubricant. Conversely, friction forces in the latter stage of the compression stroke increased significantly, as shown by the circle in Figure 7. The ST piston produced different friction wave characteristics than the other pistons. The friction increase showed good agreement with increase in the piston side force. Therefore it seemed that friction increase in the latter half of the compression stroke was due to the piston side force.

significant increase in the friction spike when compared with the AL piston, as shown in Figures 6 and 7.
