## MANDREL BARS RECOVERY OF PROPERTIES BY QUENCHING AND TEMPERING PROCESS\*

Mandrels are tools applied to manufacturing seamless tubes. In VSB plants (Vallourec Soluções Tubulares do Brasil), it is used in two mills. Mandrel and PQF Mills. This is an expensive tool due its alloy (hot work tool steel – AISI H13) and length (between 12 meters and 22,5 meters). An opportunity to apply mandrels from PQF in Mandrel Mill has been identified. However, mechanical properties of PQF mandrels must be improved. This work presents the heat treatment process of Quenching and Tempering developed internally at VSB to improve PQF mandrel properties aiming to achieve Mandrel Mill requirements. Hardness and metallography tests were performed before and after some steps of the heat treatment to characterize and validate the process.

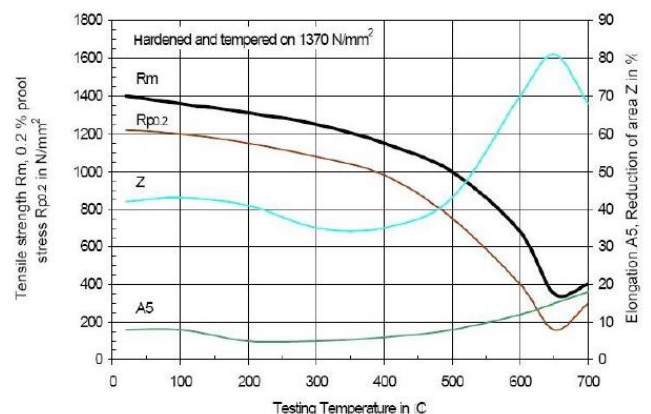
**Figure 3:** Diagram Tempering Temperature x Mechanical Properties.

The heat treatment dimensioning were based on the AISI H13 Continuous Cooling Transformation Diagram (Figure 1), Tempering Diagram (Figure 2) and Tempering Temperature x Mechanical Properties Diagram (Figure 3) [2].

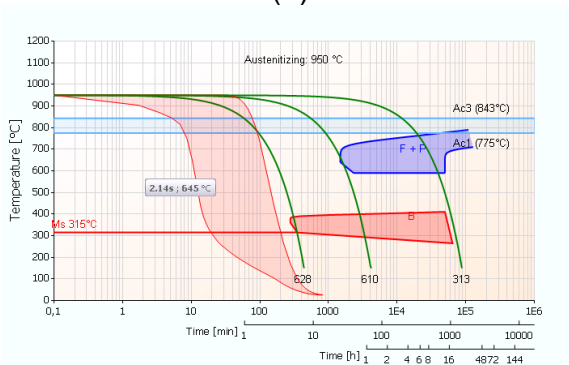
Figure 4: (a) Chemical Composition Simulated in ThermoCalc. (b) ThermoCalc simulation result.

As the figure 4(a) shows, the mandrel bar chemical composition simulated is different in comparison with AISI H13, due to the software restraints. However, it was tested at the closest chemical composition possible. This information was useful for guidance.

Besides the diagram informations and analysis, a ThermoCalc simulation was carried out to a more precisely dimensioning of the heat treatment.

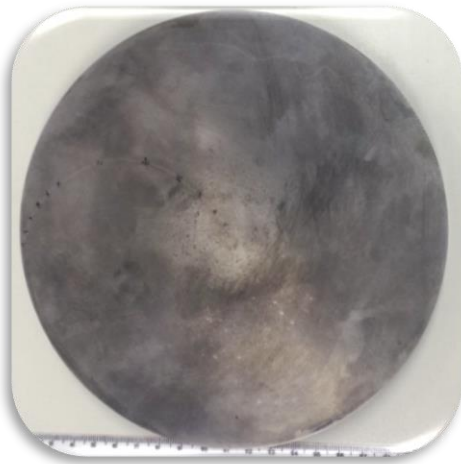
Figure 7: Macrography at receipt condition.

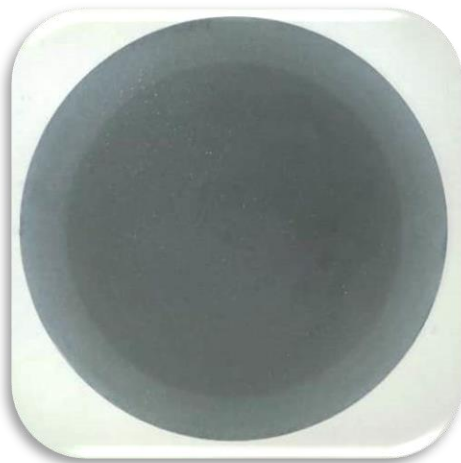
Figure 8: Macrography after quenching.

The microstructure of quenching phase does not reveal clearly the bainite or martensite formation due to the self-tempering. However, the difference of phase revealed by macrography suggests that external layer with 20 mm is formed by tempered martensite and the core is formed by bainite (see figure 8).

Macrography after quenching phase suggests a layer with 20 mm composed by refined martensite and the core composed by lower bainite + carbides.

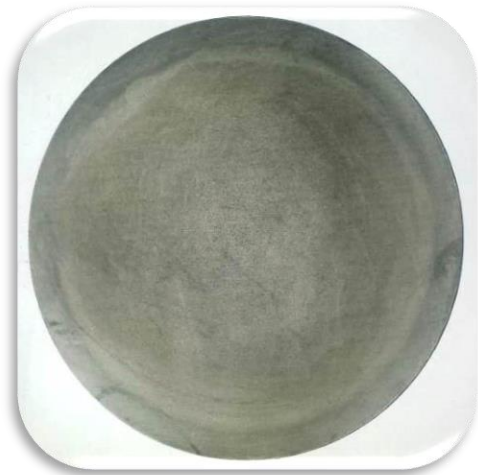
Figure 9: Macrography after third tempering.

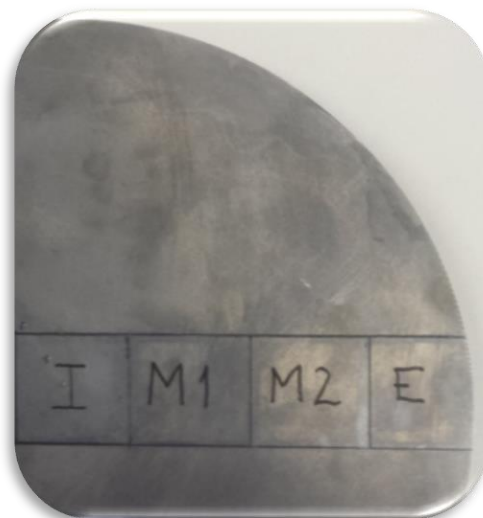
- I → core
- M1 e M2 → middle
- E → external surface

Figure 10: Specimen identifications.
