## INCREASING PRODUCTIVITY AND ROLLING QUALITY THROUGH OPTIMIZED MILL WINDOW GEOMETRY<sup>1</sup>

### Abstract

<sup>1</sup> *Technical contribution to the 47<sup>th</sup> Rolling Seminar – Processes, Rolled and Coated Products, October, 26<sup>th</sup>-29<sup>th</sup>, 2010, Belo Horizonte, MG, Brazil.*

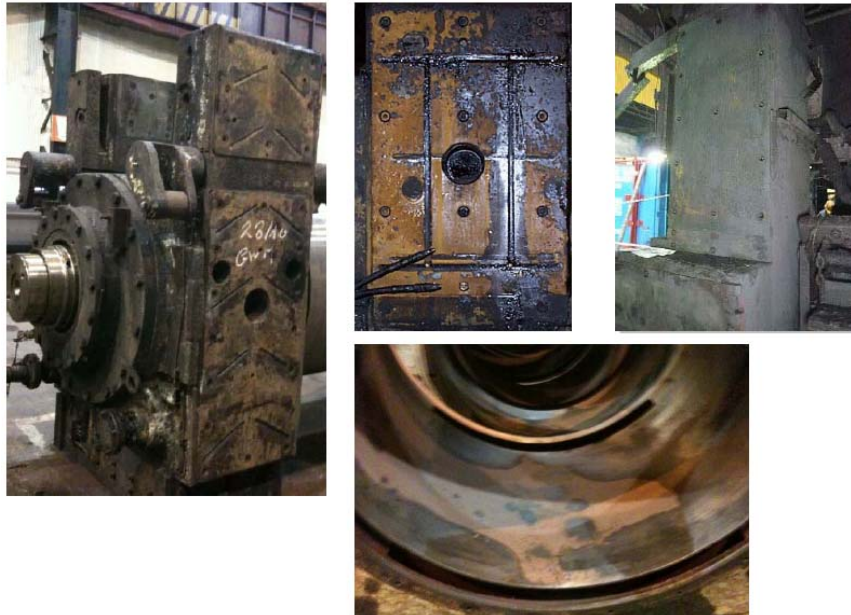
**Figure 10.** Root Cause for Instability - reduced Maintenance + Care in complex Mill Systems

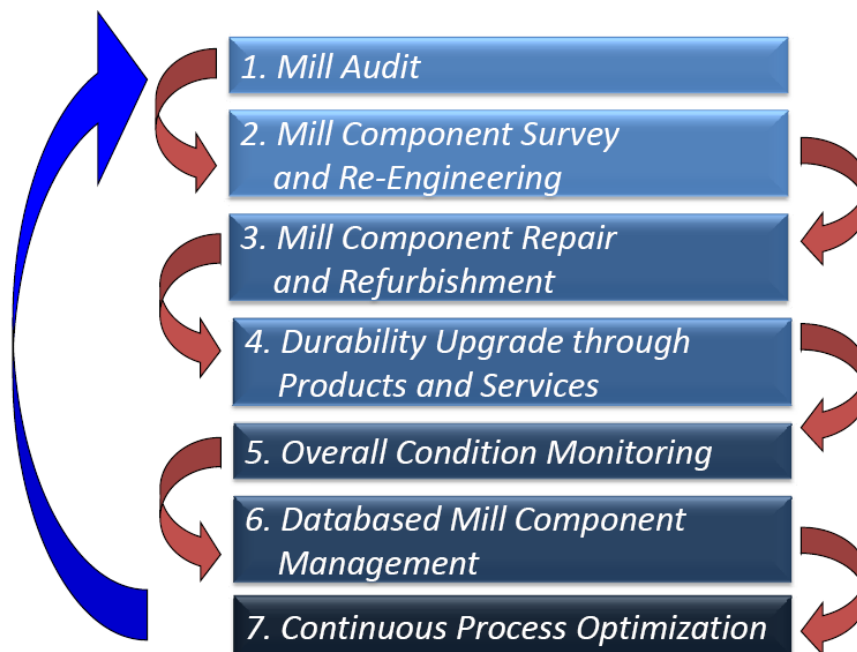
**Figure 11.** holistic Approach to understand, improve and stabilize complex Rolling Mill Systems.

One important characteristic of this holistic approach - it has to be a systematic one which starts with the basic mill analysis, the understanding of the given followed by the re-engineering and revamps which are necessary.
