NEW WALKING BEAM FURNACE – GERDAU AMERISTEEL MIDLOTHIAN TX¹

Daniel R. Davies²

Abstract

¹ *Technical contribution to the 47th Rolling Seminar – Processes, Rolled and Coated Products, October, 26th-29th, 2010, Belo Horizonte, MG, Brazil.*

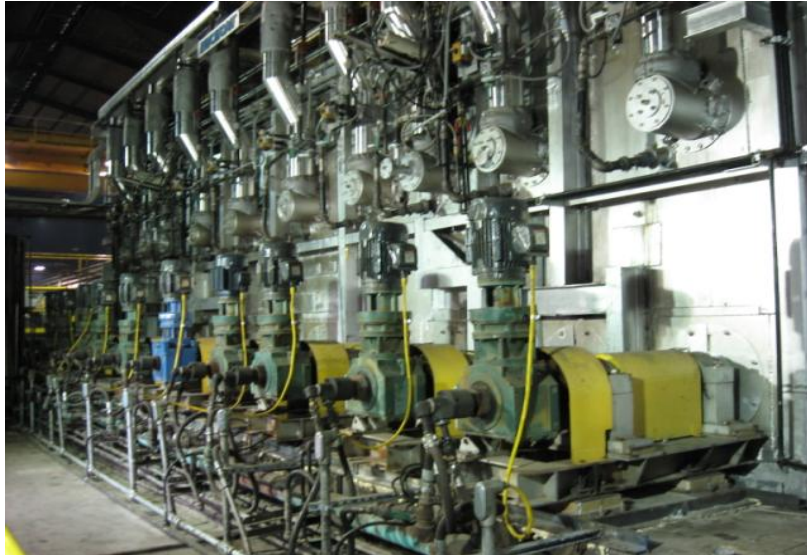
Figure 2: Discharge End of New Furnace

The modified (new) furnace is a ten zone, top and bottom fired, walking beam furnace. It is side charged and side discharged. The new effective length is 80'-7-3/4". Figure 2 and corresponding data below depict the basic specifications on the new furnace.

- Manufacturer: Bricmont
- Type: Top/Bottom Fired Walking Beam Furnace
- Dimensions: 80.5'L x 41' W
- Side Charge – Side Discharge
- Ten (10) Zones of Control
- Combustion System: Conventional (100%)
- Product: 17" x 12" x 17.5' Beam Blank (BB)
- Level I/II Control

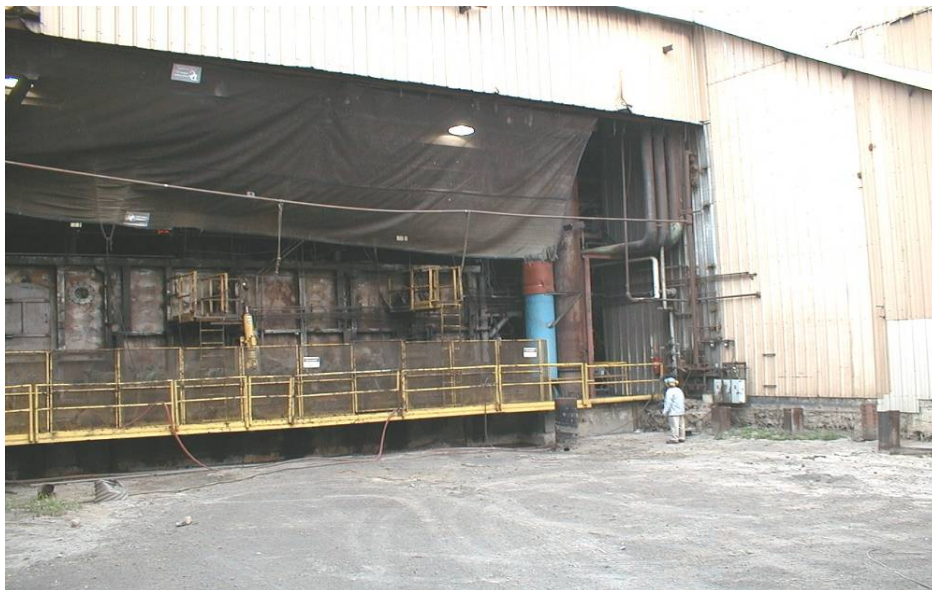
Figure 3: Furnace Charge Area – Limited Construction Access

Figure 3 shows the limited access to add the extension to the charge end of the furnace.

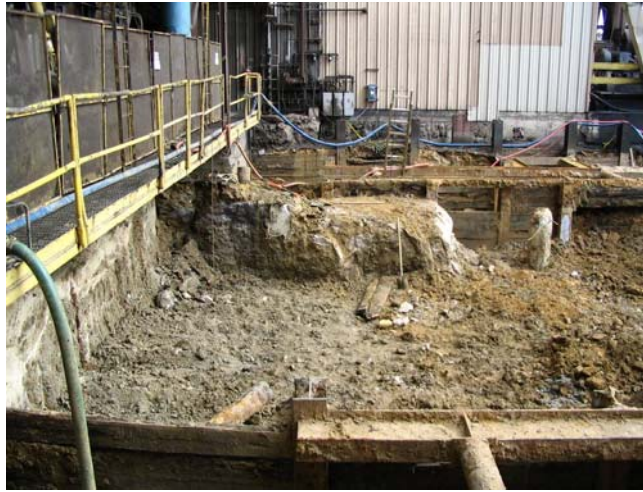
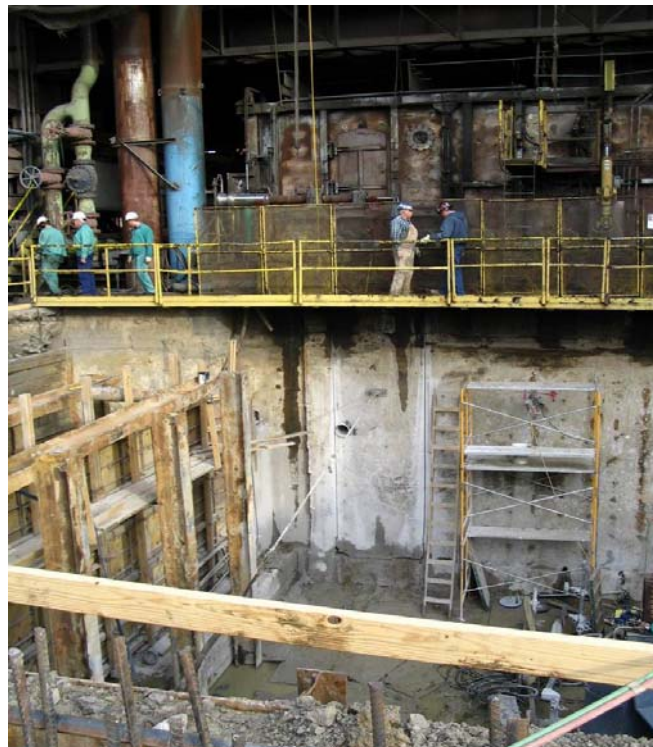
The charge end of the furnace had to be excavated and undercut so the foundations could be installed and the new furnace extension structure could be tied into the existing furnace structure.

Figures 4 and 5 show the start of excavation and foundation forms.

Figure 4: Furnace Charge End Excavation

Figure 5: Furnace Charge End Excavation – Foundation Forms

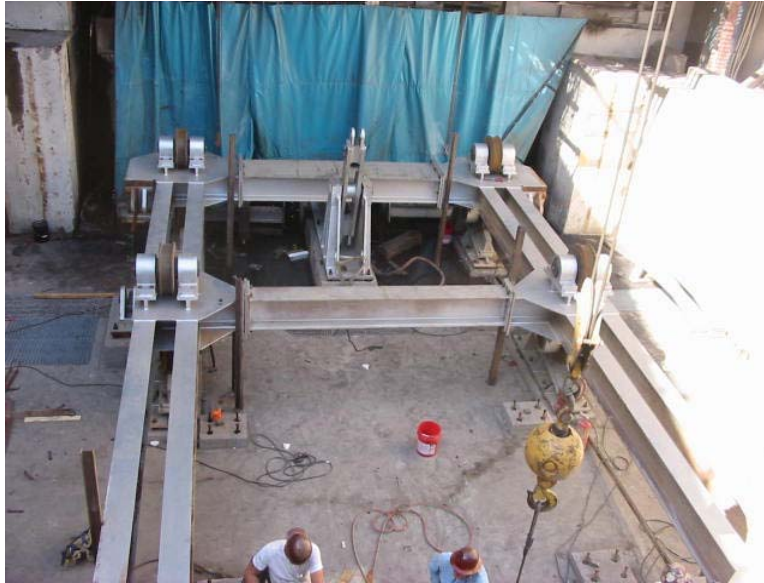
Figure 6: Furnace Charge End Extension – Walking Beam Mechanism Lift Frame

Once the foundation on the charge end was complete, the furnace extension walking beam mechanism was installed. This work was completed while the existing furnace was still operating.

Figure 6 shows the new walking beam mechanism (lift frame).

- A new walking beam mechanism and wheel and ramp assembly was added to the extended furnace. The mechanism consists of a separate lift frame

(moved by two hydraulic cylinders) and a traverse frame that is link-connected to the existing traverse frame. Although capable of separate lift actions, the lift frames typically operate together and are operated hydraulically and synchronized electronically (via LDT's). The two traverse frames are mechanical tied together and operated with a new hydraulically operated cylinder. The existing wheel and ramp mechanisms were reused on the existing sections of the furnace.

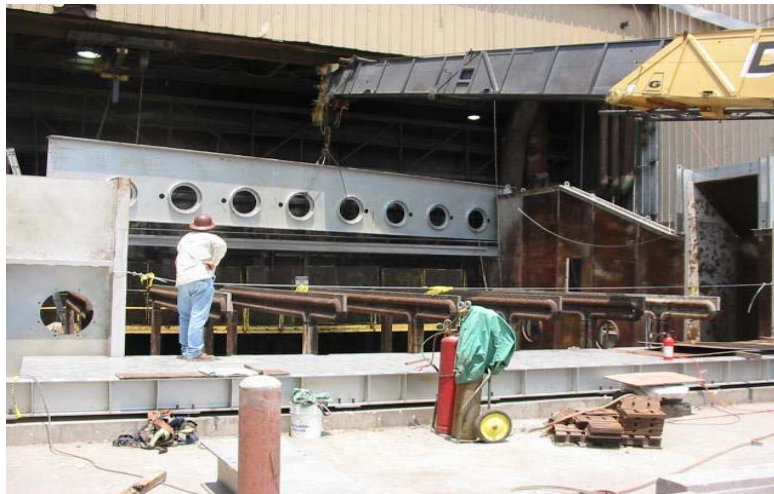
Figure 7: One-Piece Burner Wall Section Being Installed

The remaining part of the furnace installation was hampered due to the restriction of the surrounding equipment and buildings. The furnace structure had to be assembled in modules so large sections could be installed at once. This simplified the installation and saved time and cost.

Figure 7 shows the top preheat burner wall being installed in one whole section.

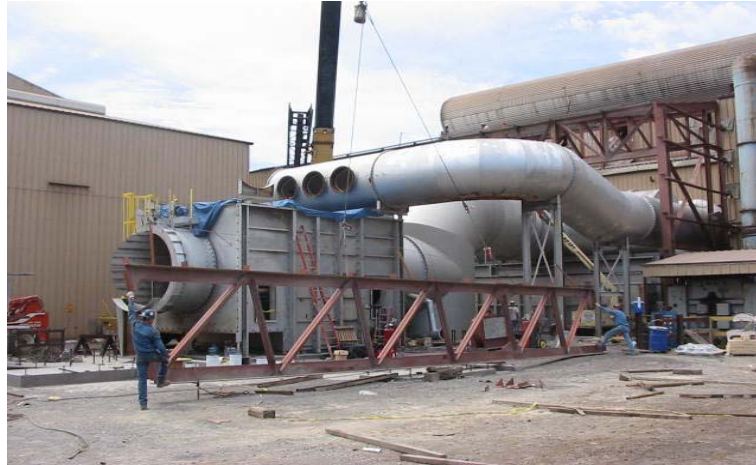
Figure 8: New Recuperator and Combustion Air Piping.

Once the furnace extension was installed, a new recuperator and ejector stack system was installed along with new combustion air piping back to the furnace burners. This completed the furnace extension part of the project.

Figures 8 and 9 show the recuperator, combustion air piping and stack in place behind the new charge end extension.

- A new 3-bank 2-pass recuperator was supplied and was designed and sized to provide adequate combustion air to all the new burners (both furnace sections).
- A bottom baffle wall was added to help segment the zones of combustion control in the heat and soak zones of the existing furnace.
- New long skids and crossovers for the existing furnace were supplied and installed along with new hot riders.
- New skid refractories for replaced skids in the existing furnace were supplied and installed.

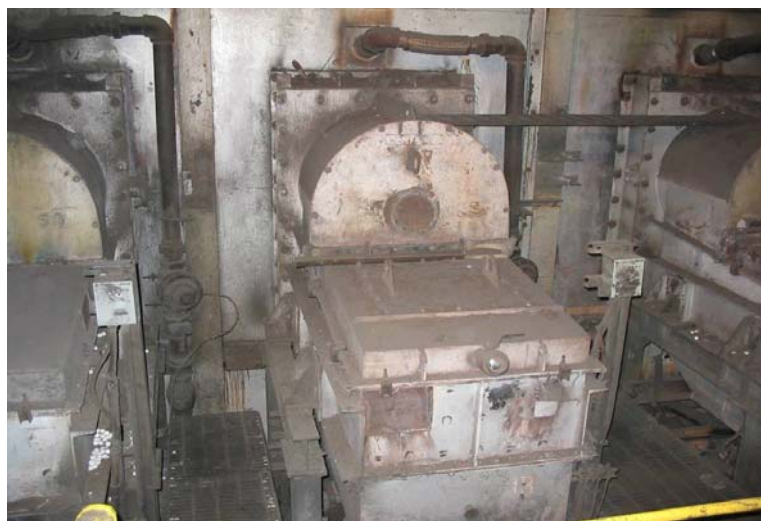
Figure 10: Existing Regenerative Burner

The entire work on the existing part of the furnace had to be done while the furnace was shut down. This included the burners, piping, skid system, refractory replacement and in-furnace roll table replacement. Figures 10, 11 and 12 show the old regenerative burners being removed and the new burners installed.

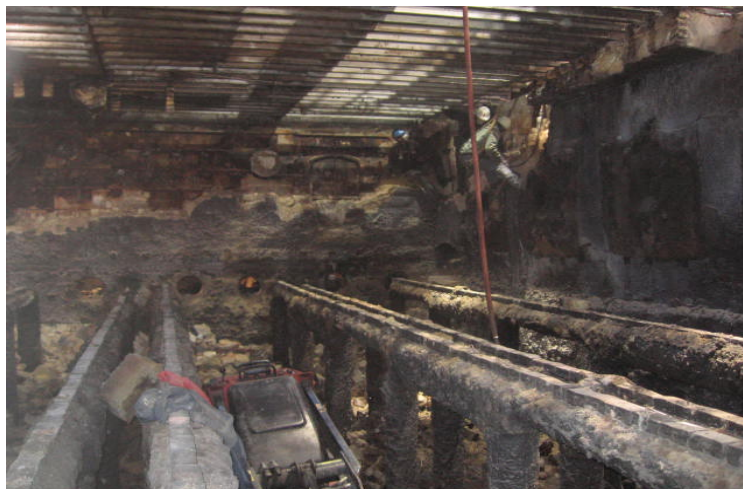
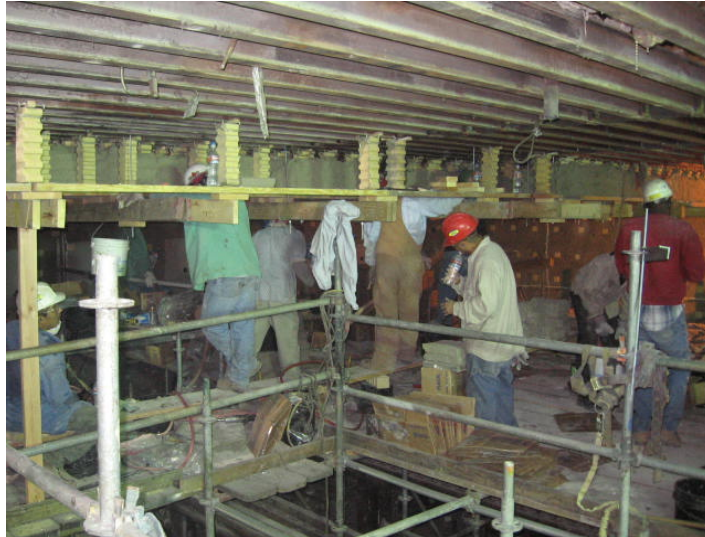
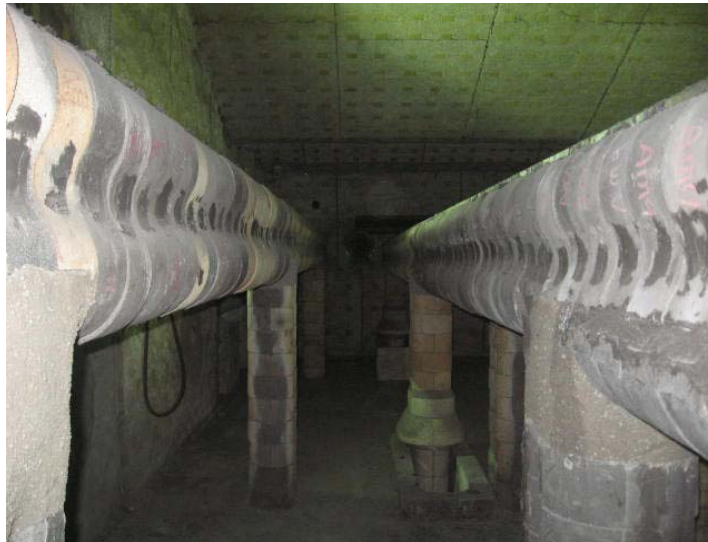
Figures 13 through 15 show the old refractories being removed and the new refractories installed.

Figure 13: Old Refractories Removed

Figure 14: New Refractories Being Installed

Figure 15: New Refractories Installed

- Refractories were supplied installed for the new furnace extension as well as for the existing furnace along with tie-in sections (roof, side and end walls).

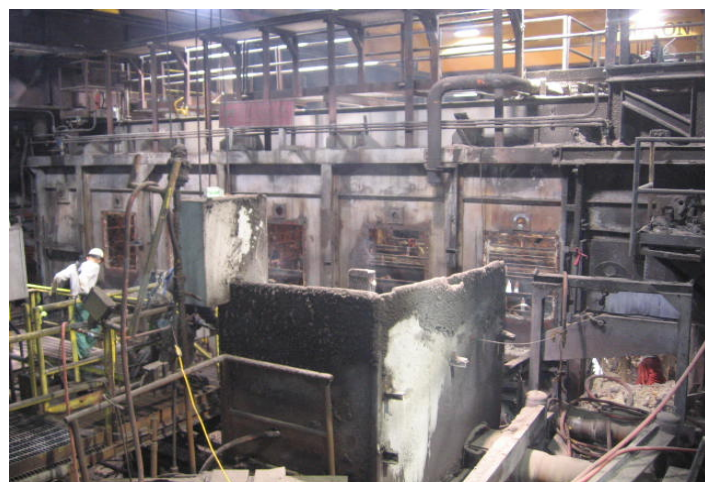
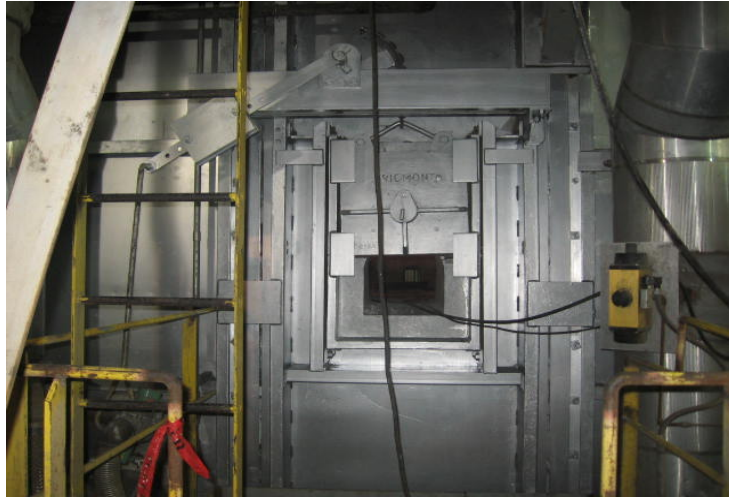
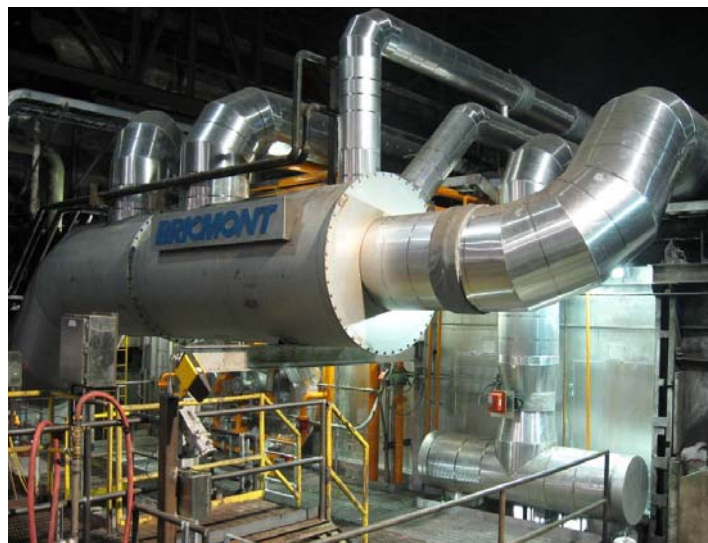
Figures 16 through 18 show the old steel work and piping being removed and the new steel and piping installed.

Figure 16: Old Steel Work and Piping Being Removed

Figure 17: New Steel Work Installed

Figure 18: New Piping Installed

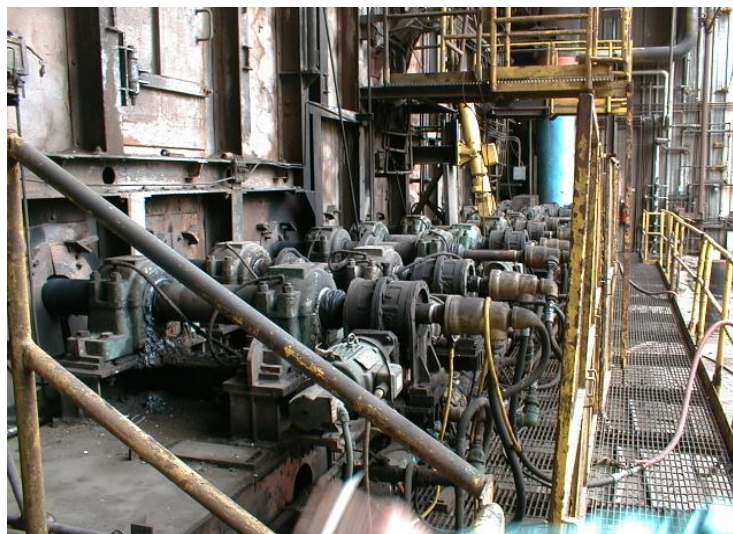
Figures 19 and 20 show the old in-furnace rolls being replaced by the new in-furnace rolls.

Figure 19: Old In-Furnace Charge Rolls

Figure 20: New In-Furnace Charge Rolls Installed.

- The existing in-furnace rolls at the charge and discharge end were removed. Ten new redesigned rolls were added at the charge end including new motors and reducers and individually controlled with new VFD units. The discharge rolls on the existing furnace were replaced with ten new redesigned rolls along with new motors, reducers and VFD units.

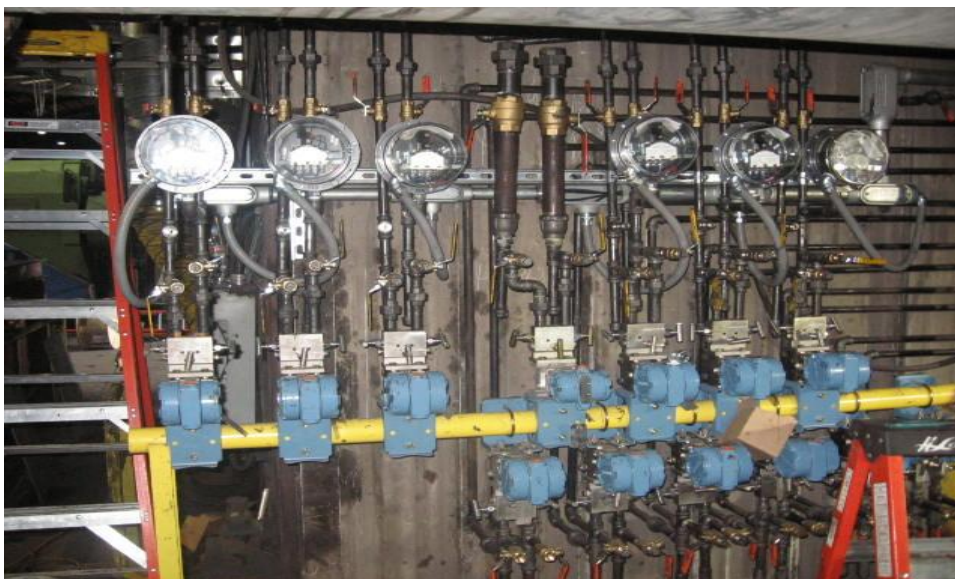
Figure 21: Transmitter Mounting

Most of the controls system work was done while the furnace was operating. The removal of the old system and switch over to the new system was done during the furnace outage. New level 0 system was installed, including thermocouples, gas and air control drive actuators, and transmitters. Transmitters were installed on a rack and mounted for easy access. Picture 20 shows the transmitters mounted together for convenient access.

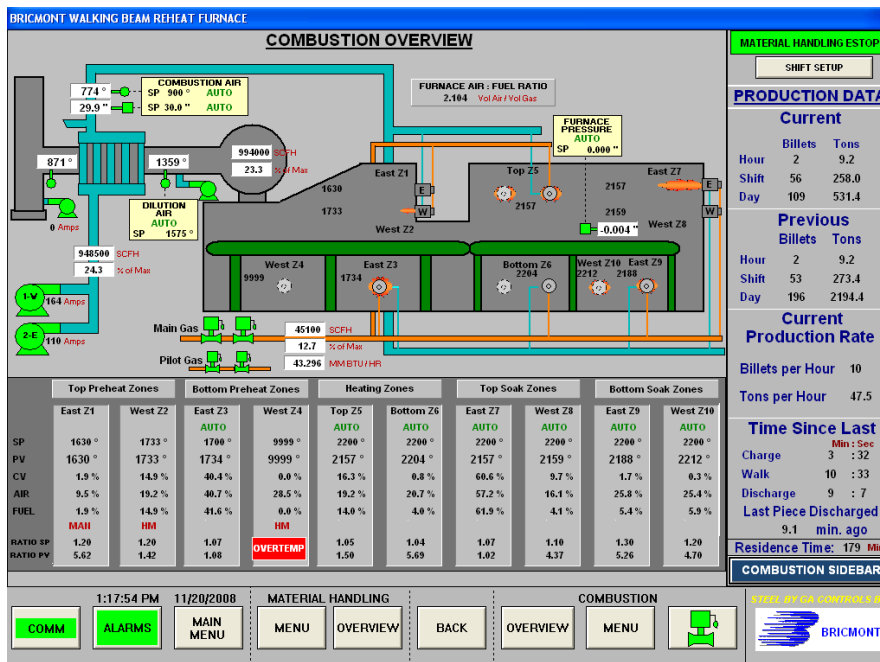
Figure 23: Control System Furnace Overview

Level 1 was replaced with a PLC/PC control system consisted of Allen Bradley ContrroLogix PLCs for combustion and material handling. A special Allen Bradly PLC served as the safety PLC. PCs located in the mill pulpit served as various HMI's and a PC server was supplied for the level 2 system. The main control configuration is shown in Figure 22. Figure 23 shows the control system furnace overview.

The entire furnace heating strategy can be optimized as all burners have the capability of being turned on and off by the control system. As the level 2 system determines the optimized furnace temperature profile, the level 1 system turns

burners on and off throughout the furnace to optimally meet the required heating demand.
