THE CHALLENGES OF BLAST FURNACE REBUILD¹

Key words: Blast furnace; Rebuild; SVAI; Brazil

¹ *Technical contribution to the 3rd International Meeting on Ironmaking, September 22 – 26, 2008, São Luís City – Maranhão State – Brazil*

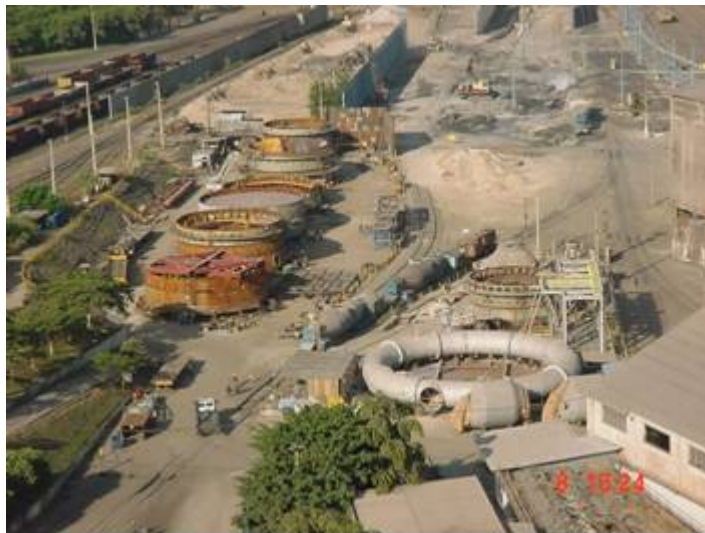
Figure 1. Pre-assembly area.

The bustle main can be seen in the foreground with the furnace rings in the background. The pre-assembly area was positioned within an active area of ironmaking at the CSN site and this therefore gives limitations for the possibilities of pre-assembly. The scale of the main crane that was utilised for all the major lifts is shown in Figure 2. It had a capacity of 240 tonnes at a radius of 24 m. The existing outrigger crane on the furnace was also used for the positioning of the modules. The crane was specifically supplied for the purposes of the outage from Europe.

It is shown in Figure 1 the pre-assembly area used prior to the outage period.

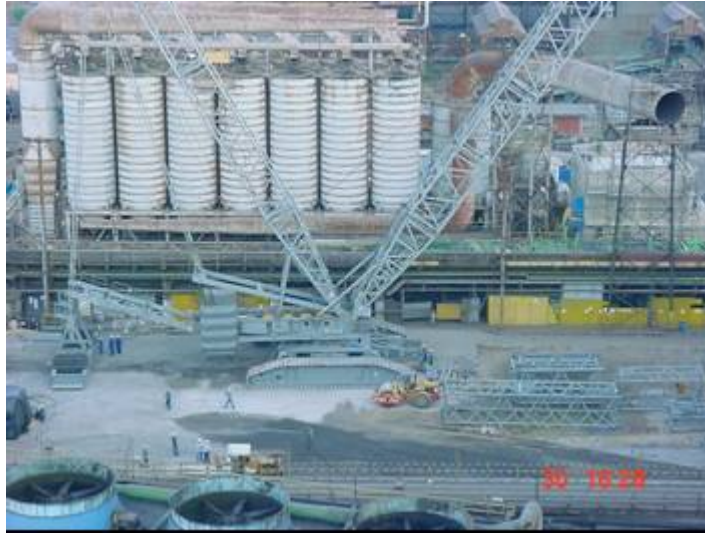
Figure 2. Crane with 240 tonnes capacity.

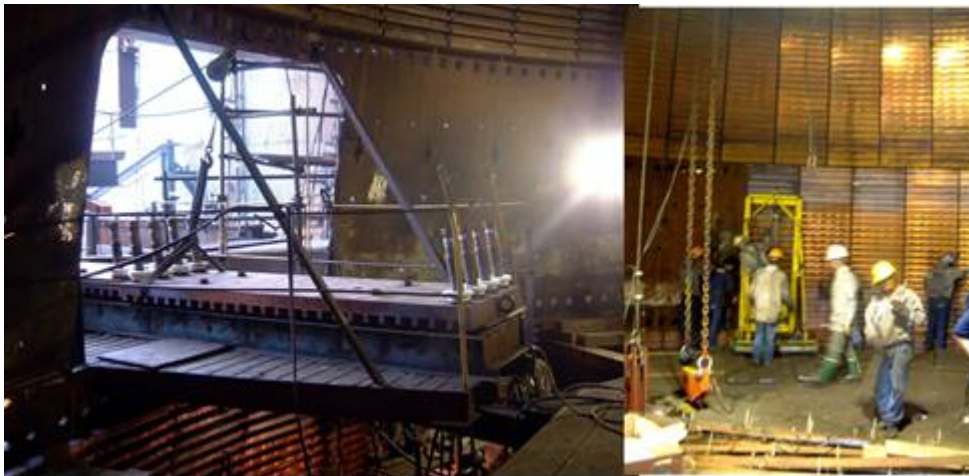
Figure 3. Installation methods for staves.

It can be seen in Figure 3 how the staves were delivered into the furnace and how they were installed.

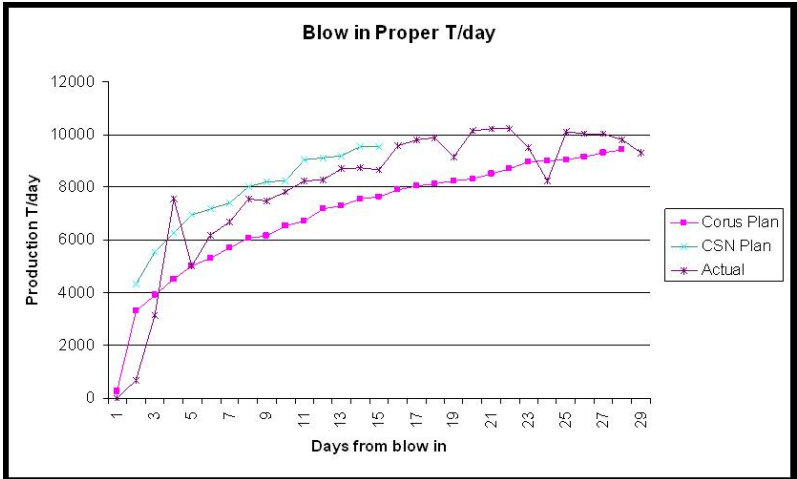
Figure 4. Production Rump Up.

The furnace reached its average daily production design figure after 15 days. This was particularly due to the professional manner in which CSN conducted this phase of the project. It is possible to see in Figure 4, the actual daily production against the Corus plan and CSN Plan.

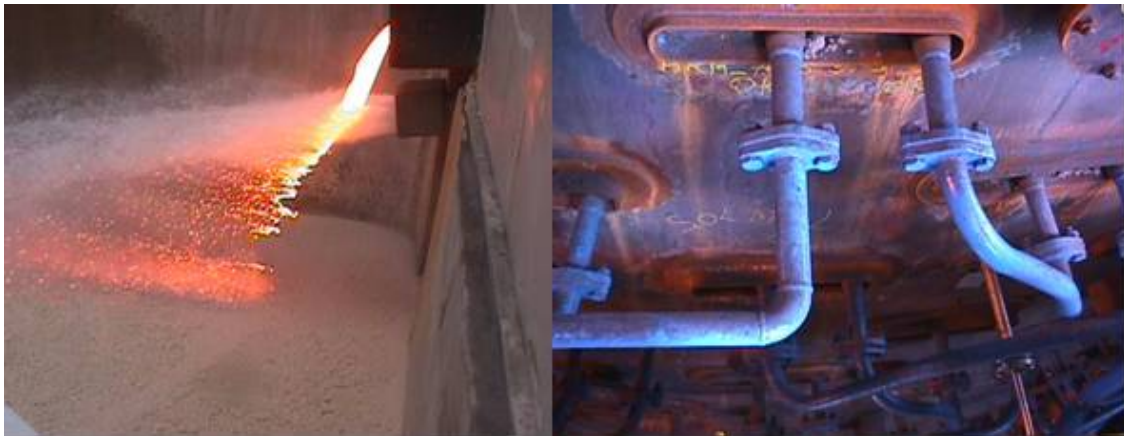
Figure 5: New slag granulation in operation and new pipes for the BF cooling system.

SVAI reviewed the process conditions for the BF cooling system, including the functional description and commissioning supervision. The slag granulation basic and detail design, functional description and commissioning supervision were also part of the scope. It was mandatory to follow USIMINAS standards in each phase of project. In Figure 5 it is possible to see the new slag granulation in operation and the new pipes for the furnace cooling circuit.

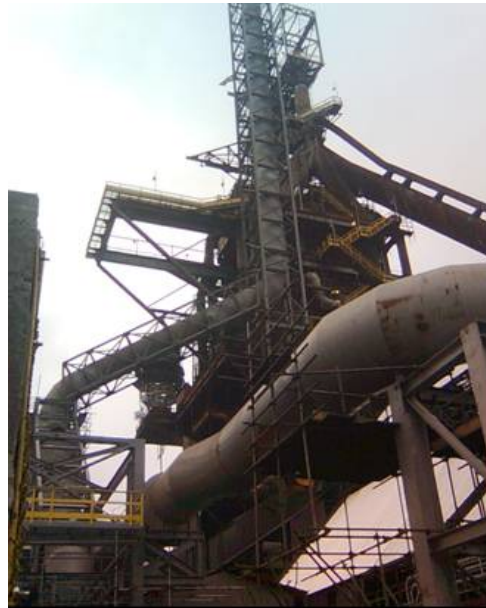
Figure 6: BF1 overview with new slag granulation chimney.

The main results of the activities and learning problems of the project are described below. The cranes were delivered without major problems. The revamp of the cranes was scheduled and re-scheduled many times due to operational requirements of the blast furnace. Good experience with the position change of the electrical panels from the crane to an electrical room. Slag Granulation Chimney was supplied by Polyplaster without major problem, some delays during engineering phase was eliminated during fabrication phase. The solution of the pin to allow the chimney movement was executed during fabrication phase with good performance. In the Figure 6 it is possible to see the new chimney after erection.
