PREDICTIVE REPEATING DEFECT DETECTION WITH ABB SURFACE INSPECTION SYSTEM¹

Abstract

¹ Technical contribution to 44th Rolling Seminar – Processes, Rolled and Coated Products, October 16 to 19, 2007, Campos do Jordão – SP, Brazil.

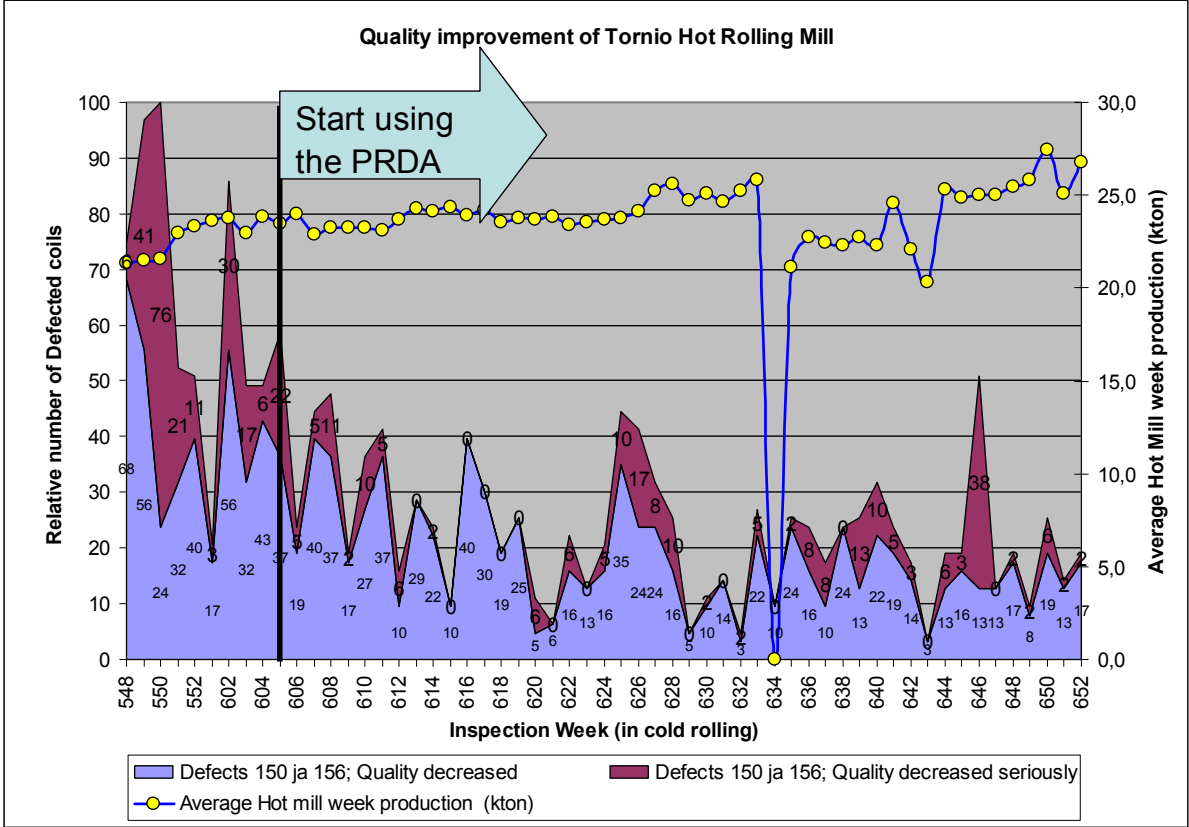
Figure 2. The Chart shows the amount of repeating defects on the Tornio hot mill.

The chart on Figure 2 shows the weekly occurrence of two types of defect, 150 and 156, which are both roll marks. The chart shows a time period of over one year. The PRDA function was implemented in the SIS in February 2006. Conclusion from the chart can be made that the with the help of the PRDA function the operators have been able to catch the roll marks as they have started to happen and so the amount of roll marks has been significantly decreased.

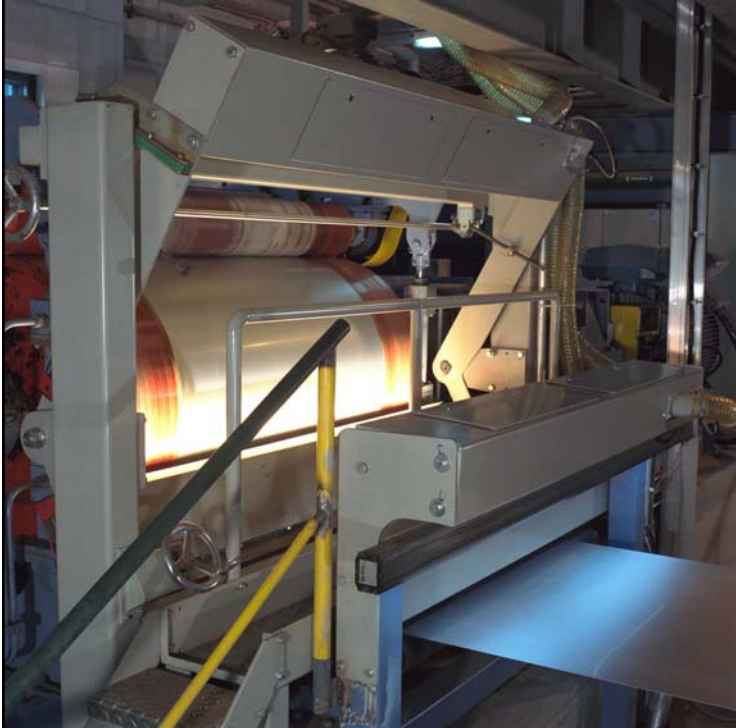
Figure 3. ABB SIS installed on annealing and pickling line in Outokumpu Tornio Works in Finland.

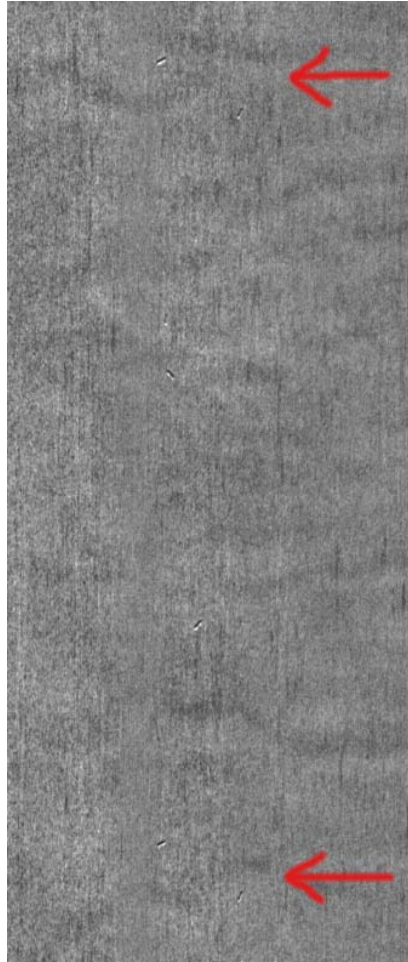
Figure 4b. Another picture of the same 2.2 m picture that is 0.4 m long in rolling direction. The same roll mark is now visible twice.
