SPEED INCREASING AT CM2 THROUGH THE ELIMINATION OF CBS SCRATCH GOUGE¹

Abstract

Key words: Cold rolling; Surface defect; Aluminum flat rolling.

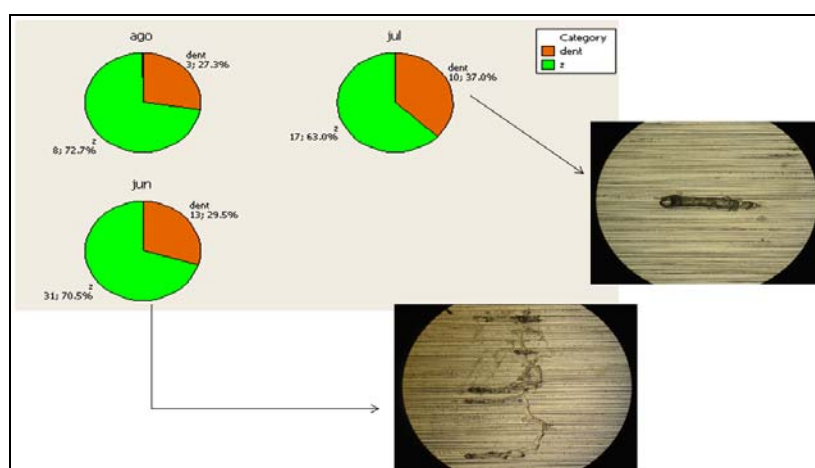
Figure 1 – Scratch gouge type determination: 70% Chinese Script and 30% Scratch Dent.

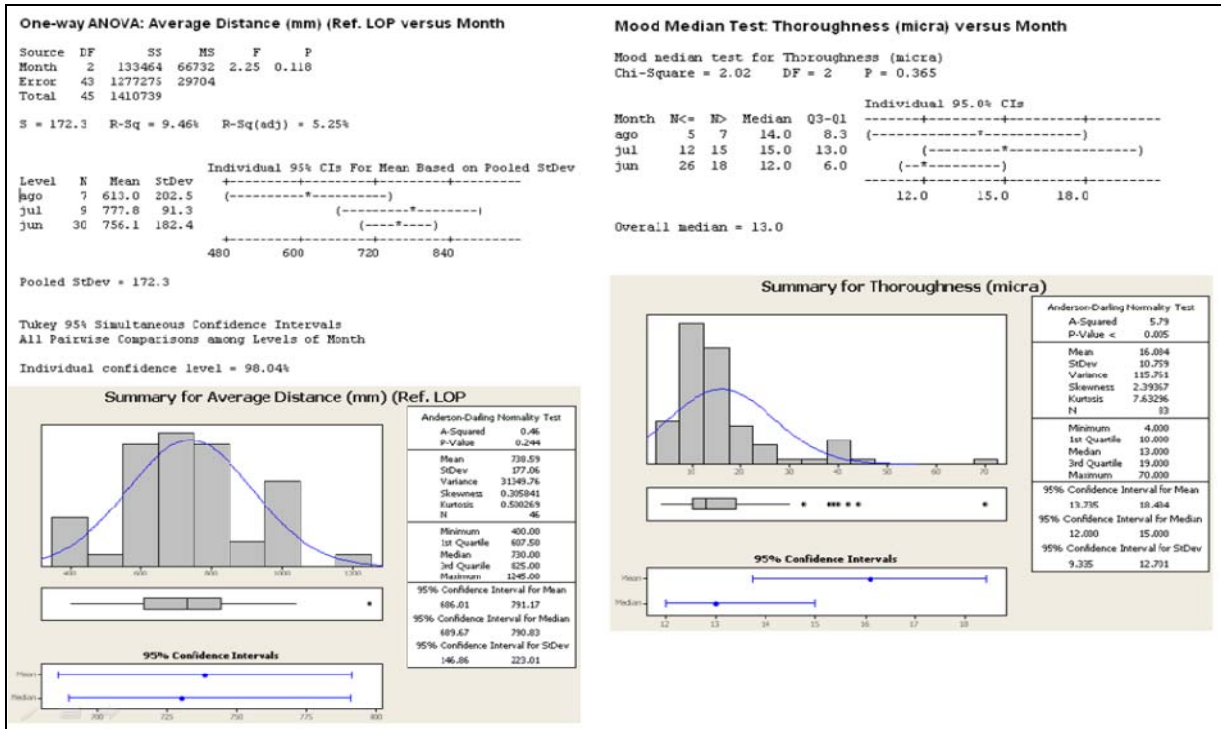
Figure 2 – Scratch gouge characterization: Left – Average distance from operator side edge; Right – Average indentation depth.

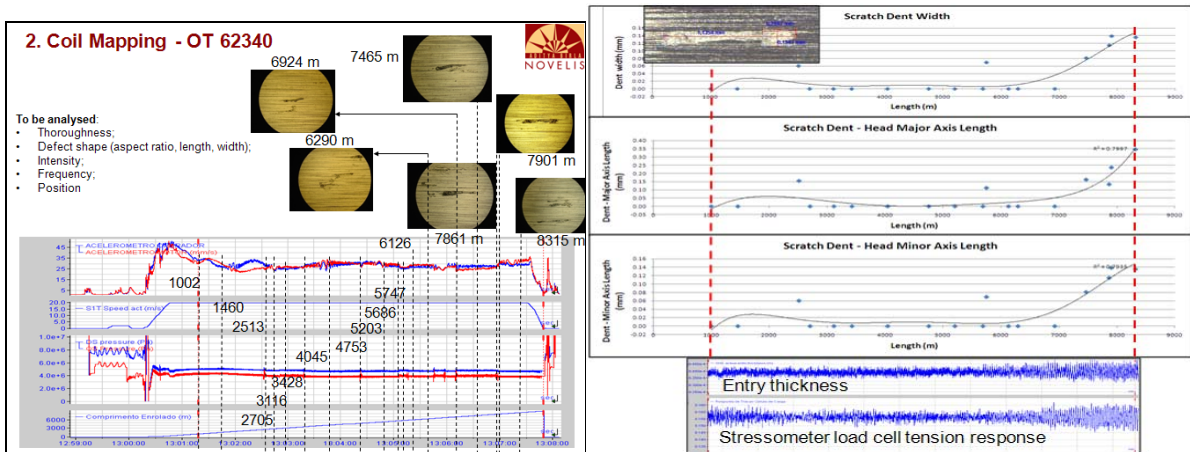
A coil was rolled in high speed (1180 mpm) to produce a severe scratch gouge and then it was mapped to observe how the defect evolved through the coil.

Figure 3 – High speed test and coil mapping. Left – Coil mapping; Right – Defect dimensions evolution through coil length.

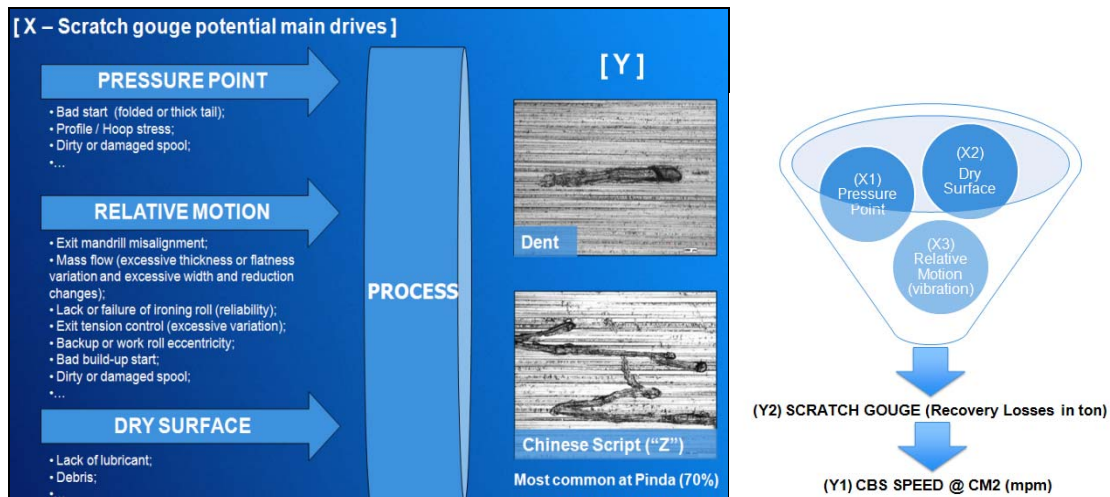
Figure 5 – Left: Scratch gouge mechanical initiation model; Right: Key project metrics.

Building a solid understanding of the issue the team was able to clearly build a defect model to illustrates the defect initiation mechanism and use it as a basis for solutions generation.

Once the defect model and the key variable were identified a series of tests were conducted to define the best solutions to drive the desired results. The main solutions are listed below divided by the mechanism field:

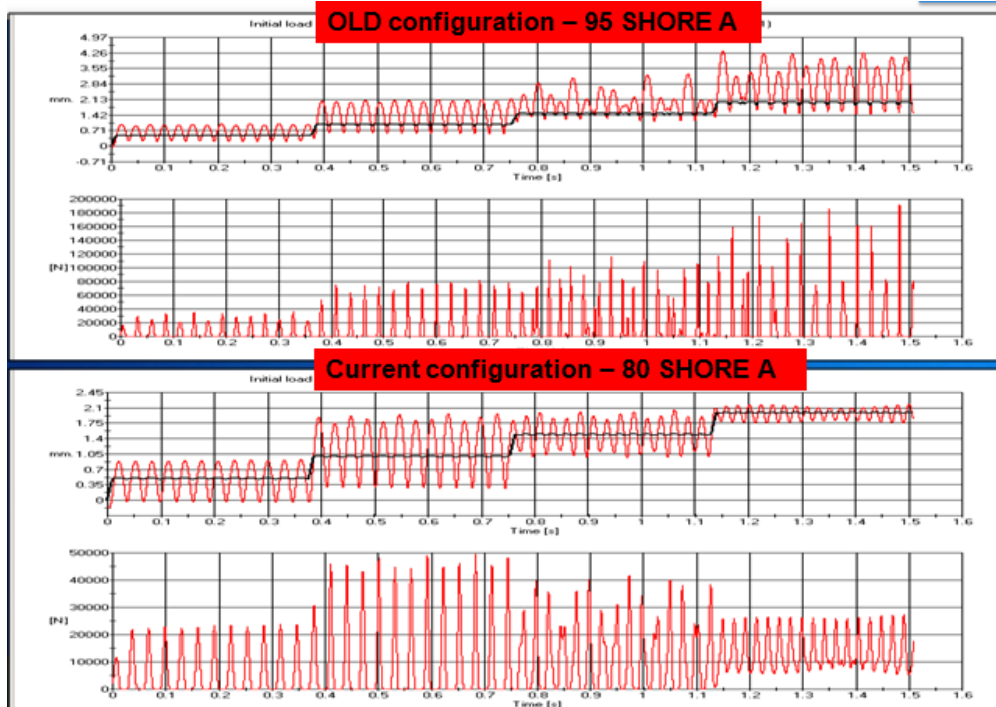
- New ironing roll coverage design: A series of modeling conducted at NGTC (Novelis Global Technology Centre) to determine an ironing hardness able to absorb higher levels of vibration (one of the main actions).

Figure 6 – Top: Modelling of old configuration considering a harder coverage; Bottom: Modeling of the current configuration considering a softer coverage.

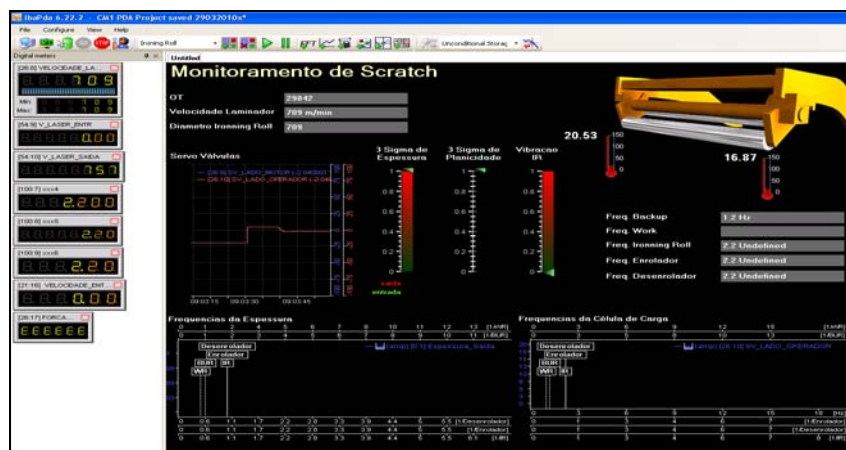
Figure 7 – Ironing roll monitoring system.

- Ironing roll coverage width increased from 1000 mm to 1200 mm following network information from Logan plant (Don Miller – Cold Rolling Automation). This achieve a better force distribution in minimize air entrapments (one of the main actions).
- Acquisition of 250 new steel spools.
- Implementation of on-line monitoring system for on-line temperature and vibration measurement of the ironing roll.

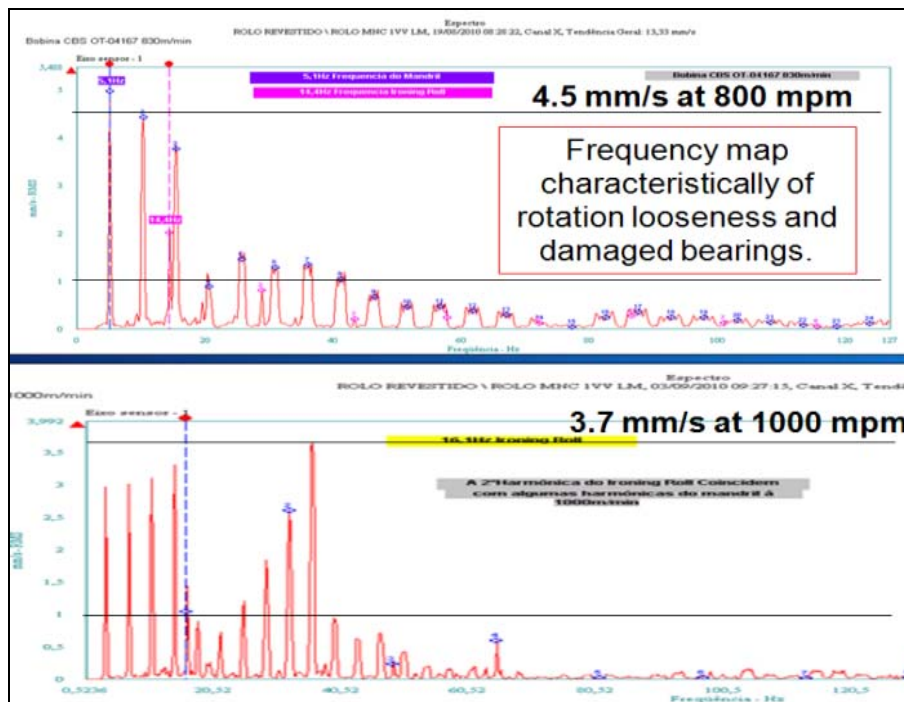
- Work roll roughness increased from 18-21 μin to 21-24 μin . This provides better grip between laps and on the exit deflector, providing better stability to the strip, thus avoiding relative motion and surface wear (one of the main actions).
- After a series of vibration measurements the exit mandrill was replaced. The measurements identified frequency maps characteristically from rotational looseness and damaged bearings.

Figure 8 – Exit mandrill vibration maps. Top: Before replacement; Bottom: After replacement.

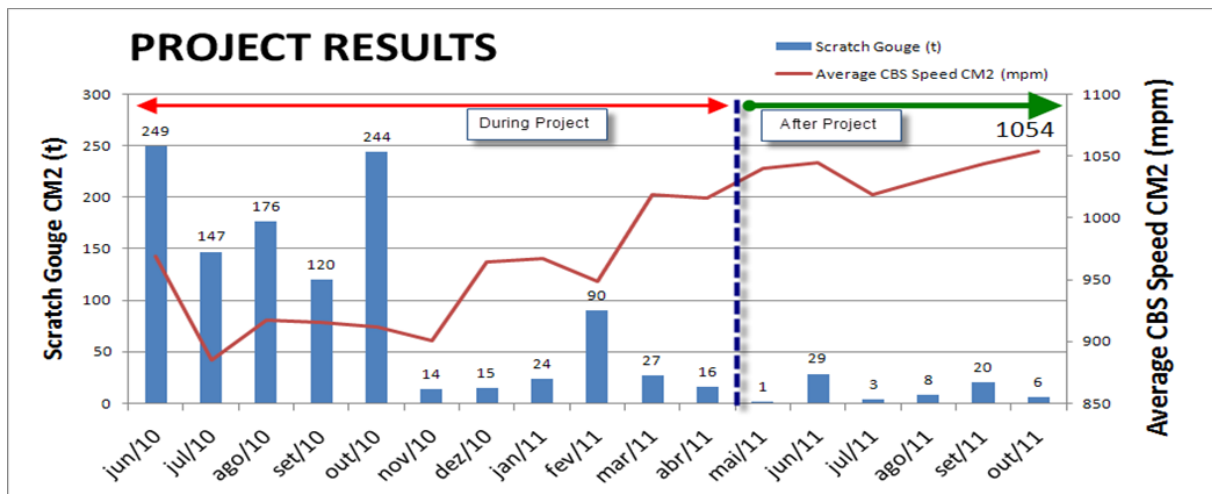
Figure 10 – Rejection (in tons) during and after the Project.

- Recovery losses: Decreased from 187 ton/month to 15 ton/month.
- Average CBS speed: Increased from 930 mpm to 1054 mpm.
- Cold rolling capacity improvement: 12000 tons/yr (goal was 10000 tons/yr).
- EBTDA generation: US\$ 6 million (considering lowest margin product: CBS).
