# The VAI-CON<sup>®</sup> Link Suspension System from Development to Six Years of Experience

G.Furter  
T. Sadler  
G. Staudinger

**Event: XXXV Steelmaking Seminar & V Casting Seminar, May 17 to 19, 2004 - Salvador - BA - Brazil.**

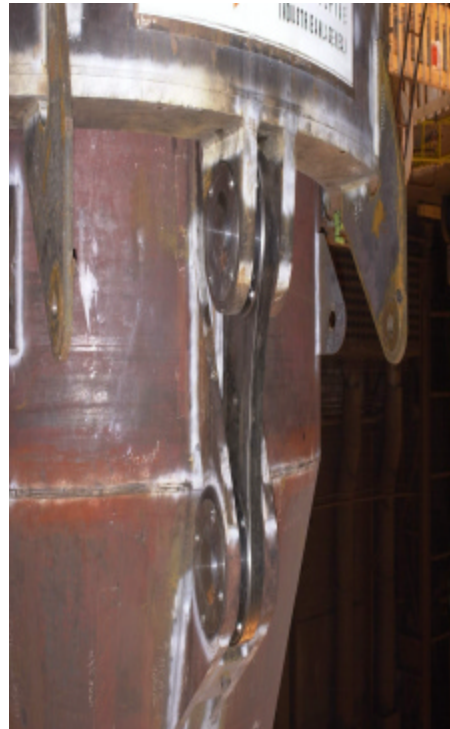
**Figure 5:** Vertical link arrangement

The bearings are protected by heavy cover plates against contact with liquid steel, slag, dust, etc. The pin itself is sealed with Fey rings and a heat-resistant oven rope with a holder ring against impact with slag, liquid steel or heavy dust. **Figure 5** shows the actual link arrangement.

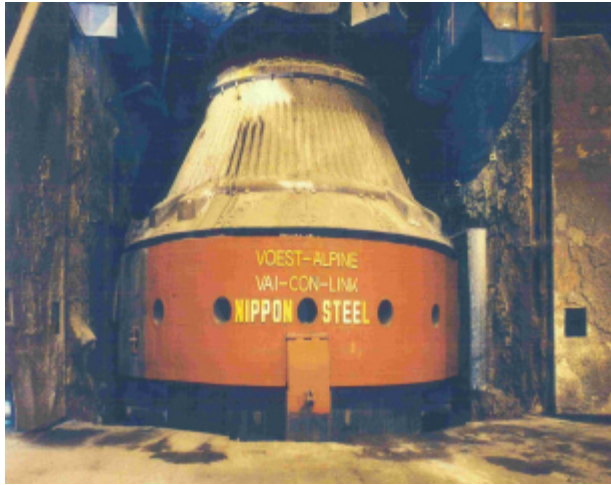
**Figure 6:** First installation of the VAI-CON® Link Suspensions at ISCOR Newcastle (South Africa) on an existing trunnion ring (Nippon Steel) in Dec. 1997.

The first installation went into operation in December 1997 in a 175-ton LD converter at ISPAT ISCOR Newcastle in South Africa. The existing trunnion ring (of NIPPON Steel design) was re-used. This installation was followed by another four installations in South Africa and one in Europe in 1998. This amounts to a total of six years of experience, which was an opportune time to obtain feedback from the installed systems. **Figure 6** shows the initial installation of the VAI-CON<sup>®</sup> Link suspension system at ISCOR Newcastle in South Africa in an existing trunnion ring (Nippon Steel) in December of 1997.

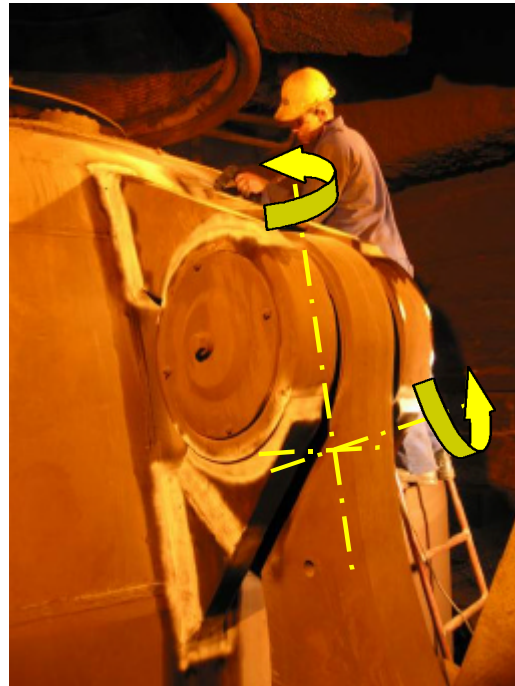
**Figure 7:** MT of vertical link arrangement. The arrows show possible rigid-body rotations of the link.

During the first quarter of 2003, VAI inspected the LD converter and the maintenance group at ISPAT ISCOR Newcastle in order to obtain more information on the behaviour of the system after more than five years of operation. The converter was put into bottom-up position in order to better access the links. All slag-protection boxes of the three vertical links were opened (the two horizontal links and the stabilizer are not protected). General visual inspection of the system showed that the equipment is in good condition, though skull formations were found in some locations between the lugs and the links. This is due to normal operation and is no cause for concern. Nevertheless the skull was removed. It was also noted that all the links were in a more-or-less arbitrary position. The spherical plain bearings on both ends provide each link with two free DOFs. There is possible rigid-body rotation around the length axes of the link as well as the cross axis that is normal to the vessel shell (see also **Figure 7**). The arbitrary position indicates that the spherical plain bearings are functional.

The weld seams between the lugs and the vessel shell and the trunnion ring as well as the welds of the lugs themselves were all cleaned and checked (VT<sup>1</sup>, MT<sup>2</sup> and UT<sup>3</sup>) by an external expert (see also **Figure 7**) The test results were very positive; no problems were detected at all. Some protection

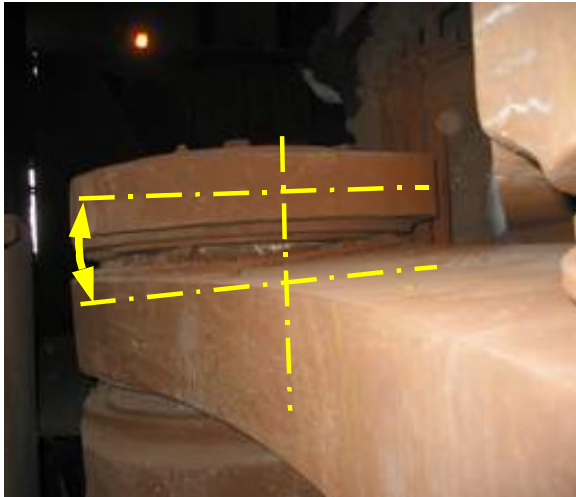
**Figure 9:** Horizontal link with swivelled link showing the function of the spherical plain bearing

An example of the horizontal links is shown in **Figure 9**. The link is rotated by a certain angle indicating a right function of the main bearing. Some skull formation and dust accumulation are visible between the lugs and the link. Particularly in Newcastle the horizontal links are additionally exposed to temperature shock (the arrangement is shown in **Figure 10**). Primarily they are exposed to high temperature (under regular operating conditions) but additionally to water leakage from the offgas hood. The system can withstand these influences as well. The horizontal link arrangement shows some rust formation (even on the bearings). However, due to the solid and heavy design, any stress-corrosion or any other corrosion does not negatively influence the system. Rust in the main bearings have more or less the same effect as dust, just increasing the friction effect in the bearing (see above).

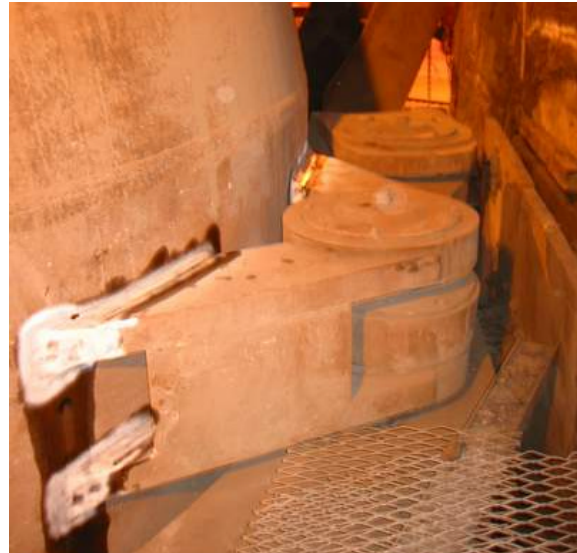
**Figure 10:** Horizontal link arrangement.

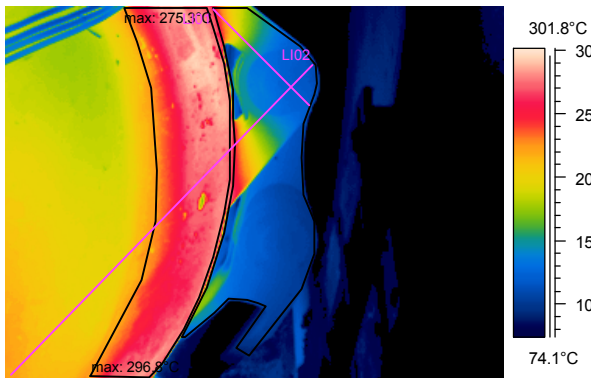
**Figure 11:** Temperature image of the horizontal Link arrangement (ISPAT ISCOR Vanderbijlpark).

A typical temperature scenario is shown in **Figure 11**. It can be seen that the lugs operate much like cooling ribs as well. This has a positive effect in that the main bearings as well as the link are exposed to much less heat as compared to the vessel shell. A temperature drop of 100 °C can be observed along the length of the lugs between the vessel shell and the bearing housing (see **Figure 12**).

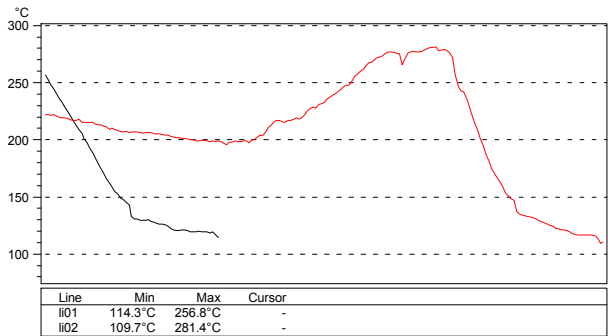
**Figure 12:** Temperature graphs along path defined above.

Even under high temperature conditions (end of campaign), the maximum temperature measured in the area of the bearing is not more than 220 °C, which is a conservative comparison when looking at the design criteria of the spherical plain bearings (compare section 2.1).

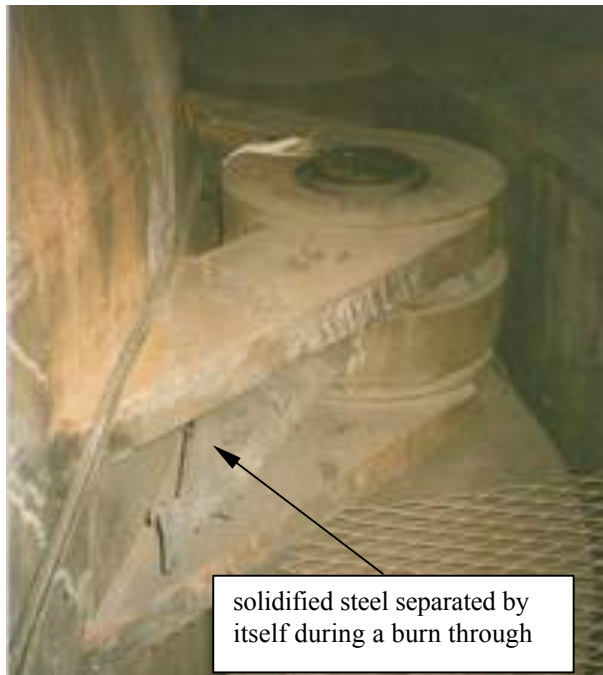
**Figure 13:** Solidified liquid steel on horizontal link arrangement after a burn-through

An inspection of the suspension system showed another major advantage of the system. The heavy structure and solid dimensions of the adjacent parts cause liquid steel to instantaneously freeze and cover the parts with a solid steel skin. The huge masses of the involved suspension system have a very high heat capacity as well. The transient heat scenario thus causes the liquid steel to solidify quickly. For this reason there are high heat effects on the surface only. The equipment is usually not washed.

**Figure 13** shows the horizontal link arrangement after a burn-through. The solidified steel automatically separates from the equipment after cooling down (caused by the temperature gradient in the frozen steel). This is an additional feature of the VAI-CON<sup>®</sup> Link system. It withstands the most stringent operating conditions. Burn-throughs are a nightmare for every steel producer but cannot be completely avoided (Murphy's law). The equipment—particularly the links—were also checked through measurements of the surface hardness. However, the loss of hardness was acceptable, so no part of the suspension system was replaced after this serious burn-through. It took roughly two months to repair the vessel shell and trunnion ring. This behaviour must be taken into consideration when the question arises, "What happens when a link is missing?" It has been proven that not even a serious burn-through will destroy a link.
