# CARBIDE REINFORCEMENT FOR FINISHING MILL ROLLS AND THE EFFECT ON TEST RESULTS AND STRIP SURFACE\*

## Abstract

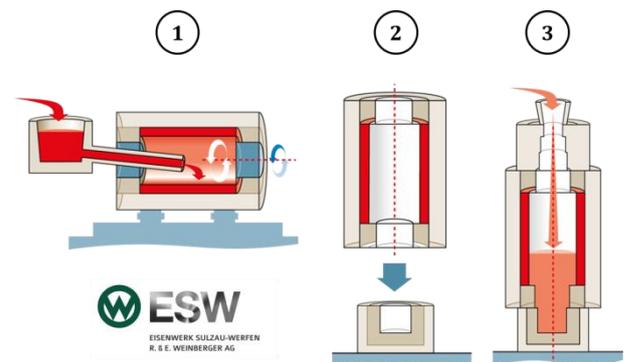
Figure 1: Production route of ESW's horizontal spincasting process for work rolls [11]. 1: Spincasting of the shell material, 2: Mounting of the molds, 3: Casting of the core material

ESW produces work rolls by means of the horizontal spincasting process, see Figure 1. The first step is the spincasting process itself (1) where the wear resistant shell material is cast at high centrifugal forces. The solidified shell material is mounted together with the spincasting mold to the bottom and top neck molds (2). As final step, the core material (usually nodular cast iron) is cast and the bonding zone between shell and core is formed (3).

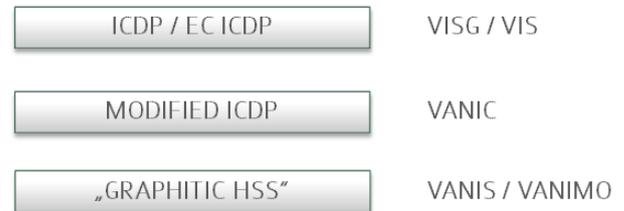
Figure 2: ESW's product portfolio for the last finishing stands of hot rolling mills.

ESW's product portfolio for the last finishing stands reaches from Carbide-Enhanced ICDP (VIS) over a modified ICDP grade (VANIC) to graphitic HSS (VANIS and VANIMO), see Figure 2.

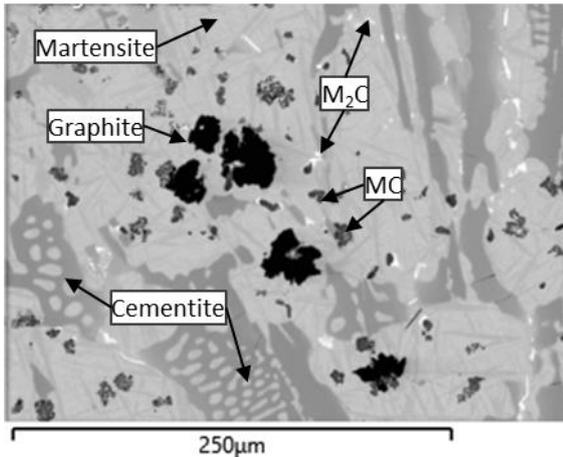
Figure 3: Microstructure of VANIMO with MC,  $M_2C$  and  $M_3C$  carbides as well as graphite embedded in tempered martensite

The microstructure of graphitic HSS roll grades consists, like in case of ICDP roll grades, of cementite and graphite embedded in tempered martensite. Additionally very hard carbides such as MC and  $M_2C/M_6C$  are present in the microstructure of graphitic HSS. A possible microstructure of VANIMO is shown in Figure 3.

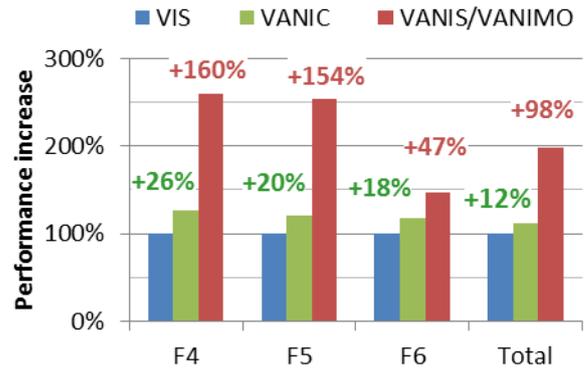
Figure 4: Wear performance of VIS, VANIC and graphitic HSS (VANIS/VANIMO) in the last 3 stands of a 7 stand mill

Figure 4: Wear performance of VIS, VANIC and graphitic HSS (VANIS/VANIMO) in the last 3 stands of a 7 stand mill shows the comparison between VIS, VANIC and the graphitic HSS grades VANIS and VANIMO in regard to the rolled tons per mm shell material. In this case, the pure wear on the work roll is displayed (not the stock removal). Additionally the performance of the roll grades is compared for each stand separately.

It is obvious that the largest benefits were achieved in stand F4, where the performance of VANIC was +26 % in comparison to VIS and the graphitic HSS grades reached an increase of +160%. The higher wear resistance of VANIC and VANIMO can also be seen in stand F5 (VANIC +20 %, VANIMO + 154%), followed by stand F6 (VANIC +18 %, VANIMO +47 %).

In total, VANIC reaches +12 % in comparison to VIS while the graphitic HSS grades achieve +98 % in pure wear. These figures show that not only the work roll grade but also the rolling conditions influence the wear performance of the work roll. A close look at the work roll history helps to increase the performance of the rolls in the mill.

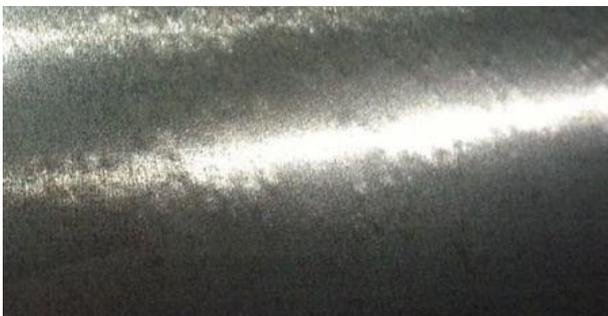
Figure 5: Possible appearance of segregated carbides on the barrel surface

The spincasting process is always related to high centrifugal forces. This means that due to the process so-called “gravity-segregation-effects” can occur within the liquid shell material as well as during solidification. If more wear resistant phases such as carbides agglomerate and segregate, the wear on the barrel surface develops irregularly and may look as shown in Figure 5

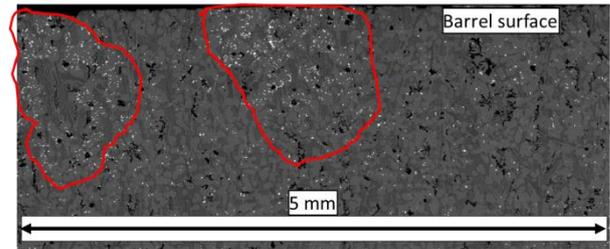
Figure 6: SEM-BSE investigations of segregated carbides in a graphitic work roll grade

An investigation of this surface shown in Figure 6 clearly shows agglomerations of small MC carbides, shown in white. MC carbides are the hardest carbide types [14-15] and therefore are highly wear resistant. If this carbide type is not distributed homogeneously in the matrix, the wear on the barrel surface develops irregularly.

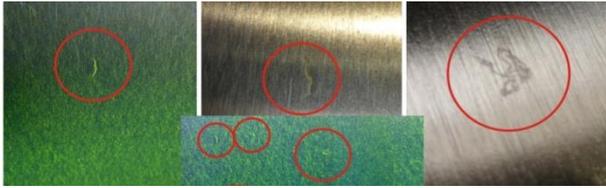
Figure 7: Typical appearance of insufficiently dissolved ferroalloys

On the other hand, a full dissolution and homogeneous distribution of the ferroalloys in the melt is essential. Figure 7 shows a barrel surface with insufficiently dissolved ferroalloy particles which lead to imprints in the rolled material. During roll testing, these defects may be found by Eddy Current (EC) or UT surface wave testing. Also penetration testing (PT) or magnetic testing (MT) clearly reveal such defects where they appear as small cracks or porosities when they reach the barrel surface.

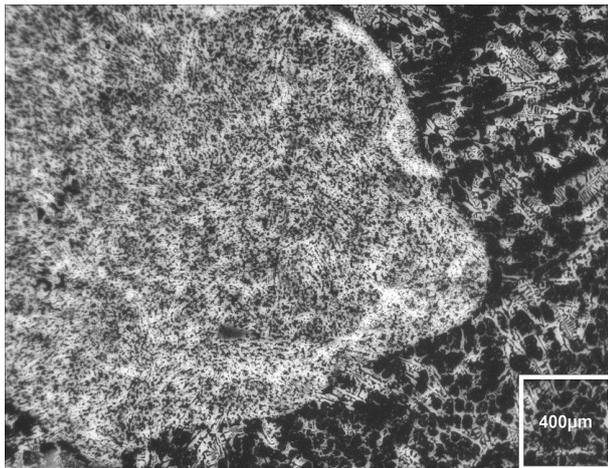
Figure 8: Light-optical image of an insufficiently dissolved ferroalloy

If a metallographic sample is taken from such defect and etched with 5-% Nital, the microstructure looks as shown in Figure 8. In this image carbides appear white and the matrix as well as the graphite particles are black. The normal microstructure shows typical ledeburitic carbides with an area fraction of about 35 %. The insufficiently dissolved ferroalloy has a much higher carbide fraction and much finer structure.

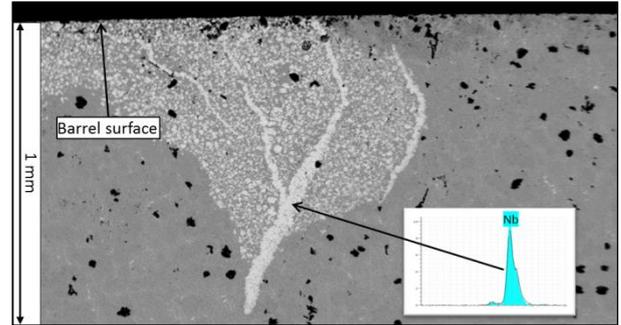
Figure 9: SEM-BSE image of the depth profile of insufficiently dissolved FeNb

The depth profile of such defect is shown in Figure 9. The round graphite particles are shown in black, the matrix and cementite in grey. The insufficiently dissolved ferroalloy can be seen as a white structure. The depth of the particle is approximately 1 mm from the barrel surface. It can be clearly seen that the dissolving process was just in progress when the metal solidified. An EDX scan revealed that the particle contains high fraction of Nb which means that the dissolving process of FeNb was insufficient.

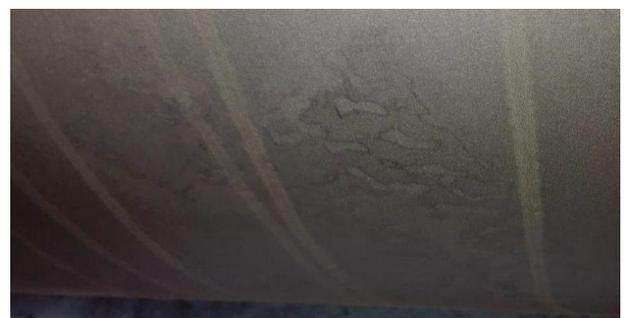
Figure 10: Possible appearance of “degenerated” carbides on the barrel surface

For high-performance work roll grades such as VANIMO, not only the correct amount and types of carbides but also their morphology is essential for a smooth barrel surface. Figure 10 shows an example, where “degenerated” carbides – this means carbides with different than usual morphology – lead to some surface pattern on the work roll barrel. The pattern in Figure 10 somehow reminds of water spots but is metallurgically caused.

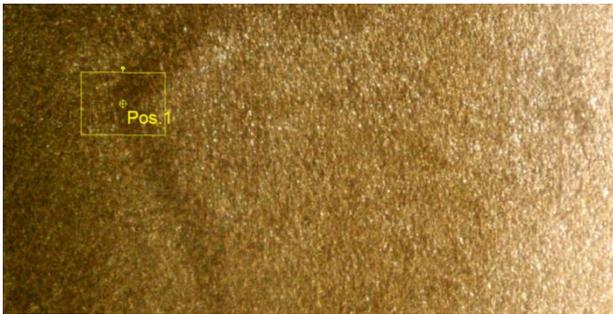
Figure 11: Detail of degenerated carbides in Figure 10

The detailed view on such “water spot line” in Figure 11 reveals its macroscopically clear line appearance. Performing a large area EDX mapping which is shown in Figure 12 we see that the amount of V is not homogeneously distributed but V is enriched in one line which is the same as the macroscopically visible one.

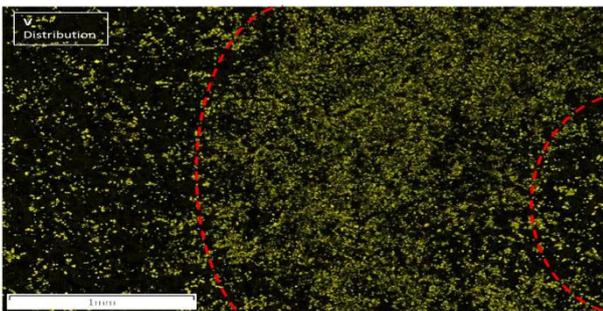
Figure 12: SEM large area mapping of V distribution

This is also valid for Nb (not shown here), which means, that MC carbides based on V and Nb are arranged in lines which cause the pattern on the work roll surface.

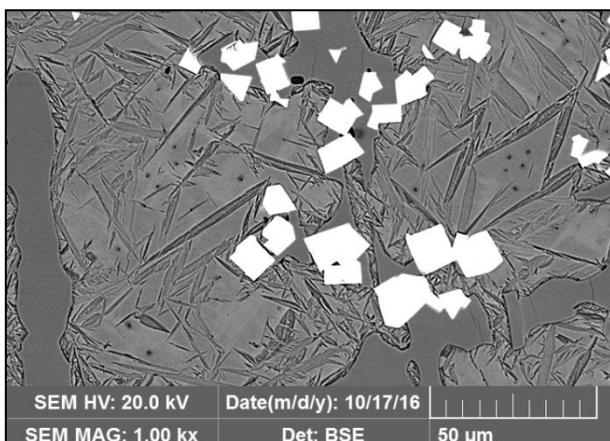
Figure 13: Cubic morphology of MC carbides (white) in a graphitic work roll grade

A close look on the morphology of the MC carbides shows clear deviations between two MC carbides types. The first type is shown in Figure 13, where the white MC carbides appear in a clear cubic structure.

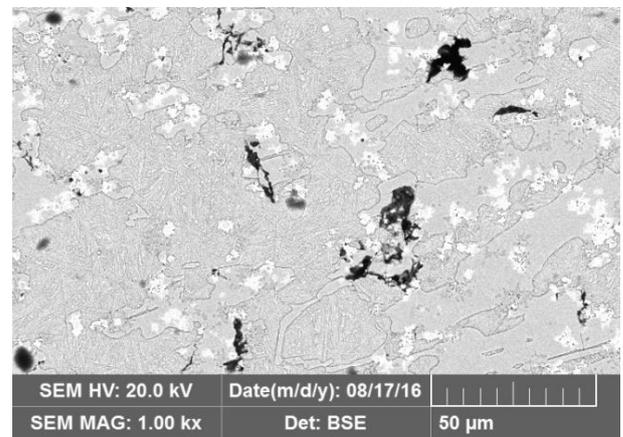
Figure 14: SEM-BSE image of degenerated MC carbides (white)

The second type of MC carbides is shown in Figure 14. Here the white MC carbides have a more irregular shape. Else, they are much smaller than the ones in Figure 13. Additionally they tend to agglomerate and form lines which result in “water spot lines” on the barrel surface.

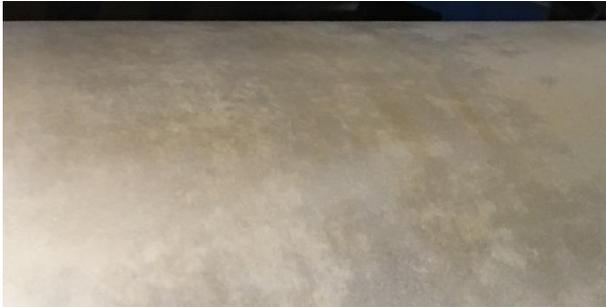
Figure 15: Barrel surface with “cloud-pattern”

is the formation of a “cloud-pattern” on the surface of ICDP roll grades. Figure 15 shows the appearance of this defect on the barrel surface.

It can be described as very small variations in the surface appearance of the work roll and can be very hard to identify. Anyhow in some mills and some applications the pattern is transferred to the strip where it is detected by the automatic surface inspection systems of the mills.

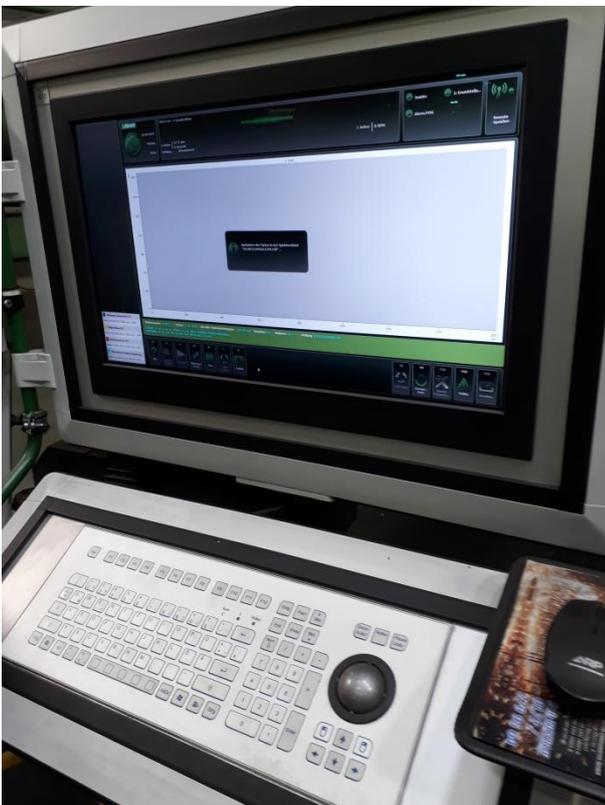
Figure 16: LRI Control Panel (Screen and PC)

The new LRI configuration is very compact. A controlpanel with screen and integrated PC as shown in Figure 16 is installed on the grinding machine. The second part is the so called iPPS (intelligent Probe Positioning System). This part controls the probehead very accurate towards the roll surface to perform the automation. See Figure 17.

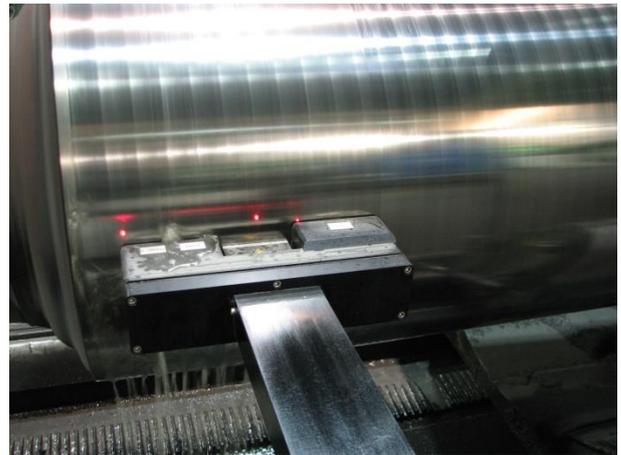
Figure 17: LRI intelligent Probe Positioning System

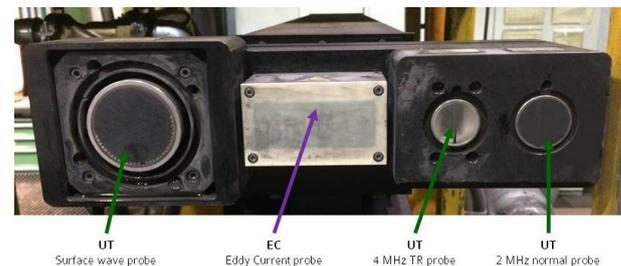
Figure 18: front of the probe head configuration

Figure 18 is showing the actual probe head configuration of this ESW automatic roll inspection system. There are the 3 described UT probes, same as in the former configuration and the new eddy current sensor in the center of the probe head.

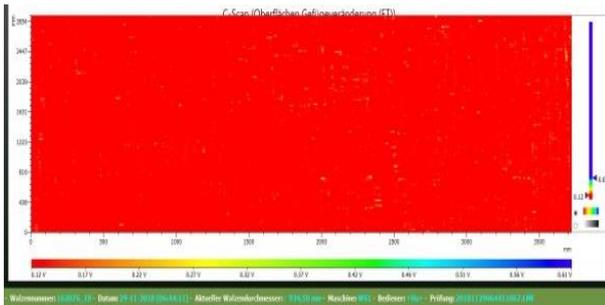
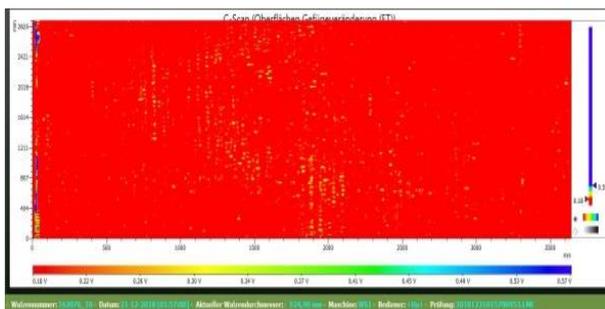
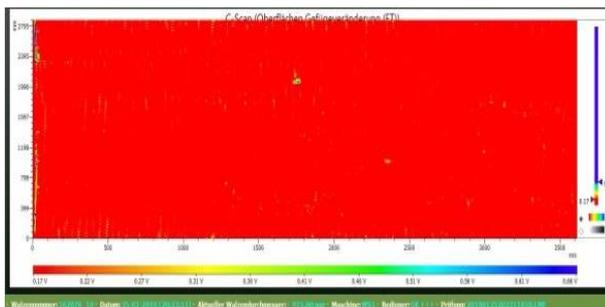
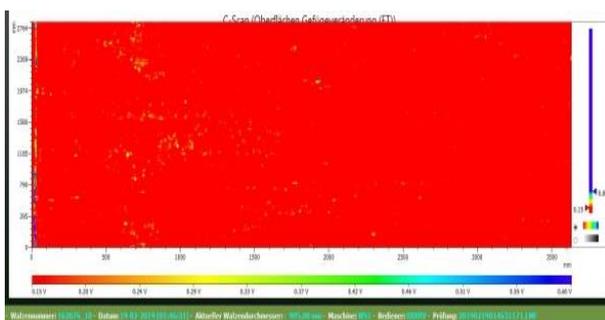
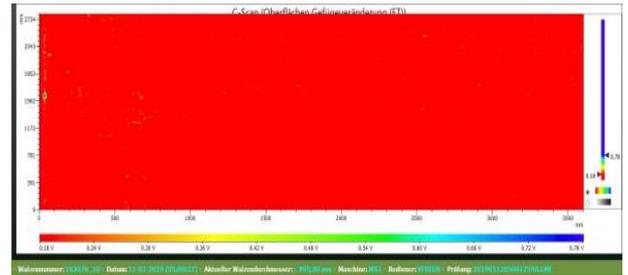
Figure 19: C-scan at Ø 935mm

Figure 20: C-scan at Ø 925mm

Figure 21: C-scan at Ø 915mm

Figure 22: C-scan at Ø 905mm

Figure 23: C-scan at Ø 895mm

For this investigation we took a special alloy of chrome cast steel. To see if the alloy is uniform we ground the roll in 5mm steps down followed at each step by a scan on the LRI System. The following figures 19-23 show the different stages of the ground roll.

In the different figures we can see, that some microstructural indications appear and disappear. The metallurgical background is a small variation in the carbide content of the ledeburitic network carbide.

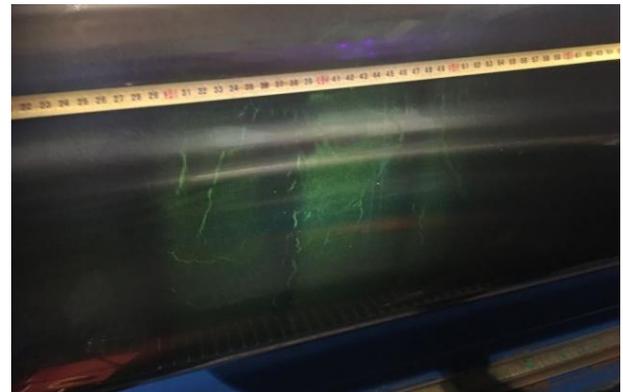
Figure 24: fluorescent magnetic particle test under UV light

**Erro! Fonte de referência não encontrada.** shows the detection of a surface pattern during service in the rolling mill.

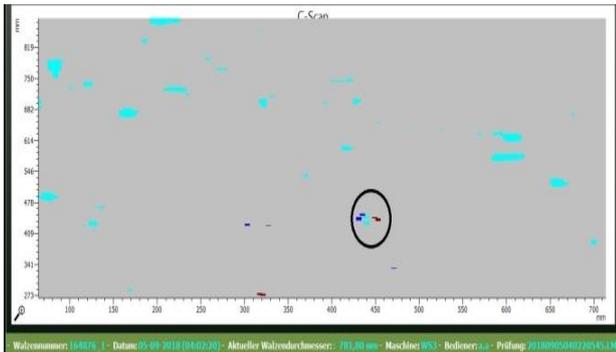
Figure 25: indication of detected area on the roll at customer side

**Erro! Fonte de referência não encontrada.** shows the detection in the circled area containing signals from the 2 directions of the surface wave probe and the EC microstructural indication.

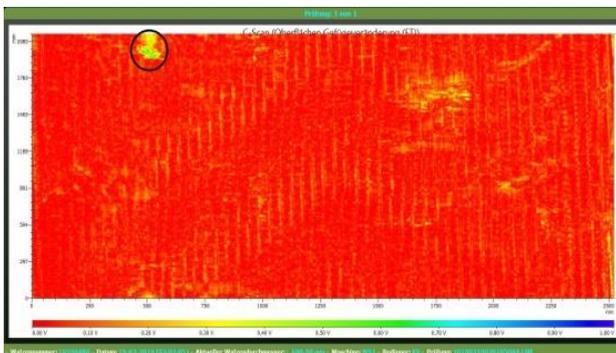
Figure 26: EC C-scan microstructure changes

The EC microstructure of a HSS roll gave some indication as shown in Figure 26 and marked with the black circle.

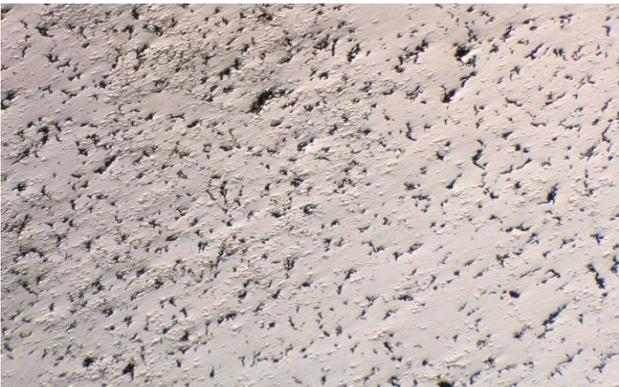
Figure 27: left top, MC carbide agglomeration

As can be seen in **Erro! Autoreferência de indicador não válida.**, the metallographic investigation brought up the high density of MC carbides. This gives a high signal in the EC microstructure channel. In total the MC precipitation was not uniform over the localized area in the barrel.

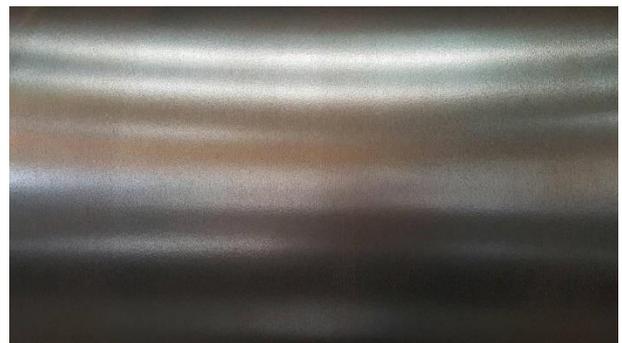
Figure 28: Smooth VANIMO barrel surface without irregularities after rolling a campaign with ~4700 tons

The surface quality of ICDP as well as graphitic HSS grades is essential for a proper usability in the rolling mill. Possible surface defects were presented and the remedies were discussed. The new possibility to detect such surface discontinuities with EC test methods makes it possible to make tests inhouse and achieve results in shorter time and less workload in the mill. Together with our customers we try to achieve a smooth barrel surface as shown in Figure 28.
