CHATTER DETECTION ON A TANDEM COLD MILL*

Abstract

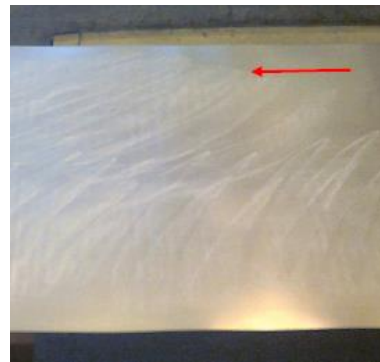
Figure 1. Fifth-octave chatter marks on steel strip.

Fifth-octave vibrations are forced vibration in the frequency range of 600Hz to 1200Hz. It's due to resonance in mill stands excited from some external source. Chatter marks are generated on backup rolls and printed via work rolls on the

surface of the strip with spacing between 10mm to 40 mm [6] resulting in significant losses related to quality downgrading. In contrast to the third-octave mode, the fifth-octave chatter does not produce audible noise nor strip breaks making it more difficult to be detected without the proper instrumentation.

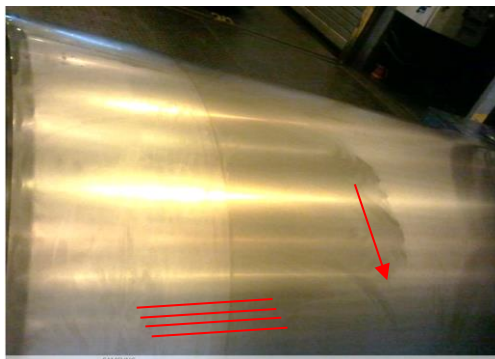
Figure 3. Backup roll of stand3 with chatter marks.

In mid-2012, however, an important quality crisis emerged: more than 1,100t of exposed materials have been downgraded. These losses were concentrated on automotive products and the defect was only detected after the galvanizing lines, which has significantly increased its impact on the company's financial figures. The defect consisted of fifth-octave chatter marks spaced approximately 40mm from each other which were later traced back to the backup rolls of stand #3.

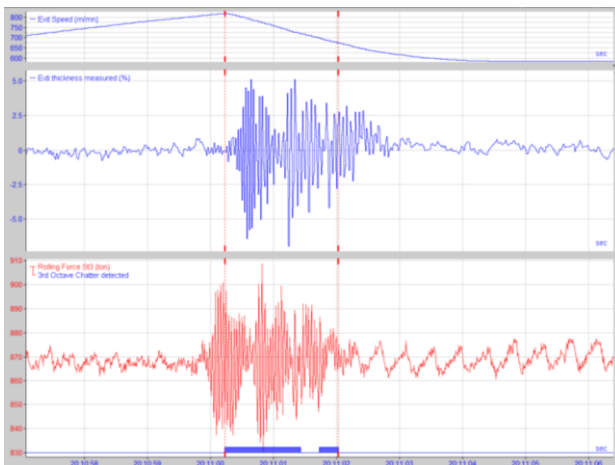
Figure 5. Rolling force variation (in red) followed by thickness disturbance (blue) in a third-octave chatter event.

This significant thickness variation generated by the mill vibration reflects in other elements of the tandem mill and its effect can be seen, in example, on entry and delivered tensions of the vibrating stand. But one of the most affected variables is the rolling force, as shown in Figure 5.

As the mill stand vibrates, the induced thickness variations are a result of upper work roll vibrating in an opposite direction to that of the lower work roll [3]. This relative movement between the rolls changes the geometry of the roll bite [8] resulting in an oscillating change in the rolling force. This unusual variation can be detected by the pressure transducers installed in the hydraulic capsule on top of the backup rolls designed to measure the rolling force.

Based on this detection by the pressure transducers, an algorithm was designed to automatically slowdown the cold mill when such oscillation is present in the system applying the same emergency deceleration ratio defined for the manual pushbutton. This algorithm was a great achievement since it relied on instrumentation already available in any modern mill requiring zero investment to be implemented.

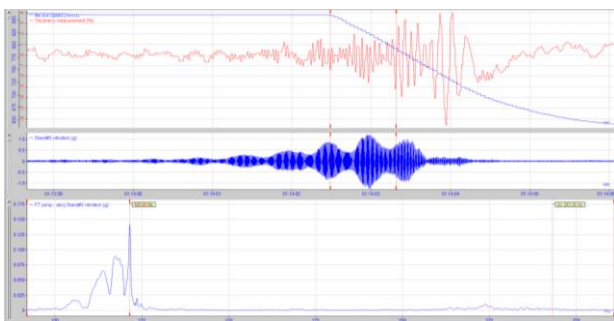
Figure 7. Vibration signal from accelerometer on top of mill housing in time and frequency domains.

These analog sensors have been connected to a dedicated piece of hardware which was able to acquire their high sampling rate and send the converted digital signal to the existing data acquisition system (DAS). These digital signals would then be filtered by the DAS in order to separate the third-octave (110 to 130Hz) and fifth-octave (300 to 700Hz) chatter frequency ranges to allow further data processing.

An algorithm has been developed to detect chatter events within the filtered frequency ranges. According to the vibration level, the system would then send a signal to the mill controllers to automatically reduce the line speed in only 4ms. Additionally, the algorithm verifies the thickness signals for variations due to chatter and flag the coil for reprocessing at downstream lines.
