DETECTION AND RESOLUTION OF ADVERSE MELT SHOP CONDITIONS THROUGH THE USE OF THE GRAFTECH ARCHITECH SYSTEM*

Theodore James Kurela¹
Nicolas Lugo-Flores²

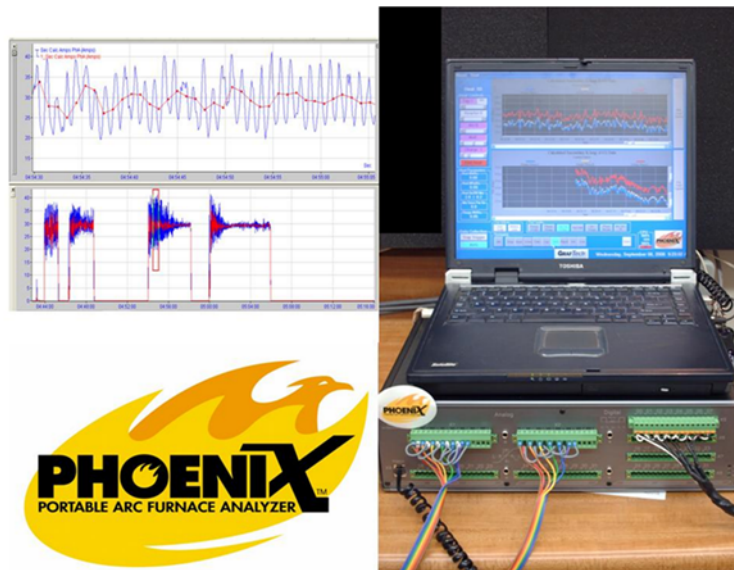
Figure 1 - UCAR Portable Arc Furnace Analyzer

Coming from a long lineage of portable data monitoring systems, GrafTech’s Phoenix PAFA (Figure 1) relies on off-the-shelf hardware components and proprietary software to collect and category electrical and process data, allowing for the performance of several types of traditional analyses of the EAF. Depending upon specific customer requirements other studies may be performed, including electromechanical vibration, regulation performance, power balance analyses, and others.

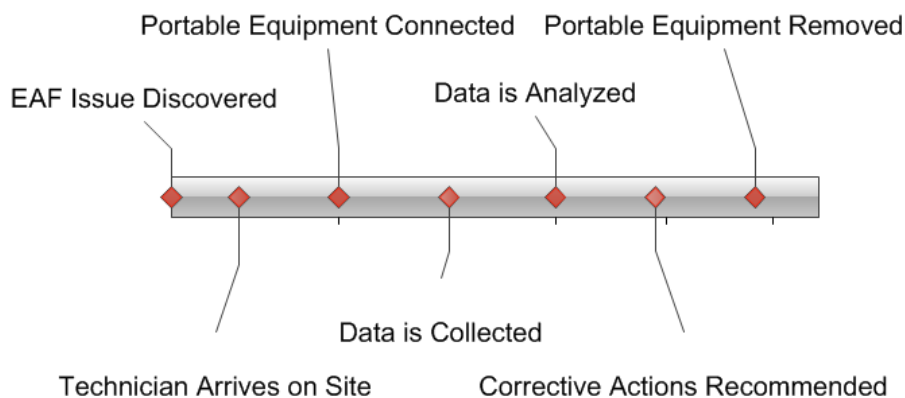
Figure 2 - Timeline of Portable Equipment Solution

One of the major disadvantages associated with the traditional way of servicing a melt shop is that, as shown in Figure 2, it includes a great deal of non-value added time in the form of data collection and travel to the customer. These time wasters are major contributors to delaying data analysis and recommendations for changes or corrective action. One simple and efficient way to eliminate the problem associated with taking time to collect data is to already have the data collection equipment on site and collecting data on a continuous basis. This, however, does not address the time needed to travel to the customer. If one could combine this idea of continuous data collection with transmitting this data for off-site analysis, data analysis could begin almost immediately.

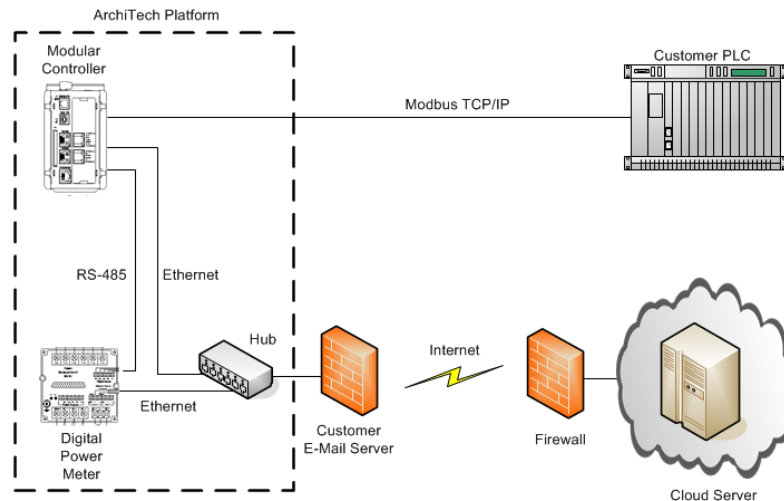
Figure 3 – Single-line Diagram of ArchiTech Platform

Simply stated, the ArchiTech is a 24/7 data monitoring system permanently installed in a customer's EAF shop that collects electrical and process data and sends this to a secure website located "in the cloud". Once there, the data is presented in graphical form and can be interpreted to help troubleshoot issues or provide a host of valuable information:

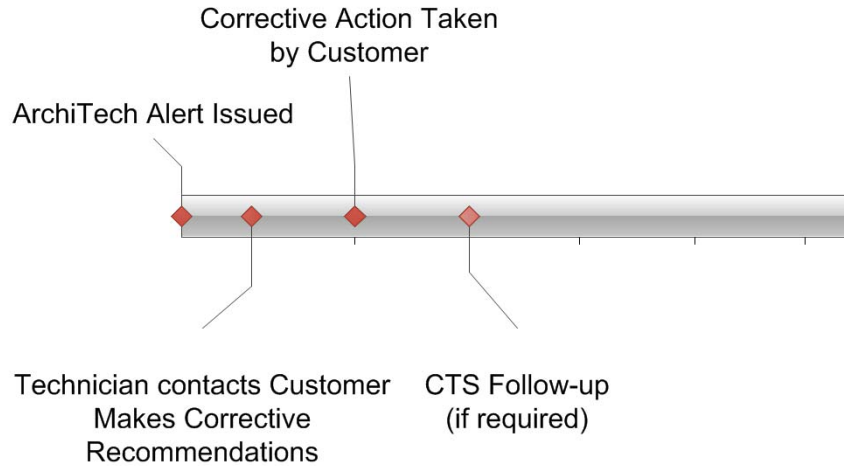
Figure 4 - Timeline of ArchiTech Solution

This type of system helps to eliminate or alleviate some of the inherent time-delay issues associated with traditional portable systems. Notice in Figure 4 the tasks made redundant by the installation of a permanent local data collection system:

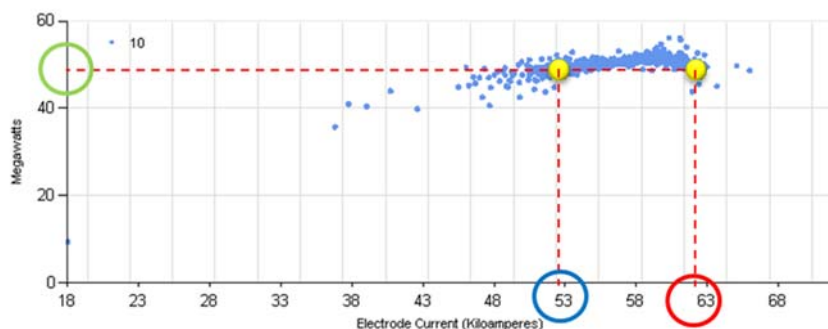
Figure 5 - Resulting Power Curve

This particular customer had no inherent furnace monitoring system and, therefore, no way to determine the long and short-term effectiveness of current melting practices and no way to compare historical and existing furnace performance. ArchiTech was installed here in 2013 and was placed into immediate use. Data provided showed a large MW imbalance caused by disproportionate current levels. Also, the resultant power curve indicated that the furnace was operating past the optimum power point due to high current levels.

As shown in Figure 5 above, current levels were reduced (which helped to reduce electrode consumption) while retaining the magnitude of melting power levels.

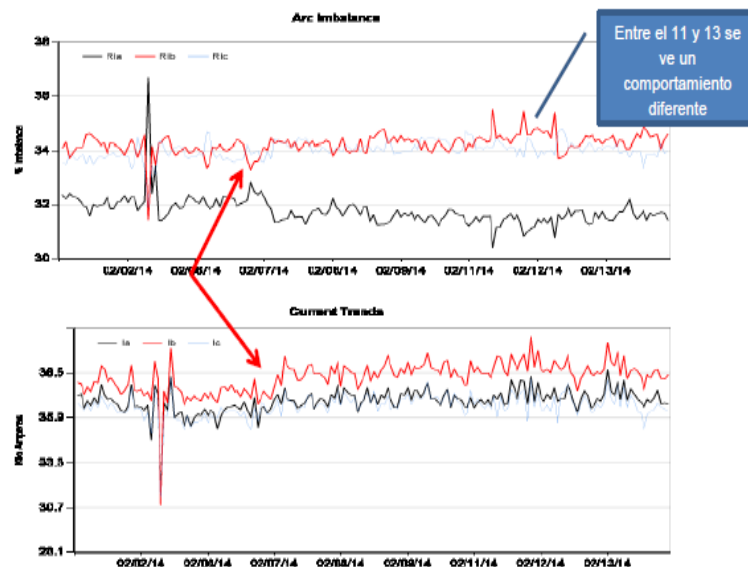
Figure 6 - Arc Imbalance and Phase Current Levels

An ArchiTech Alert was automatically generated by the website and the customer was notified about an increase in secondary currents (KA). Based on this report the customer examined their hydraulic control system and discovered a malfunction in one of the pressure accumulators that is responsible for maintaining electrode mast pressures. Because pressure was not holding, the weight of the electrode columns were causing the mast arms to slowly drift downward. This caused secondary current levels to increase causing a considerable rise in temperature which, in turn caused excessive erosion in their refractory. The customer had to repair the floor of the furnace, but it could have been much worse. If left undetected, the arc could have burned through the bottom of the furnace creating a safety issue. This would have taken the customer at least two (2) full days to repair, causing a loss of production and possible personal injury.

A repair was made to the customer's pressure accumulator and the hydraulic system was now maintaining pressure, allowing the mast arms to maintain their set position.

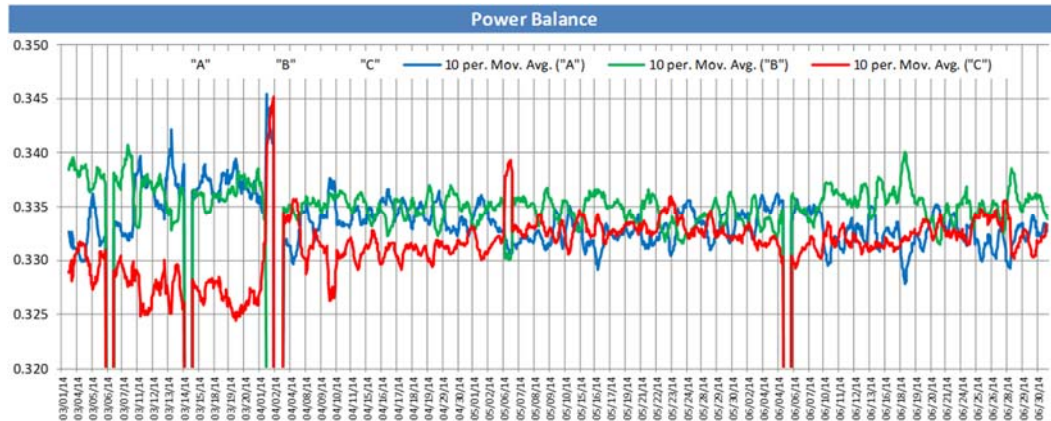
Figure 7 - Power Balance

A complete ArchiTech analysis of the shop's production and electrical parameters for 2013 and 2014 was generated in order to compare historic performance. From this analysis a continuous shift in the electrical power balance was discovered, denoted by the downward trend on the red line (see Figure 7 prior to 04/02/2014). An investigation into the regulation and power settings revealed no readily apparent issues, but when examining the hydraulic system a faulty hydraulic valve was discovered. This was replaced and the power imbalance returned to normal. The result was a return to normal electrode consumption and furnace performance:

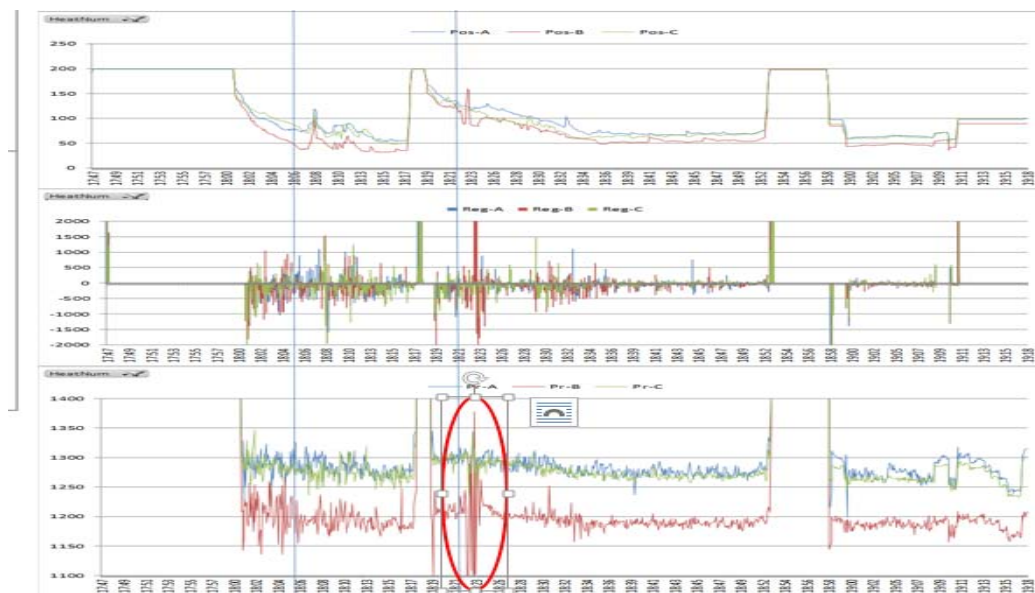
Figure 8 - Hydraulic Pressures & Regulation Response

After correcting the power balance issue the electrode breakage situation was examined. When performing this investigation we detected a reoccurring situation where one of the phases was reaching the EAF bottom before the other two phases almost on every first bucket. We also detected that during some of these events involving electrode breaks there was a sudden drop in hydraulic pressure but an expected reaction from the regulator was absent:

This adverse condition was addressed by adjusting the non-conductor current (NCC) settings also set through the regulation system. After confirming a reduction in the frequency of electrode breaks a recommendation was made to create a special scrap mix for charging the first heat of each week; this will help to provide a better, easier environment in order to help warm up the furnace and further help to reduce the number of electrode breaks.

After replacing the faulty valve, modifying the NCC settings and modifying the scrap composition of the "first heat" bucket this customer reduced the frequency of breaks from 5 breaks per month down to less than one break per month (average). Electrode consumption was also reduced by 0.2PPT.

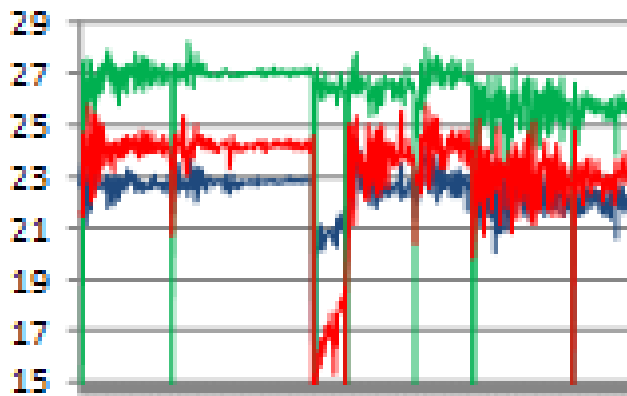
Figure 9 - Single Phasing

After analyzing the data relevant to this imbalance alert both GrafTech and customer personnel proceeded to adjust the kA balance set points for all three phases. During the follow-up GrafTech personnel also made the observation that this customer was also incurring an unusually high number of single-phase occurrences which were being caused by short columns. This condition, if not corrected, can contribute to premature transformer failure. Our suggestion for adding an electrode before the mast reaches the low-limit mast position has also lead to less single phasing.

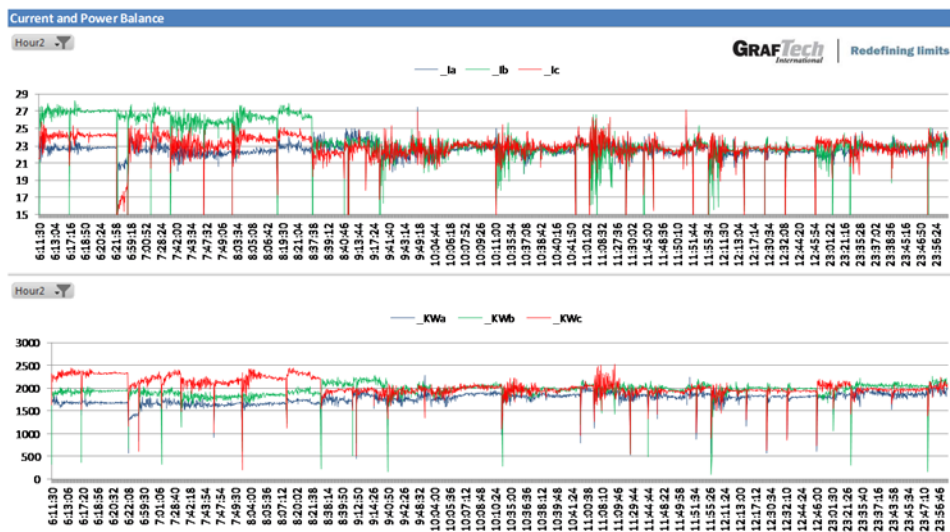
Figure 10 - Power Balance

Continuous ArchiTech monitoring of this customer’s Ladle Met Furnace (LMF) resulted in the automatic generation of imbalance alarms which were sent via email to GrafTech and shop personnel. These alarms alerted us to large power (MW) and current imbalances which were accelerating the wear of refractory material and causing premature ladle failure. This, in turn, was causing an increase in downtime and a reduction in production.

After making an adjustment to the secondary current levels the electrical balance improved (see Figure 10 above before and after the 8:37 time stamp) and the refractory failures have been eliminated. Note that because of aggressive stirring the currents are not as consistent as one would expect.

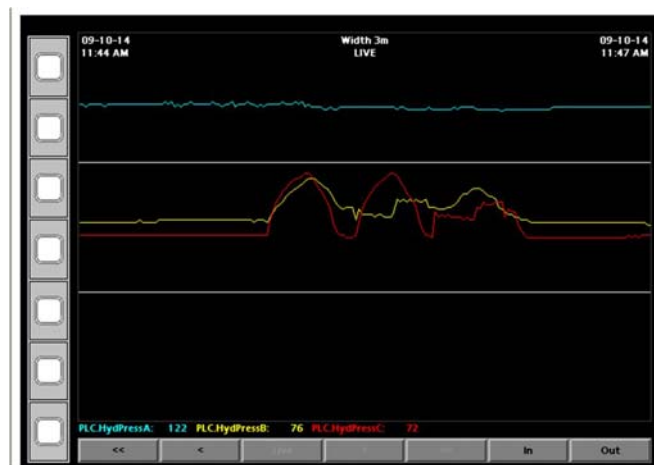
Figure 11 - Hydraulic Pressure Signals (before)

During commissioning of the ArchiTech system a procedure is used to check the integrity of the external signals, including hydraulic mast pressures. When each phase was checked it was discovered that only one phase was providing accurate pressure feedback. Note in Figure 11 below how the B and C phase mast pressure signals are erratic while A phase is predictable :

This condition was suspected of causing a recent rash of breaks during the boredown stage of the heat. After first confirming a match between the physical electrode columns and the input signals, we then further investigated and discovered that two (2) pressure transducers were reading the wrong side of the cylinder. This was also causing a bypass of the non-conductor settings of the regulator. The signal wiring error was corrected and, as shown in Figure 12 below the hydraulic pressure signals were behaving as expected. As a result of all of these changes the events related to electrode breaks is almost non-existent.

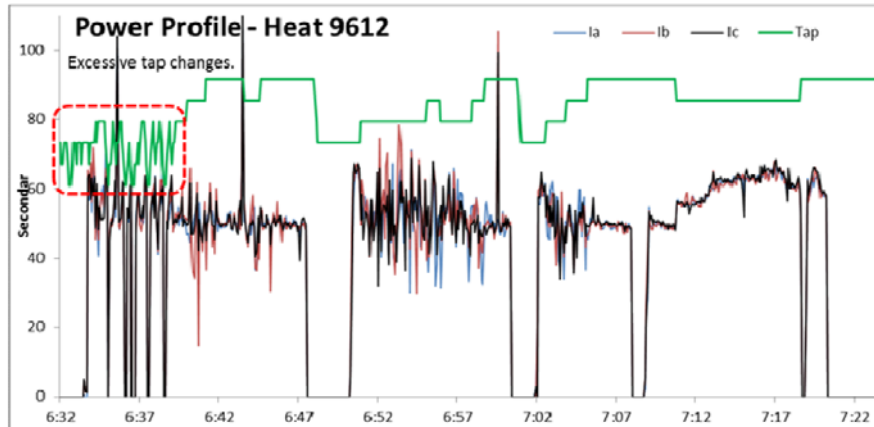
Figure 13 - Tap Setting Feedback (note oscillation)

During a routine examination of ArchiTech data we came across a situation where the our system was noticing an unusually high number of tap changes early in the heat:

Examination of the power program showed no such instruction, but when examined more closely it was revealed that one of the taps that the power program was calling for was not configured (no set point). In this case, because the program could not match the feedback current to the setpoint the system was incurring excessively high current spikes, triggering the overcurrent protection and forcing a taping down. After several minutes following initial power on, the oscillating between tap settings was alleviated when the program called for a tap setting that was configured properly in the regulator.
