HOT BLAST STOVE CAMPAIGN EXTENSION REPAIRS AT OPERATING TEMPERATURE *

Abstract

2 Case Study – Hot Blast System Repair at HKM Blast Furnace B

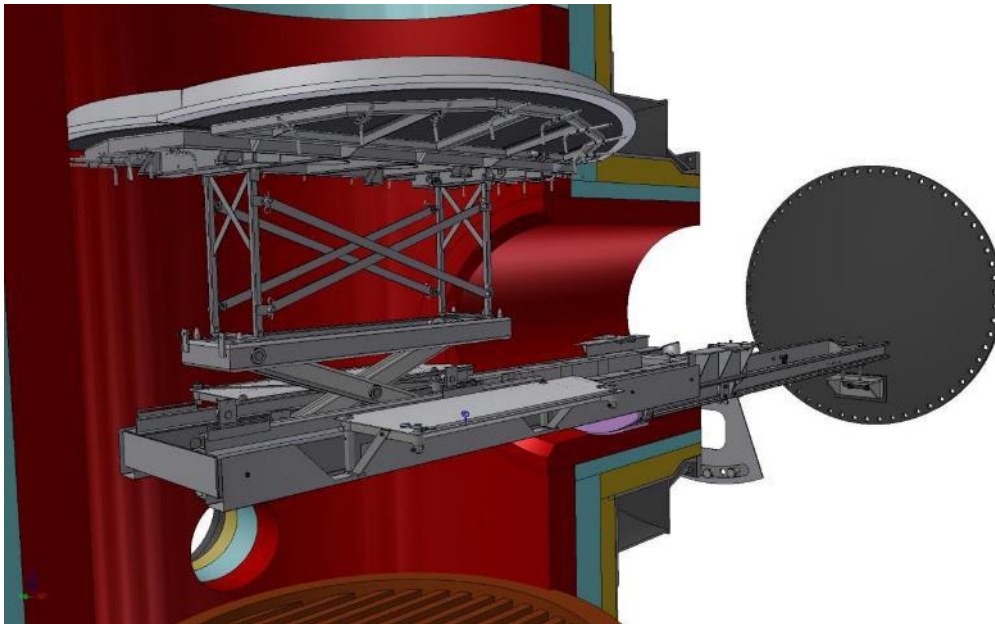
Fig. 1 – Heat Shield Design

The heat shield is modular in design and consists of a Carriage Rail Support, Main Carriage, Heat Shield Extendable Support, Foldable Heat Shield, Drive Extension Frame, Temporary Support Frame and an additional Heat Shield Support Frame.

All of the modules are fabricated using AISI 310S stainless steel for high strength at elevated temperatures. The compressed air hoses are sheathed in heat resistant material. The first layer of insulation of the foldable heat shield consists of high temperature, micro-porous ceramic board capable of withstanding temperatures in excess of 1200 °C. On top, another insulating layer of ceramic fibre-based felt and blanket enveloped in high temperature cloth is installed. Around the heat shield, a sealing ring made out of heat resistant blanket and heat resistant sleeve material is placed between the outer edge of the heat shield and the hot blast stove refractory wall.

Some of the equipment and sub-assemblies are protected against heat by additional, local heat shields. The drive extension frame, with its gearbox oil and lubricants that may burn when exposed to excess heat, is such an example. The heat shield folding and unfolding operation is executed remotely by means of drive rods and gearboxes, but in case of failure of the remote folding at the end of the repair period, a fall-back system based on pull chains and chain wheels is available. The sequence of removing the foldable heat shield after completion of the repair is largely the reverse of the installation sequence.

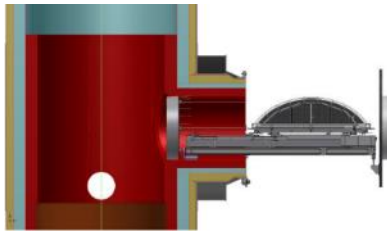
Fig. 2 – Carriage and heat shield hoisted in

The carriage and its rail support are hoisted into position using an overhead crane, with the carriage rail support getting attached to the hot blast outlet flange and (in the HKM project) the T-junction of the hot blast main. The foldable heat shield and its extendable support are installed on the main carriage and pushed forward to just before the heat plug. Hoses for compressed air (for the cooling of the heat shield itself) and ambient air (fan-blown, for the cooling of the frames and carriage) are connected. The drive extension frame, with its winches, gearboxes and extension rods for the folding and unfolding operation of the heat shield, is attached. Finally, the foldable heat shield is pushed beyond the heat plug into the burner shaft with the heat plug being pushed out by it. The heat shield is unfolded remotely and lifted to a position just above the hot blast outlet opening to allow for cool-down.

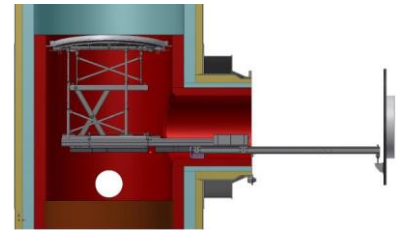
Fig. 4 – Heat shield in final position

After the area below the heat shield is cooled down sufficiently to create safe working conditions, additional support frames are installed from below and side platforms are attached to the carriage. The burners and temperature monitoring system are installed through the heat shield.

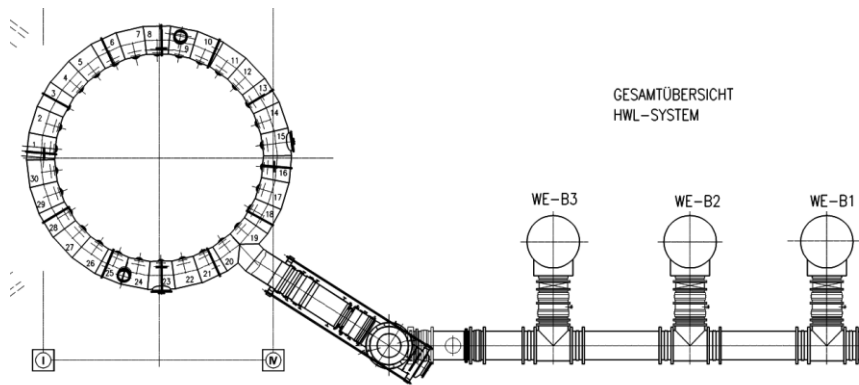
Fig. 5 – HKM Blast Furnace B Hot Blast System (note: checker chambers omitted)

Blast Furnace B at the Duisburg–Huckingen plant owned and operated by HKM was first commissioned in 1981. Its last major relining took place in 2000. It is a 2824 m³ working volume furnace that produces 2.7 million tonnes of hot metal per annum. The hot blast system consists of three stoves of an external combustion chamber design built in 1994. The hot blast main is positioned at a higher elevation than the bustle pipe and oriented at an offset from the blast furnace center line. Both this vertical and horizontal offset are accommodated in the system's mixing pot, which also has a cold blast inlet for hot blast temperature control. Since the hot blast main is lined with Silica, it was also kept at operating temperature.

HKM contracted Danieli Corus for the repair of the hot blast stove burners, repairs to refractories of and around the hot blast outlets, the replacement of the hot blast main end cover, and some additional work such as the replacement of the back draft stacks. The repair project was to be executed in parallel with a furnace reline and the modernization of the gas cleaning system. Given the critical time path and since Blast Furnace B produces more than half of the plant's hot metal, furnace downtime was to be minimized and it was decided to eliminate the heating up and cooling down of the hot blast stoves as much as possible by executing the repairs while keeping the majority of the system at operating temperature.

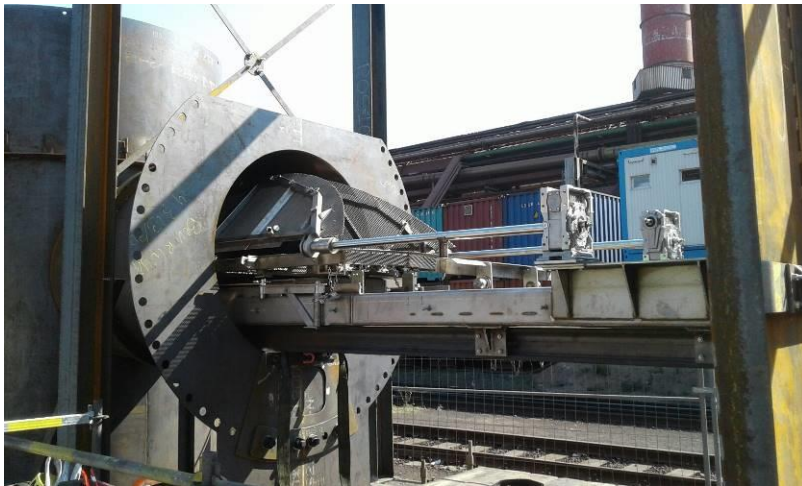
Fig. 6 – Trial set-up at HKM site

The stove burners were repaired one by one. The other two stoves were kept hot with main burner with blast furnace gas supplied by Blast Furnace A. The hot blast main was kept hot by blowing back through the stove(s) to the mixing pot valve and a temporary chimney installed on the mixing pot outlet. In preparation of the actual repair jobs, the heat shield assemblies were submitted to repeated tests, the final one of which took place in a mock-up situation erected at the HKM site.

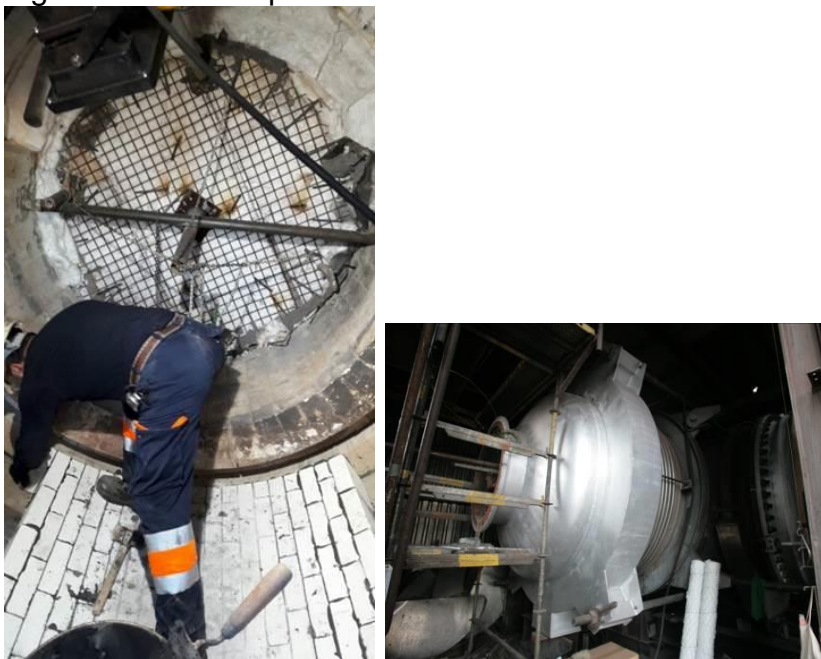
Fig. 7 – Hot blast main end cover during repair vs. end result

At the start of the project, an inspection of the hot blast main and bustle pipe was executed to establish the scope of all the required repairs (some of which outside of the scope to be executed by Danieli Corus). Following this inspection, HKM decided to cool down the bustle main and the part of the hot blast main downstream of the mixing pot for repairs, while keeping the mixing pot and the upstream portion of the hot blast main at operating temperature. Under these conditions, the hot blast main and mixing pot end covers including thrust collars were replaced and the refractory lining of the mixing pot hood replaced.

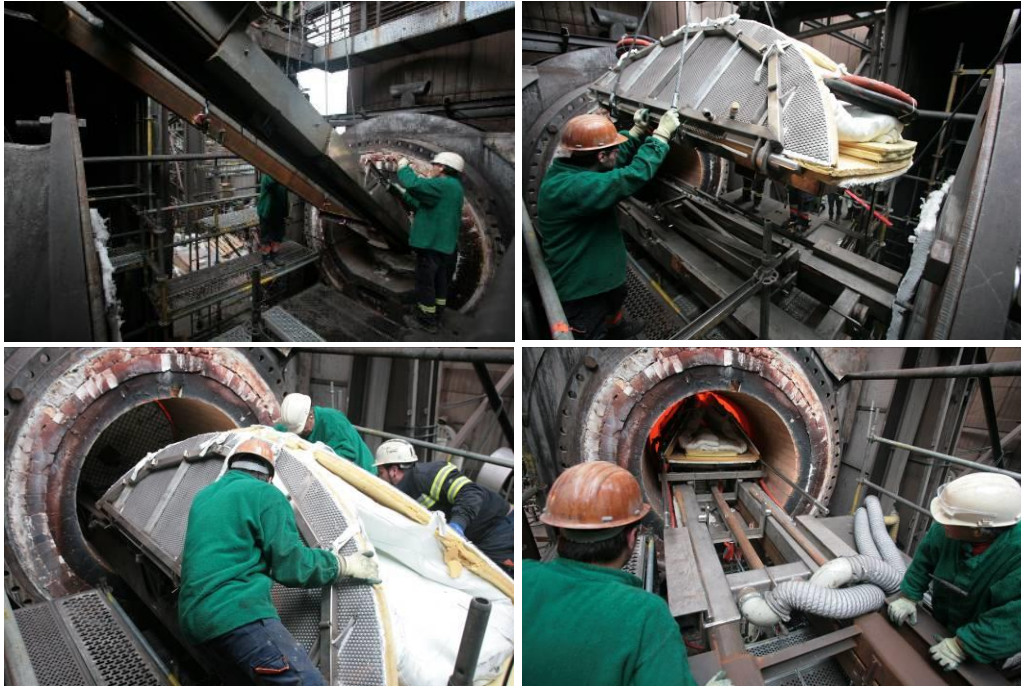
Fig. 8 – Installation of the heat shield

The burner repairs entailed the replacement of the top seven layers. The repairs took two to three weeks each from the moment of isolation until reconnection. For the repair of each of the hot blast stove burners, a dedicated folding heat shield with insulation panels/blanket was available. Two sets of the sliding/supporting assemblies were expedited to the HKM site, one for repeated use and a spare unit. The installation, insertion, lifting and unfolding operation in the harsh environment around the (plugged) hot blast outlet and (plugged) hot blast main T-junction did not introduce any complications. After insertion of the heat shield during the repair of the third burner, the unfolding mechanism jammed owing to a misguided back-up chain. The heat shield was retracted and another unit reinserted after a new set insulating panels/blankets was installed without causing any prohibitive delays.

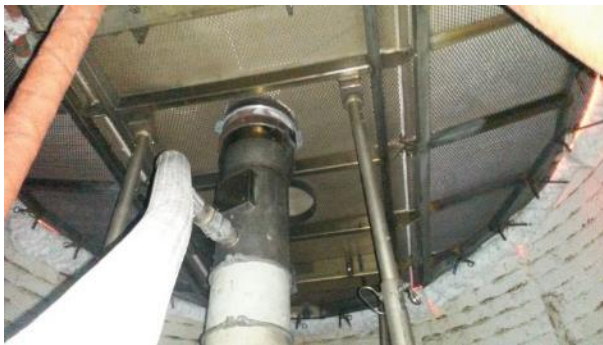
Fig. 9 – Burner in position

The folding heat shields accommodate the insertion of two burners through the heat shield and into the area above it; for each of the three repairs, only one of these was utilized. A temperature monitoring system was also installed through the heat shield, allowing to maintain a temperature in the burner shaft above 800 °C to prevent any detrimental expansion or contraction behaviour of the refractories.

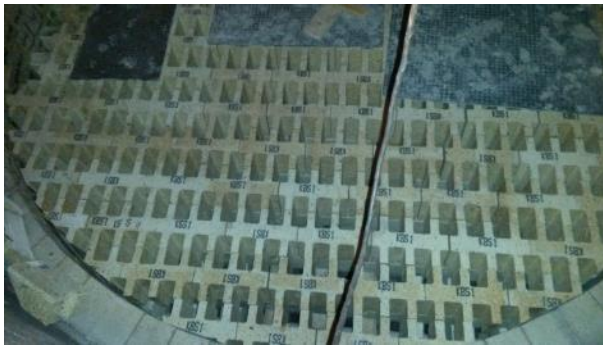
Fig. 10 – Burner after repair

During the repair period of the ceramic burner, the natural gas burner was fired during the night and demolition/installation was executed during daytime. Below the heat shield, the working environment was cooled down with temporary fans connected to gas and air connection below the ceramic burner to workable temperatures in 24 hours. Demolition and refractory installation was executed in daytime and groups of staff, equipped with special PPE and clothing depending on temperature conditions, executed the work in an alternating manner. After completion of each of the burner repairs and removal of the heat shield, a natural gas burner was used to heat up the new ceramic burner. This natural gas burner was inserted through the pilot burner nozzle.

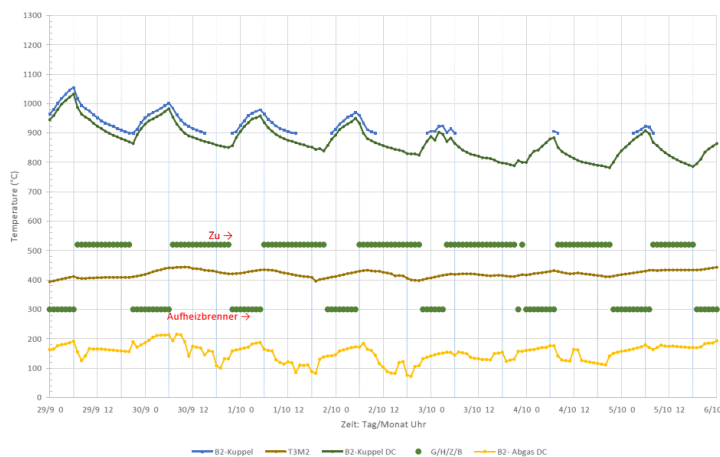
Fig. 12 – Temperature monitoring and management

Refractory temperatures were monitored in 24/7 shifts by Danieli Corus Process Engineers. The objective was to maintain a refractory temperature above 800 °C. Data for thermocouples already in place within the system was logged and additional thermocouples were installed in a number of locations. An example of the temperature curve of at one such a location is shown in the diagram in Figure 12, in this case the dome temperature of Hot Blast Stove No. 2 during the fourth week of the project. The green horizontal lines also indicate whether or not the corresponding burner was operating. (Thermocouple T3M2 is located in the checker chamber 1 m above the checker grid.)

Whereas the hot blast stove refractories (burner shaft, dome and checkerwork) were kept at their respective minimum temperature by means of the natural gas burner installed through the heat shield, the (silica-lined) hot blast main was reheated when necessary by utilizing heat from one the stoves, for which the repairs had been finished or not started. It was decided that a provisions for maintaining a maximum temperature at the checker grid had to be made. A small stack was installed on the stove dome to allow for cold air to be introduced from below the grid when necessary. In most cases, temperatures were kept above target level. There was a small number of occasions where the measured temperature dropped below the specified levels. Since the air temperature was measured and not the refractory temperature, this served as an early warning and through quick fact finding, root causes (such as a leaking valve) could be identified and measures taken.
