# INSPECTION AT THE EXIT OF A COUPLED PICKLING TANDEM COLD MILL<sup>1</sup>

The new Siemens VAI PLTCM installed at Corus (Ijmuiden, Netherlands) has been provided with a SIROLL SIAS surface inspection system installed at the exit of the rolling mill. The challenge was to ensure a perfect surface inspection in the tough environmental conditions at the exit of a PLTCM. The article describes the solutions implemented and the results obtained.

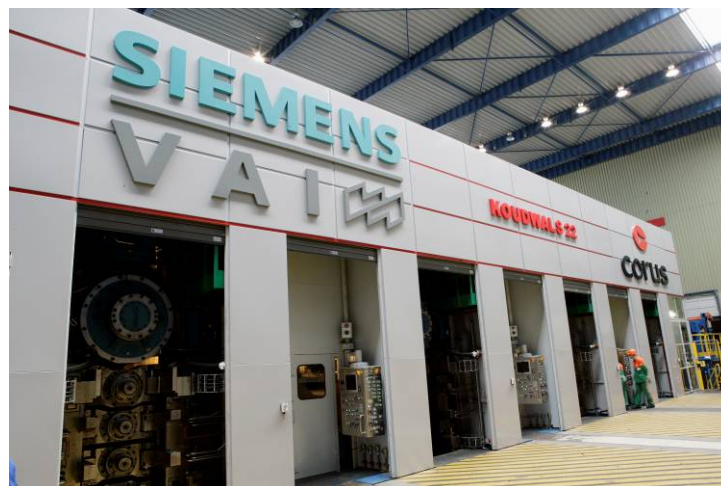
Figure 1. PLTCM Corus Ijmuiden (NL).

For its new KW22 Tandem Cold Mill at Ijmuiden (Netherlands), Corus Strip Products requested the latest state-of-the-art technology to be incorporated:

- 4 Power 6Hi stands
- Tandem mill designed for both rolling and skin passing
- Surface inspection at the exit of the mill

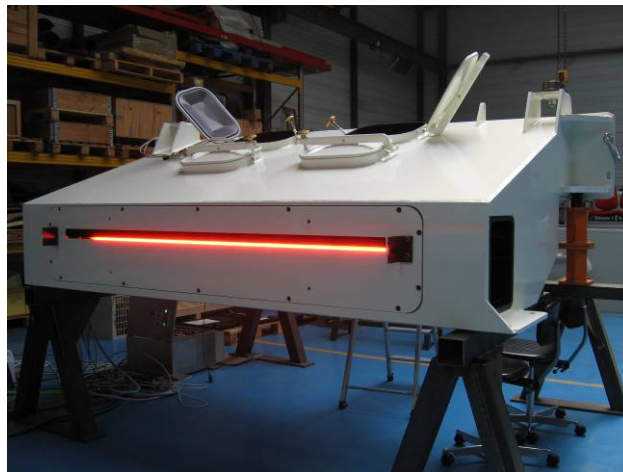
**Figure 2.** View of one “caisson” containing the lighting system and cameras.

To address this challenge, Siemens VAI incorporated the lighting system and cameras into a compact pressurized box, further named “caisson”.

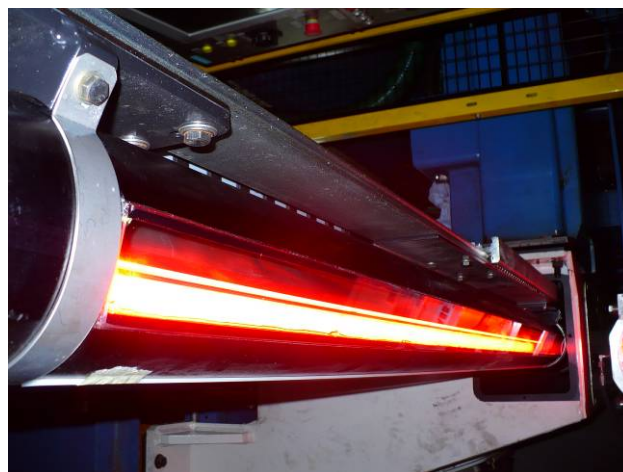
**Figure 3.** The lighting system is mounted on rails to be quickly extracted & checked.

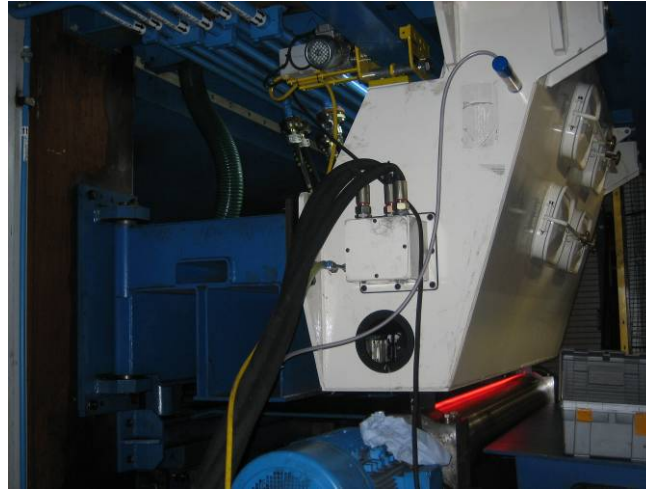
**Figure 4.** View of the top side “caisson” installed on the line

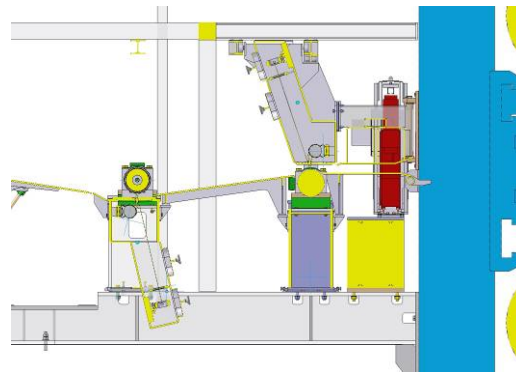
**Figure 5.** View of the arrangement at the exit of the last stand

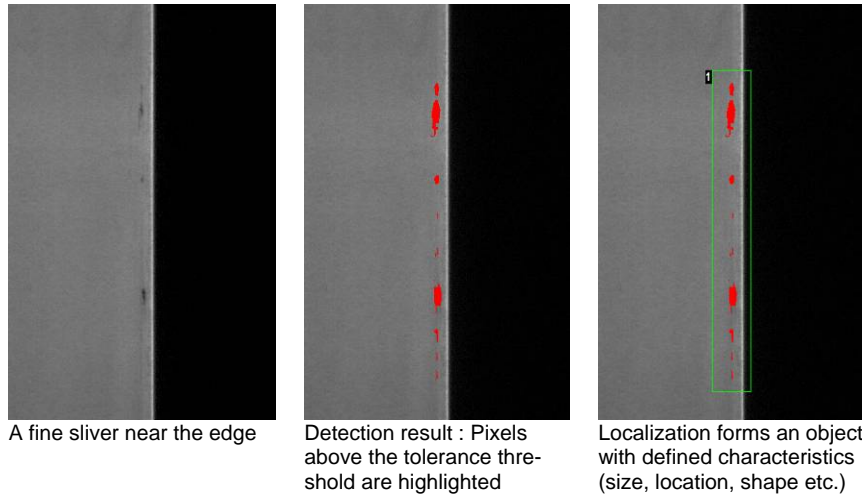
**Figure 6.** Strip Online Analysis

As it is being acquired, the image is “normalized” to eliminate the negative impact of both sensor-related (e.g. electronic noise) and product-related (e.g. product aspect variations) phenomena. Consequently, image processing is consistent and leads to an image that is free from external disturbances.

On the image, detection algorithms are applied: each pixel is analyzed to determine whether it is “suspect”. The algorithms consist of a combination of filtering and thresholds in real time and here again the system sensitivity is programmable and depends on product type.

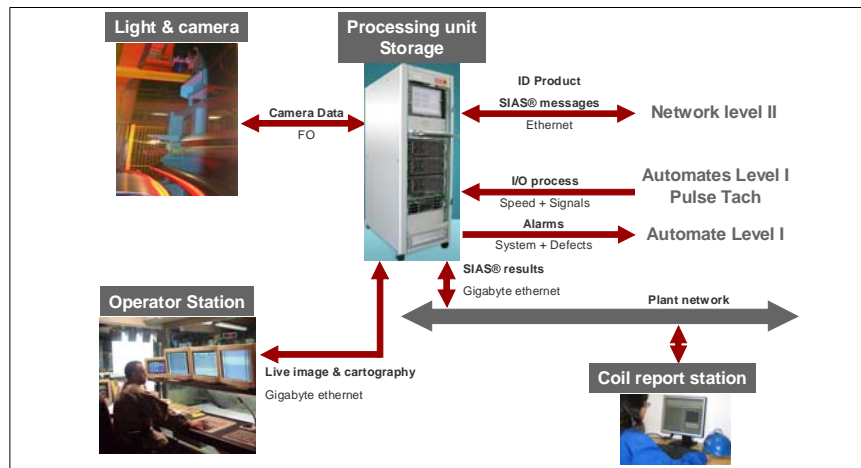
**Figure 7.** System Architecture

Each object image is then analyzed by software to identify which defect category it belongs to. This phase which consists in identifying detected objects is called classification. The SIROLL SIAS exclusive, patented classification method is a multi-stage approach for streamlined operation and maximum efficiency. It is fully traceable and highly accurate. Classification basically consists in comparing the newly detected flaw with a “knowledge base”, i.e. a defect library, a group of defect images assembled by Quality people that is typical of what can be seen on the line.

Siemens SIROLL SIAS system provides total traceability and monitoring of the inspection process, which is key to both high confidence in the results and Quality management (e.g. ISO) of the measurement.

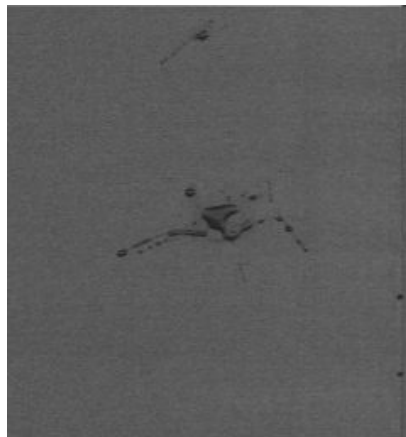
**Figure 9.** Perfect Image quality: view of an emulsion drip-down

The SIROLL SIAS system is used for quality evaluation, and is also giving a feedback on the process. Slight edge waviness around 2-3 cm (not seen by the flatness roll) is seen by the operator on the live image display for immediate adjustment of the flatness actuators. Also emulsion drip on the strip can be seen for immediate corrective action.
