MOLD COATINGS NOT THE LIMITING FACTOR¹

¹ Technical contribution to the 43rd Steelmaking Seminar, May, 20th-23rd, 2012, Belo Horizonte, MG, Brazil

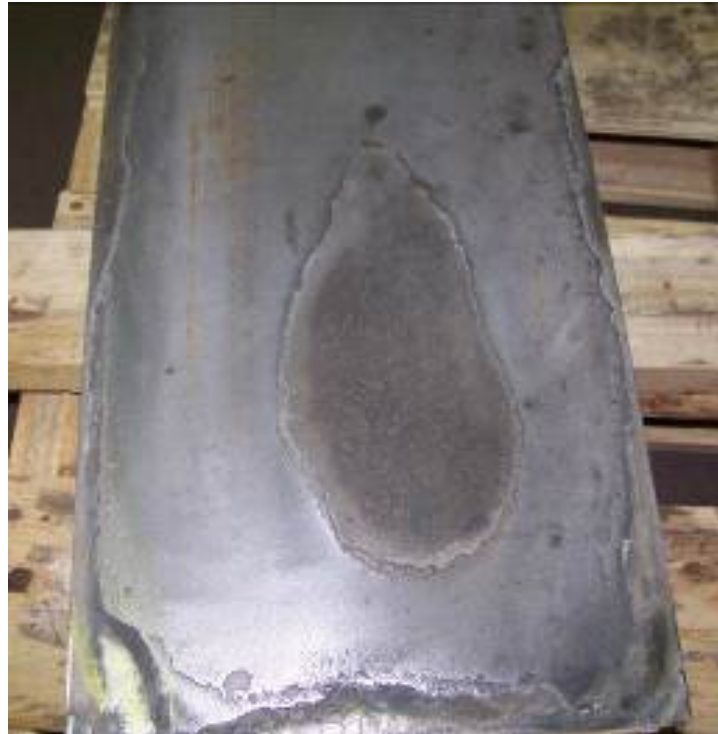
Figure 4. Nickel plated copper with typical wear.

The photos in Figures 4 and 5 and the corresponding graph in Figure 6 illustrate why coating loss across the bottom third of a UniGuard™ coated narrowface can appear to be visually worse than it is. UniGuard™ coated copper #350 below exhibited documented coating loss in multiple areas across the bottom third of the copper after less than 100,000 tons cast. Subsequent casting on #350 resulted in the additional coating loss as seen in the photograph below. The wear comparison shown graphically compares a UniGuard™ coated copper #350 to a standard nickel plated copper #352. The UniGuard™ copper #350 having casting nearly twice the tonnage

cast on nickel plated copper #352. Overall support offered by the UniGuard coated copper is still significantly better than that of the nickel plated copper. Wear on the UniGuard coated copper is less than 1 mm while the wear on the nickel plated copper is 2.5 mm and there are large areas of exposed copper.

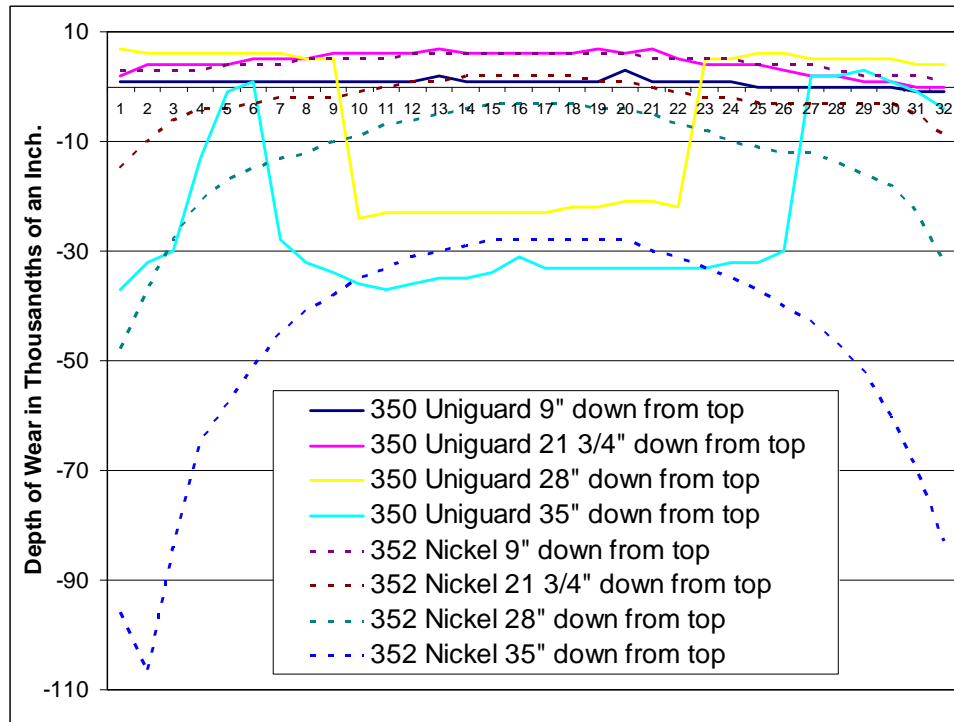
Figure 6. Wear comparison of UniGuard™ coated copper #350 and nickel plated copper #352.

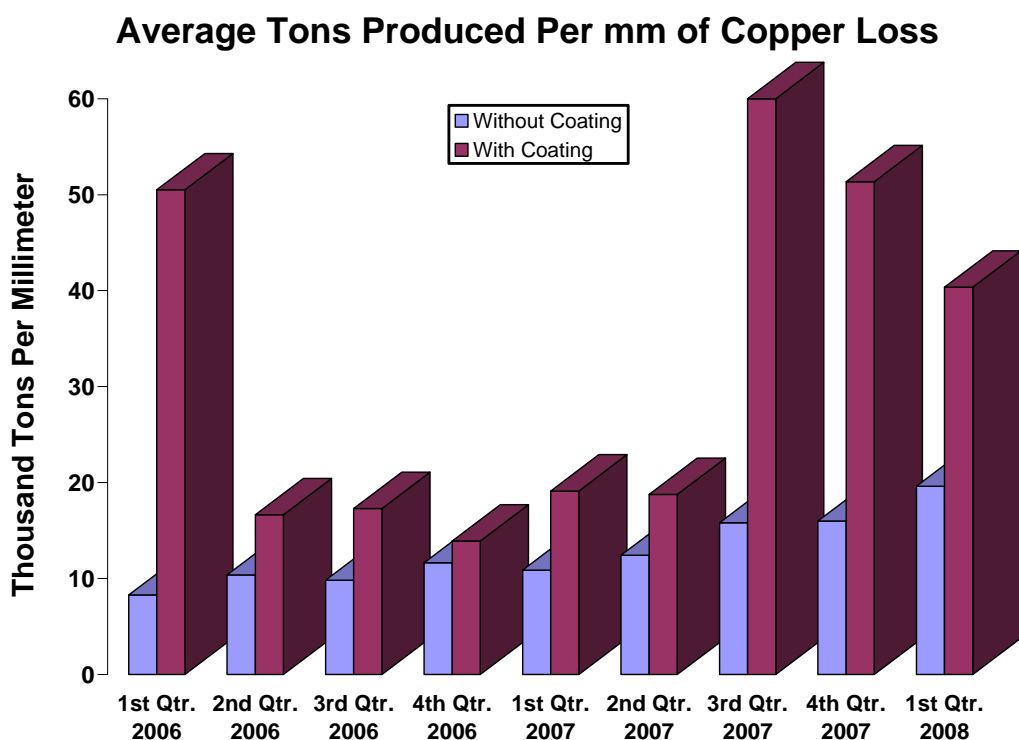
Figure 7. Comparison showing copper removed during refurbishment coated versus uncoated Gallatin BF coppers.

In 2006 Gallatin resumed trialing the UniGuard™ coating on broad face coppers and has seen a tremendous improvement in the amount of copper removed during refurbishment on those coppers which have utilized the coating. As can be seen in Figure 7 those coppers which utilized the UniGuard™ coating over the upper 300 mm of the copper had nearly half the copper removed during refurbishment (removal shown in tons cast per mm of copper removed) as compared to the rest of the mold fleet which had no meniscus protection. It should be noted that all UniGuard™ coated Gallatin broad face coppers were thin coppers approaching minimum thickness. The graph below compares these thin coated coppers to coppers over a range of copper thickness from maximum to minimum thickness. Most high speed casters see a moderate improvement in copper removal during the life of their mold coppers as they near minimum thickness.

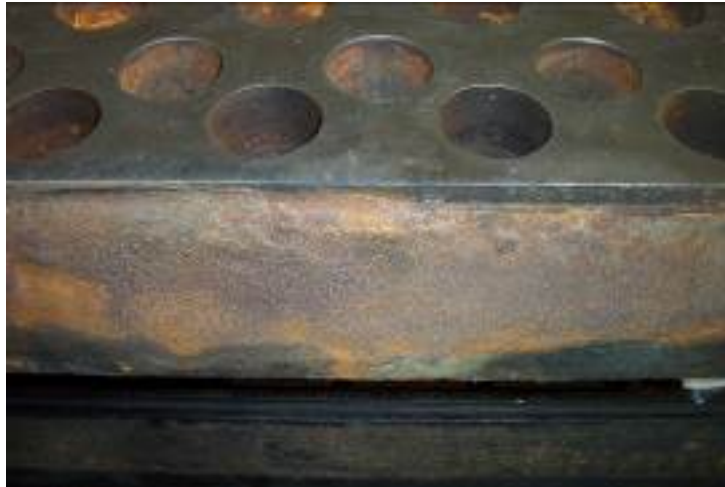
Figure 10. Eroded broad face back-up plate.

In some extreme cases of erosion typically along the bottom of broad face cassette back-ups and water jackets exposed to highly corrosive hydrofluoric acid (HF) a more substantial protective coating must be considered. In these instances only an aggressive approach utilizing stainless steel overlay then clad in nickel-chrome based thermal spray will stand up to such highly reactive chemicals for 300,000+ ton campaigns. The use of these exterior coating solutions listed above add more cost to equipment refurbishment; however, the cost of doing nothing will lead to added cost in refurbishing components after the lengthy campaign. Aggressive wear issues can erode equipment down to the o-rings which seal these water jacket and copper assemblies and result in water leaks which require molds and equipment to be removed from service. Figure 10 shows a badly eroded bottom edge of a broad face cassette back-up plate while Figure 11 shows the same surface after being stainless

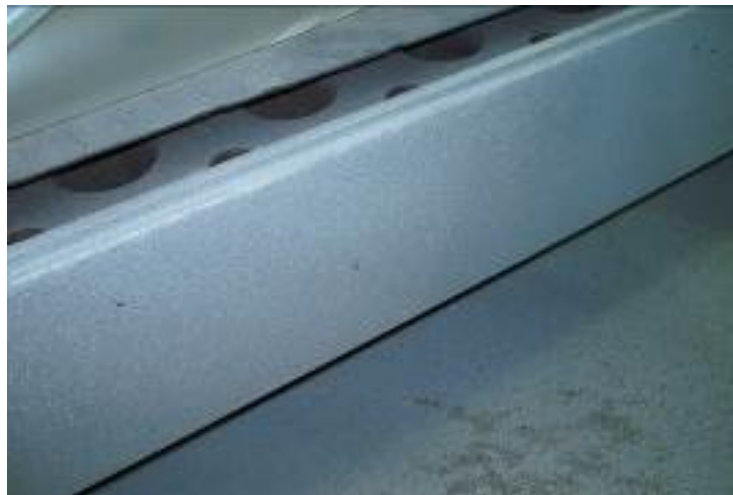
Figure 11. Broad face back-up plate after being repaired.

steel weld repaired, machined and then coated with nickel-chrome based thermal spray.

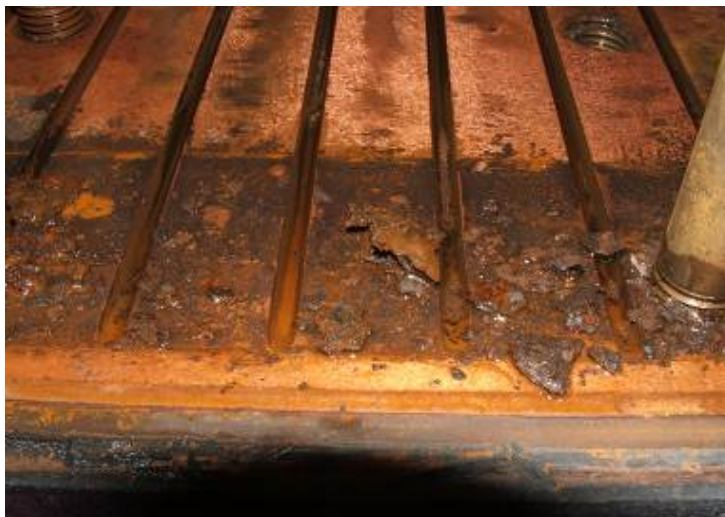
Figure 12. Scale found trapped against the slots across the bottom of a copper.

Internal corrosion issues are on the minds of many managers currently, maintenance and operations alike. The best efforts of those companies treating the water pulsing through the aging carbon steel components is not enough to keep exfoliating scale from breaking loose. Once free the scale is swept into the molds where large debris can be trapped in the cooling slots of the mold coppers. The worst cases can usually be quickly identified when an excessive pressure drop is noted across the mold which of course requires premature removal of a mold for maintenance. However, it is the moderate cases which may cause insufficient water pressure and velocity to reach the meniscus resulting in uneven cooling that can be most damaging. Such partial blockages can result in uneven meniscus heat extraction which can lead to “caster folds” or longitudinal cracking on the slabs produced. A fairly common example of the type of scale found in many conventional slab caster broad face copper/water jacket assemblies (Figure 12).

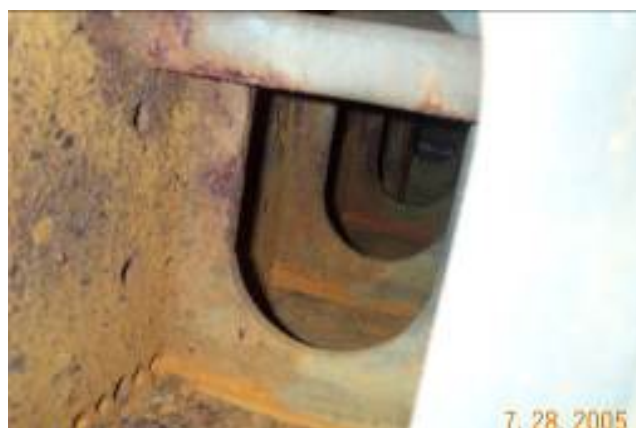
Figure 13. Interior of broad face water jacket before blasting.

Approximately five years ago the UniMold[®] Division of SMS Millcraft began internal blasting water jacket cavities of broad face water jackets to remove all loose scale for particular customers who requested this service. This is a fairly time consuming and complex process which requires specially modified blasting and descaling equipment to complete. In many cases additional clean outs must be incorporated into the water jacket or mold frame design to allow for increased access for blasting all surfaces and removal of scale and blasting media post cleaning. Shown in Figures 13 and 14 are internal photos showing before and after blasting the interior surfaces of a conventional broad face water jacket.

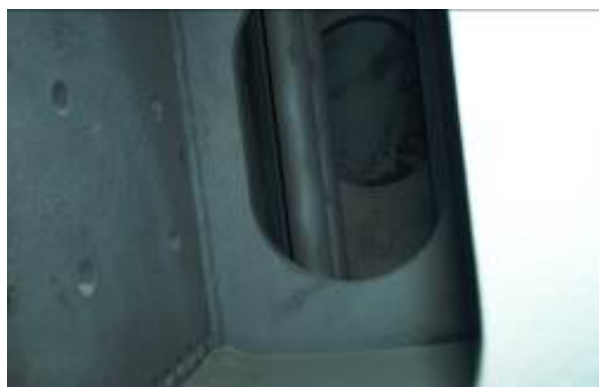
Figure 14. Interior of broad face water jacket after blasting.

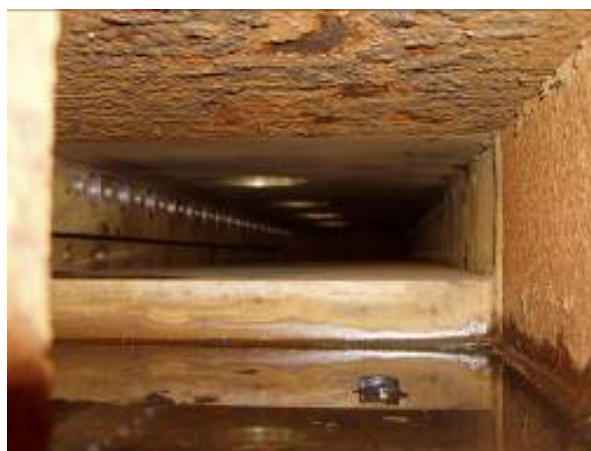
Figure 15. Inside of mold frame before blasting.

Many carbon steel water jackets have had the copper mounting surface and main o-ring groove re-machined numerous times to restore these critical surfaces to the drawing tolerances. For a caster that is 20+ years old the thickness of the plate which the copper rests or bolts up against is approaching its minimum thickness in many cases. An effective way to limit the corrosion and maintain the flatness and integrity of the copper mounting surface of the broad face water jackets for years is to cover this surface with a thin layer of Ni-Cr based thermal spray. Most importantly having a machined and coated copper mounting surface allows for the copper to float and expand freely. In those instances where a copper is restrained and not allowed to move and expand it can result in cracking of the mold coppers. In Figures 15 and 16 are before and after photographs showing the internal powder coating of a mold supporting fixed side frame.

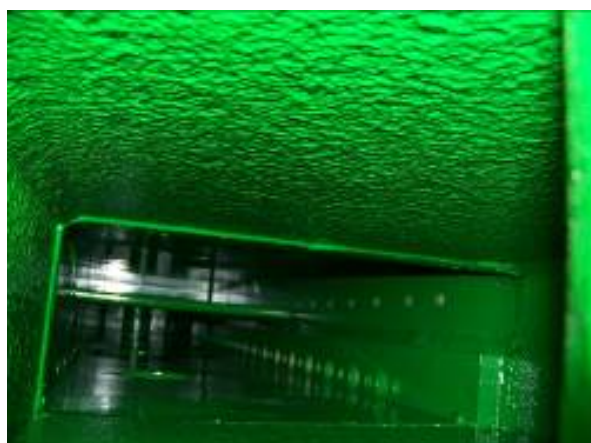
Figure 16. Mold frame after blasting and powder coating.
