RESULTS OF THE COINJECTION OF PCI AND SYNTHETIC TITANIUM DIOXIDE PRODUCTS FOR PROTECTION OF THE HEARTH OF ROGESA Nº 5 BF AFTER STOP FOR RELINING¹

Walter Hartig²
Djamschid Amirzadeh-Asl³
Dieter Fünders⁴

Abstract

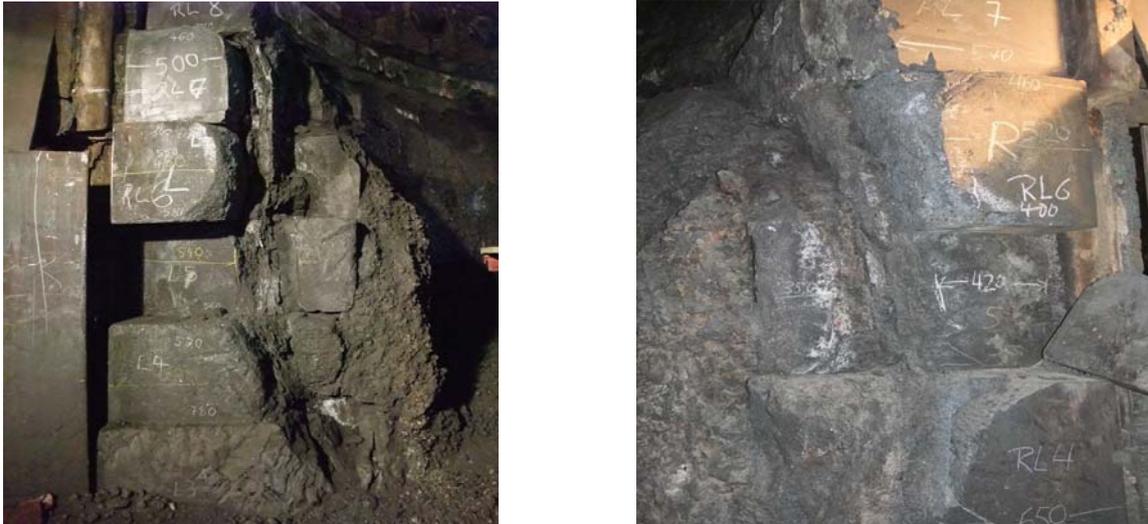
The two pictures (Figure 2) show the hearth walls at the clearing opening in August 2010 (tuyere 28 and 30).

- the formation of the brittle layer is well to be seen mainly in layers N^o 4 to 6 where the plain carbon with the low heat conductivity was installed;
- the higher conductive semi graphite in layer 1 to 3 shows lower sensitivity;
- in front of the brittle layer there exists still a part of the carbon block with a scull to the inside.

Figure 2. Hearth walls with brittle layer.

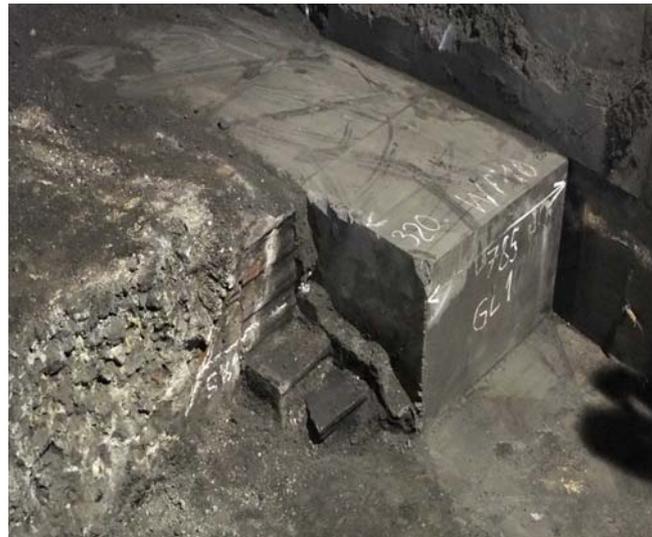
The lower row N^o 1 at the bottom corner shows definitively no wear and is still in it's original state.

There existed still remains of the ceramic cup (Figure 3).

Figure 3. Carbon block at the corner bottom/wall.

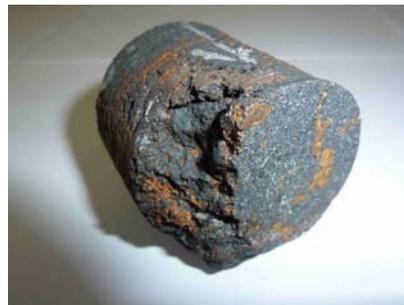
Figure 8. Core boring sample from hearth level 5 inside.

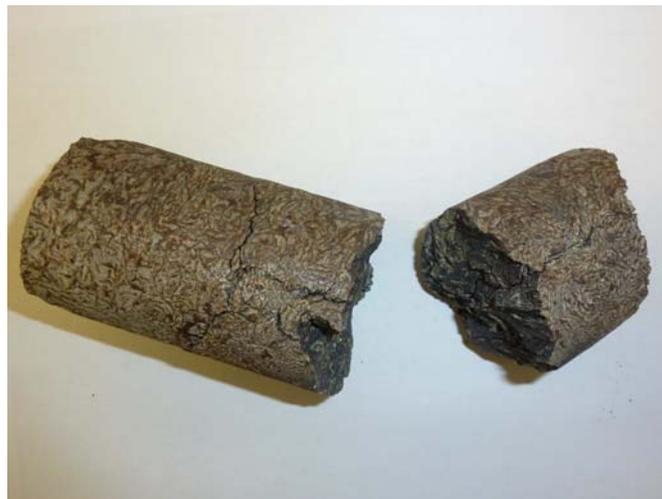
Figure 10. Core boring sample section 6 from bottom layer inside.
