TOP COMBUSTION STOVE TAILOR MADE HOT REPAIR*

Abstract

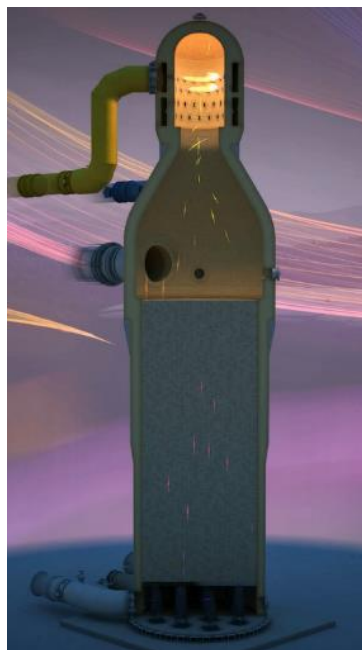
The Shaftless hot stoves are characterized by having no combustion chamber, the burner is located at the top of the dome and above the checker bricks.

Figure 6. Kalugin shaftless stove

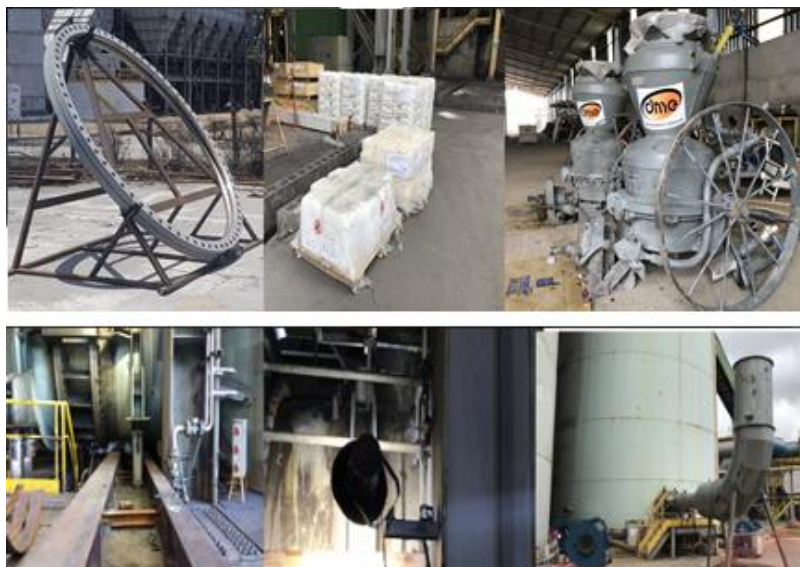
Figure 14. Full Services: Engineering, Fabrication, Equipment development, wire cutting under hot conditions, Heating up and thermal comfort, eletromechanical and refractory activities

The hot blast outlet connection nozzle was cut especially because the limitations on work space and time. In these situations, we are able to provide an ideal solution. The especial technique is one of the most efficient ways to remove large pipes of a considerable size under hot temperature, in this case was cut of about 1.100°C. There is virtually no limit in terms of sawing depth. The cut sawing can provide an ideal solution for many tricky or difficult applications like those that we have at the hot blast outlet connection nozzle, which is combining metallic and hot refractory cut at the same time.

The stoves were heated using the auxiliary burner located in the dome manholes. An especial venture was developed and fabricated to attend the project located at the inspection manhole in the grid room.

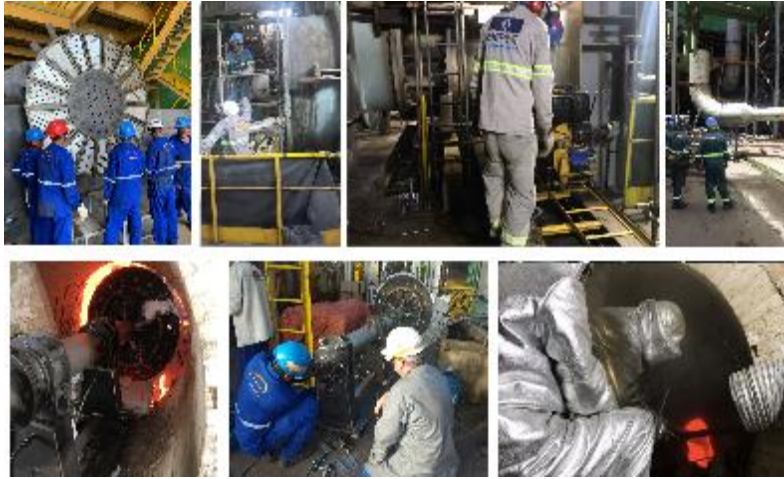
Figure 15. Jobsite activities
