2nd RELINE OF ROGESA'S BLAST FURNACE NO. 5 IN DILLINGEN/SAAR, GERMANY¹

Abstract

In 2010 Rogesa executed a reline of its blast furnace No. 5 within a downtime period of 102 days. This report shows a very detailed description of the situation at ROGESA in Dillingen/Germany with regard to the operated blast furnaces and their performance during the different campaigns. The work which was carried out is shown thoroughly and the time schedule is explained. A major part in this report comprises the methodology of the erection of the new blast furnace shell. A specific topic amongst others is the installation of the new Paul Wurth BLT[®]GEN3 gear box to optimize the charging process and fuel consumption. Finally, the successful blow-in results are shown.

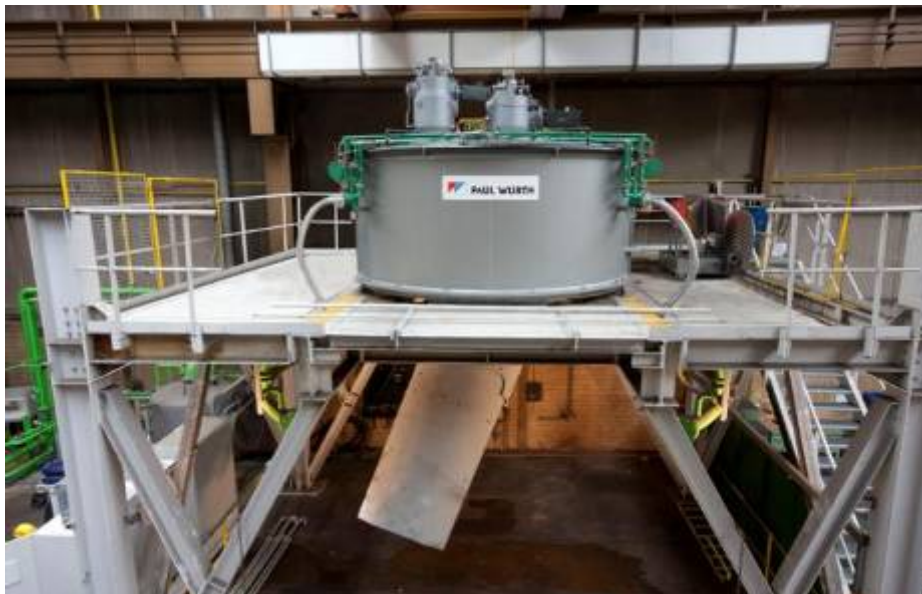
Figure 6 shows a picture of the new BLT[®]GEN3 Gear with distribution chute installed on the Paul Wurth test rig, Fig.7 after installation on BF5 during the reline with the new charging hoppers.

Figure 6. Paul Wurth BLT[®]GEN3 gearbox and rotating chute at the test rig.

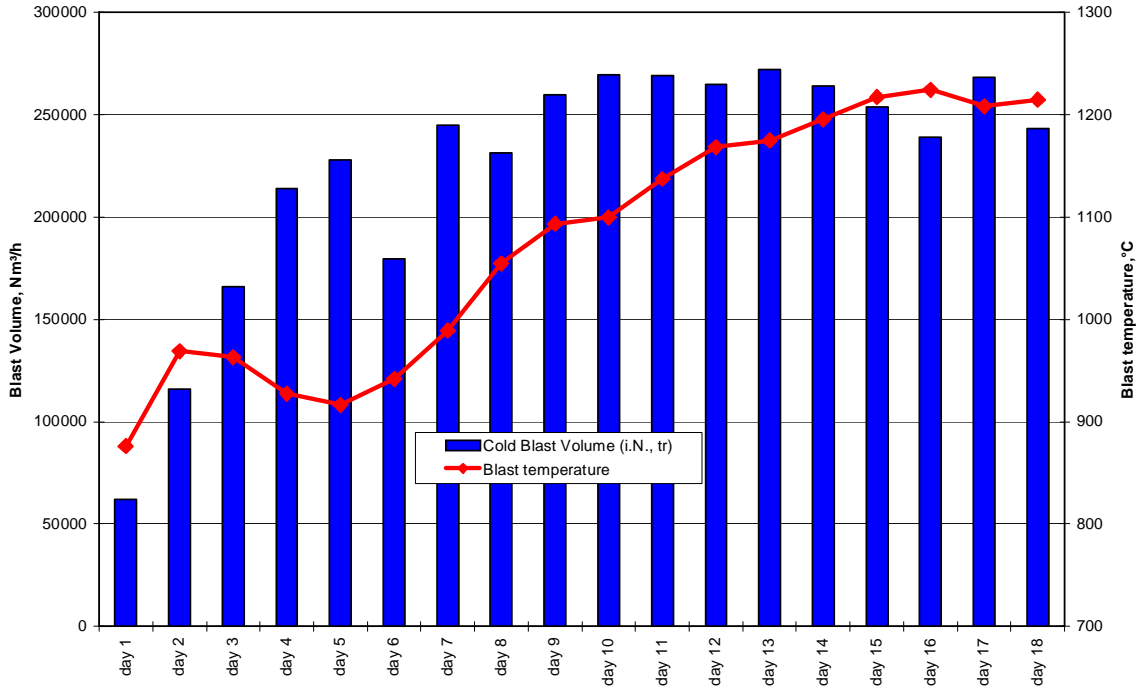
The blow-in operation proceeded without major problems and the blast volume could be raised progressively (Fig. 10). The consumption of reductants could be decreased stepwise to the scheduled value of 485 kg/t HM. Fig.11 shows the consumption of the reductants. Already after 6 days, the coal injection could be taken in operation and after 15 days a rate of 160 kg/t HM was reached.

Figure 10. Hot blast volume and hot blast temperature for the first 18 days.

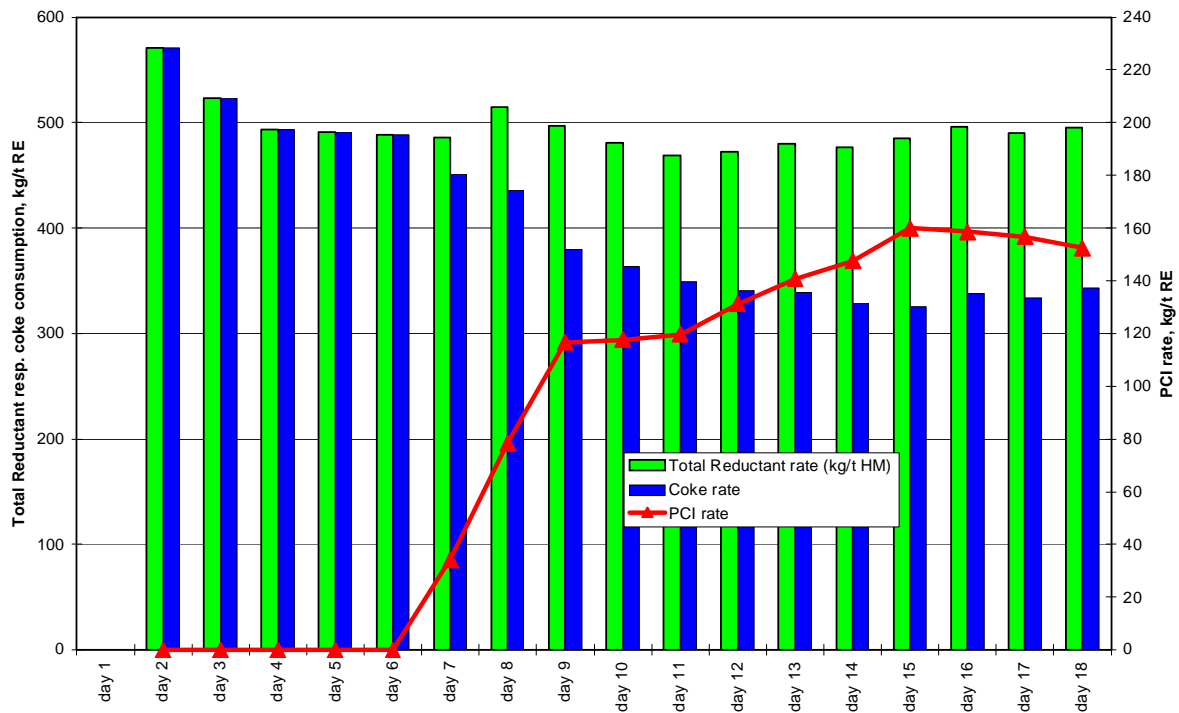
Figure 11. Consumption of reductants.

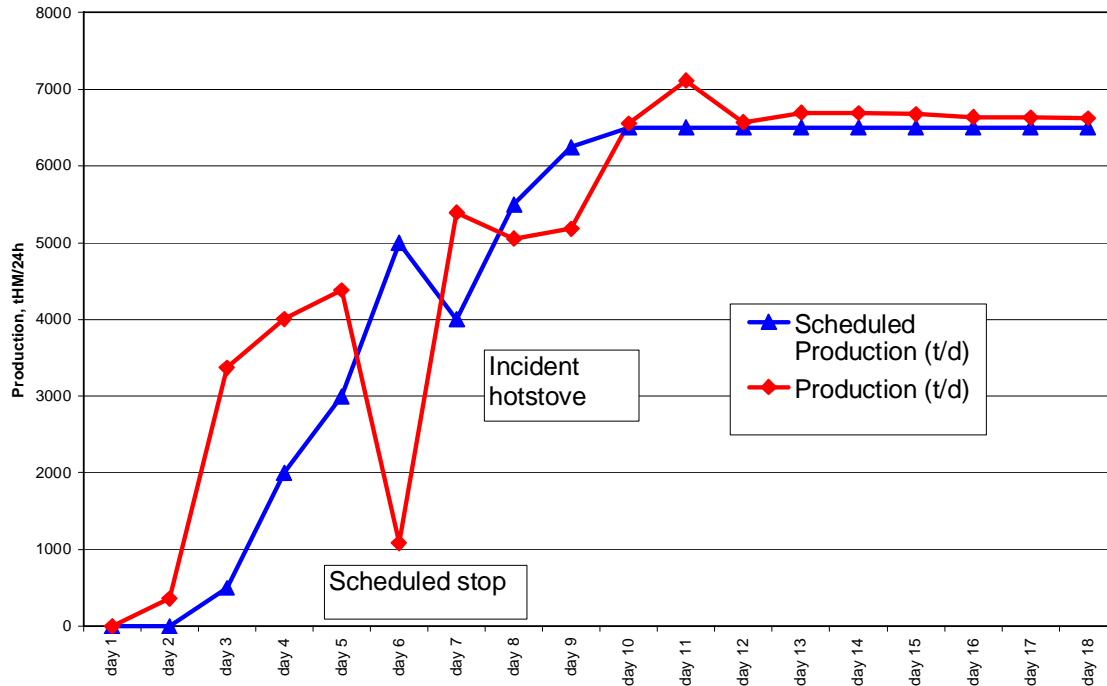
Figure 12. Shows the scheduled and effective hot metal production during the first 18 days
