# APERAM (ACESITA) BLAST FURNACE NO. 2 – DESIGN AND PERFORMANCE OF THE BLAST FURNACE COOLING AND LINING SYSTEM<sup>1</sup>

The objective is to discuss the performance of the blast furnace after a repair performed in 2005 of the Upper hearth layer, Tuyere zone, Bosh and Belly. In May 2012 the furnace reached the seven year target of the repair for the Belly of the furnace. The article will cover the following items: design of the repair; start up and ramping up the production; casting practices; way of operating, using both coke and charcoal as fuel; devices and system for measuring the lining thickness over time; the continuation of the furnace campaign, campaign lifetime, the future.

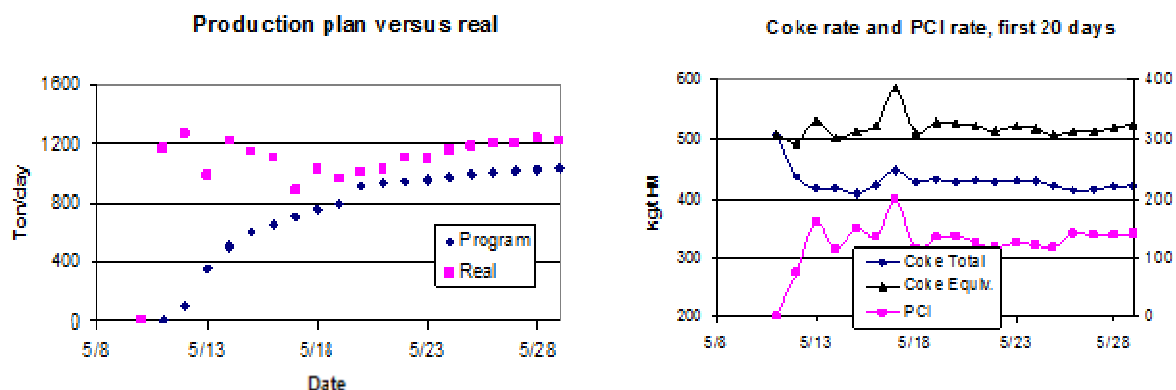
Casting was observed to be critical at 20-30 hours after the start of the blow-in with slag observed at the tuyeres. But after 4 days the furnace was considered to be in a reasonable condition so production level could start to be increased, and also the level of charcoal fines injection. This point then marked the beginning of the Optimization stage, starting on 12th May 2005.

Figure 9. Production data, actual versus plan and actual reductant rates for first 20 days after blow-in.

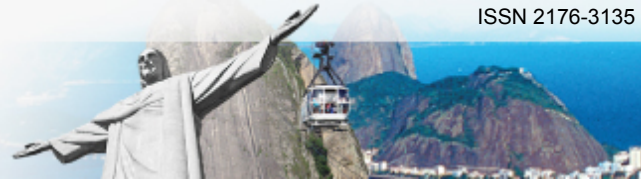
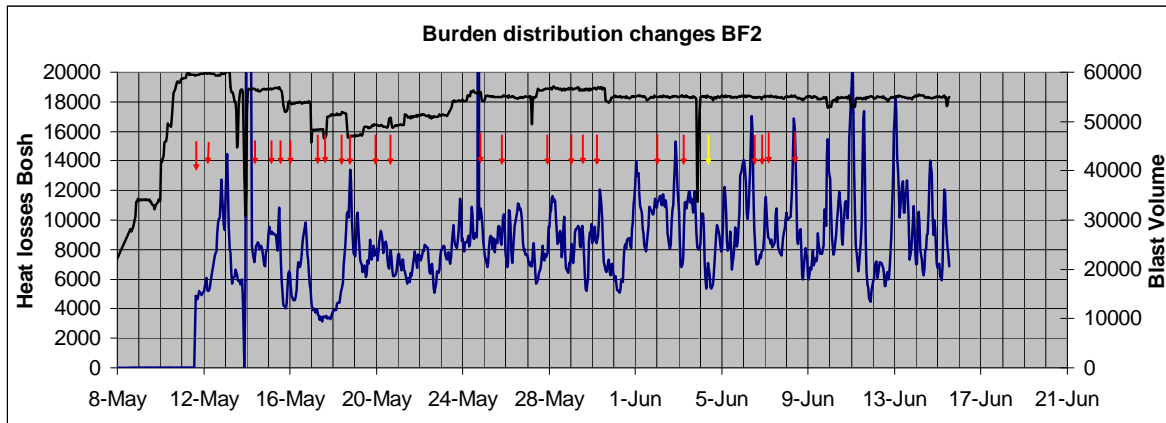
Some problems were encountered when trying to return the furnace back to normal operating levels. These problems began already on 13th May when frequent burden slips occurred, with relatively high bosh heat loads recorded prior to the slips. In between the slipping events there were also periods with relatively stable operation. To try and stabilize the process further the burden distribution was extensively reviewed. Changes were made and these would stabilize the process for a number of hours, and even a few days, but then peaks in the heat load to the bosh and belly would recur. This was of particular concern to the client, as it repeated the problems experienced in the beginning of the 2002 campaign, which eventually resulted in the premature failure of the bosh. The Danieli Corus team were not so concerned regarding the integrity of the bosh, as the design installed during the repair is proven to be sufficiently robust as to withstand the heat loads that were being subjected to it, however the phenomenon of the high, intermittent heat loads did suggest that an underlying root cause had not yet been identified.

Figure 10. Arrows indicate where burden distribution changes were made.

Once all attempts to improve the burden distribution had been exhausted (Figure 4), and no further improvements could be realized, a different approach was taken by the Danieli Corus team. The burden distribution was still monitored, as it had led to a lowering of the average heat loading, but the intermittent peaks were still to be investigated. An extensive review of the date, both after the blow-in and before suggested that the liquid drainage from the furnace may not be as good as it should be, compared to before the blow down. Further investigations, including detailed observations of the casthouse practices, revealed that although the furnace appeared dry, as indicated by witnessing a blow at the taphole, the team suspected that it was withholding liquids in the hearth. This was confirmed after trials with a short (2 min) stop practice after one cast where the taphole had been seen to be blowing. The results were that it then continued to cast only hot metal for 10 minutes and hot metal and slag for an additional 25 minutes.

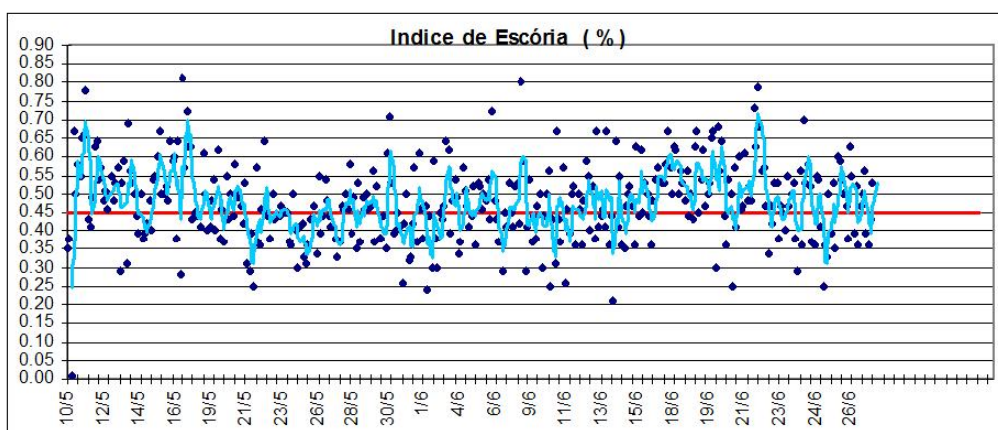
Further trials and changes were made until a combination of increasing the soaking bar diameter by 6 mm, reducing the aim taphole length by 0.2 m, reducing the gap time by 5 minutes and using the short stop practice when heat loads were high or on an increasing trend was implemented. This combination of changes improved the drainage of the furnace, as shown in the increase of the slag coverage (Figure 11).

Figure 11. Slag coverage from start of blow-in.

The heat load peaks were also eliminated, which could be used as evidence to support the working hypothesis that slag levels in the hearth had been limiting the extent of the raceway, promoting the flow of fresh raceways gasses, with some hot slag carryover (slag splashing) against the bosh. This then lead to high heat load measurements in localized regions of the bosh, with the continued flow of hot gas against the wall also increasing the heat load in localized regions of the belly. When taking into account the relatively small hearth, which was then made smaller by the rest materials that were left in after the salamander tap (only the area around the taphole was excavated), it was further postulated that the reduced available volume for the flow of fresh liquids through the hearth to the taphole will have contributed to the fluctuating, occasionally high, liquid levels in the hearth. This rest material, made up of coke and solidified iron and slag, would only be replaced with fresh deadman coke once sufficient passage of hot metal had re-melted and absorbed the coke. As it was only in contact with hot metal on once surface, it was expected that this process may take some weeks rather than days to occur.

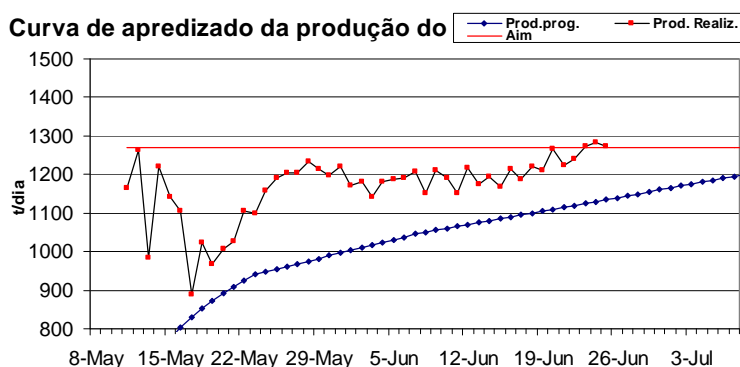
The changes made and the process stability that followed allowed the production to be increased so that the full capacity of the furnace could be demonstrated (Figure 12). The knowledge gained during the investigation process also presented a credible theory as to the mechanism behind why the original design failed so catastrophically in the first 6 months after the 2002 reline. The refractory material used in the 2002 reline has a resistance to thermal fluctuations ten times lower than that as used in the Hoogovens design. In the case where process irregularities result in high heat loading, the Hoogovens lining is sufficiently robust to allow investigations and trials to take place to remedy the situation. This cannot be said for many other linings, where process parameters, including burden distribution and production rate, must be adapted to accommodate premature damage in the bosh and belly area.

Figure 12. Hot metal output actual versus plan for first few weeks after blow-in.

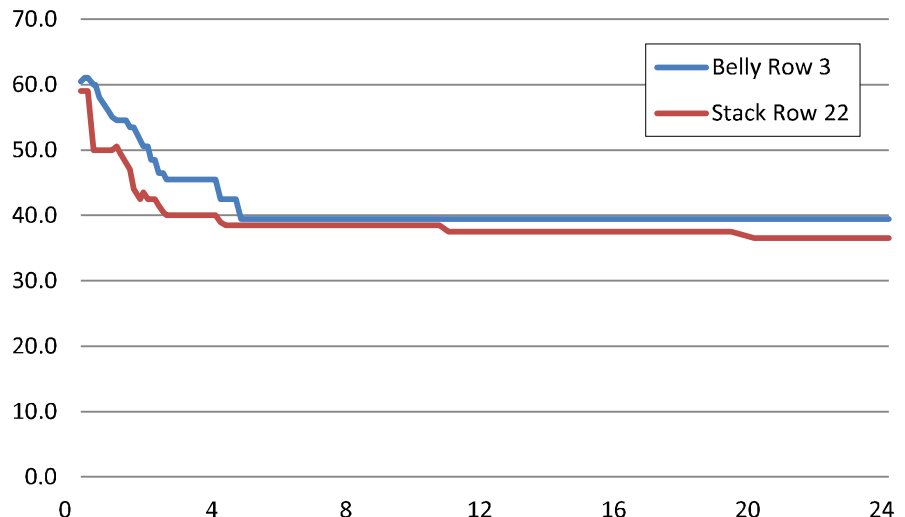
The long term potential of the design is further illustrated in Figure 14, which indicates the remaining lining thickness (in millimetres) at two positions in the furnace throughout the first 24 years of the furnace's campaign.

**Figure 14.** Lining wear at IJmuiden Blast Furnace No. 6.
