QUICK RECOVERY FROM A CHILLY HEARTH OF COSIPA #1 BLAST FURNACE ¹

Abstract

This paper describes all the operations carried out and the lessons learned in the recovery of Cosipa # 1 blast furnace from a hearth chilling occurred in October 2007 after a 52,8 hours stop. The furnace recovery strategy involved the coke rate changing at the burden column, the accomplishment of the connection between tuyeres and tapholes by lancing and the sequential tuyeres preparation and opening after programmed stops. The slag – iron separation and the two tap holes operation succeeded 4 and 6 days after the blow in respectively which helped the recovery to be controlled, safe and very fast and also allowed the furnace to going back to normal operation in 10 days only. The operation and maintenance crews did excellent jobs and Cosipa and Danieli Corus teams worked in a constructive atmosphere sharing all the information, decisions and actions in one of the quickest recoveries worldwide.

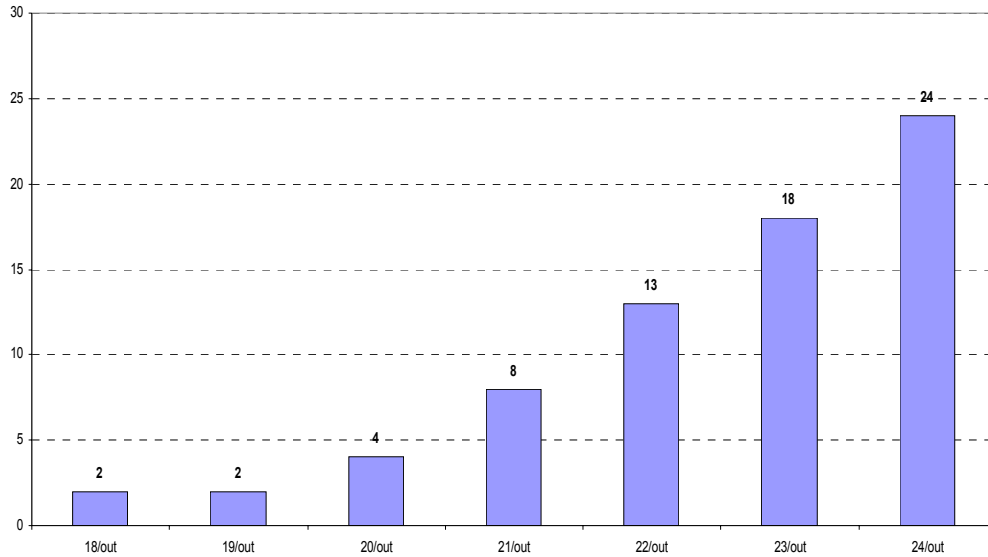
Figure 10 – Number of tuyeres opened

From these Figures 10 and 11 one also can see that were made 5 stops to open all 24 tuyeres and to adjust the hot blast volume to the normal level of 2400 Nm³/ min. The next figure 12 gives an interesting idea of the tuyeres openings along the time and how it occurred around the tap holes.

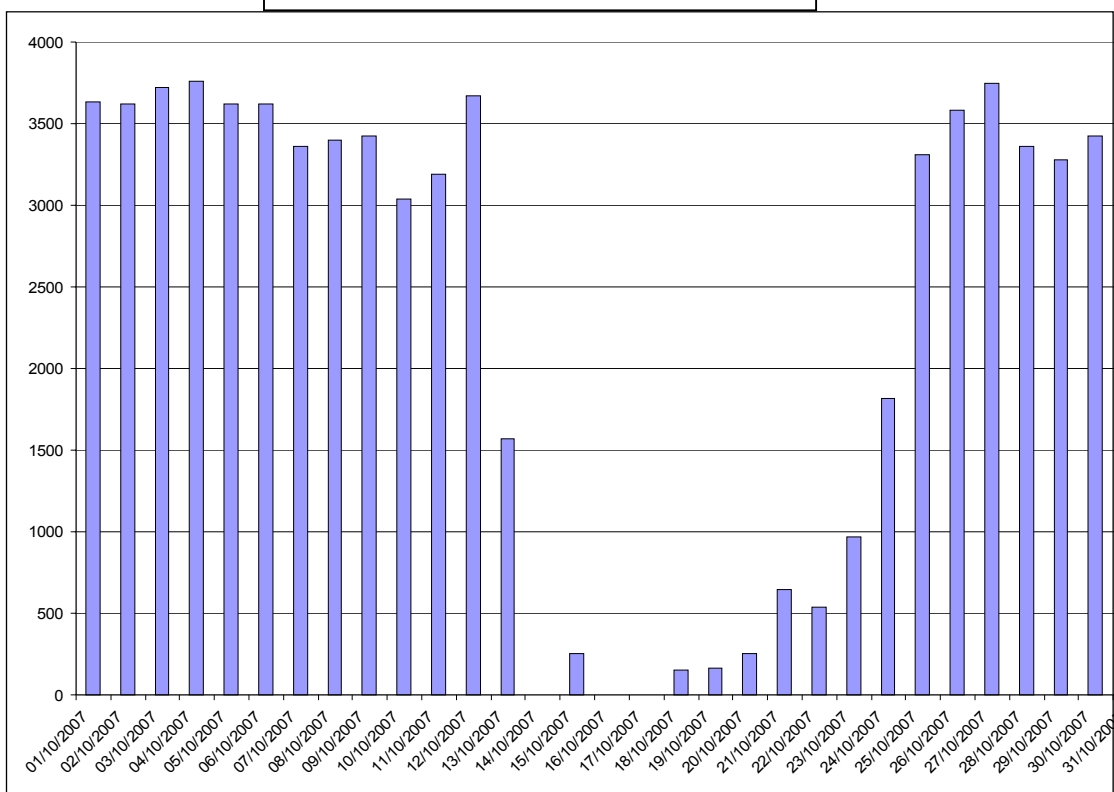
Figure 13 - Hot Metal Production

At the Figure 13 is showed the behavior of the hot metal production during the recovery reaching the previous level of 3500 t/day at end of it.

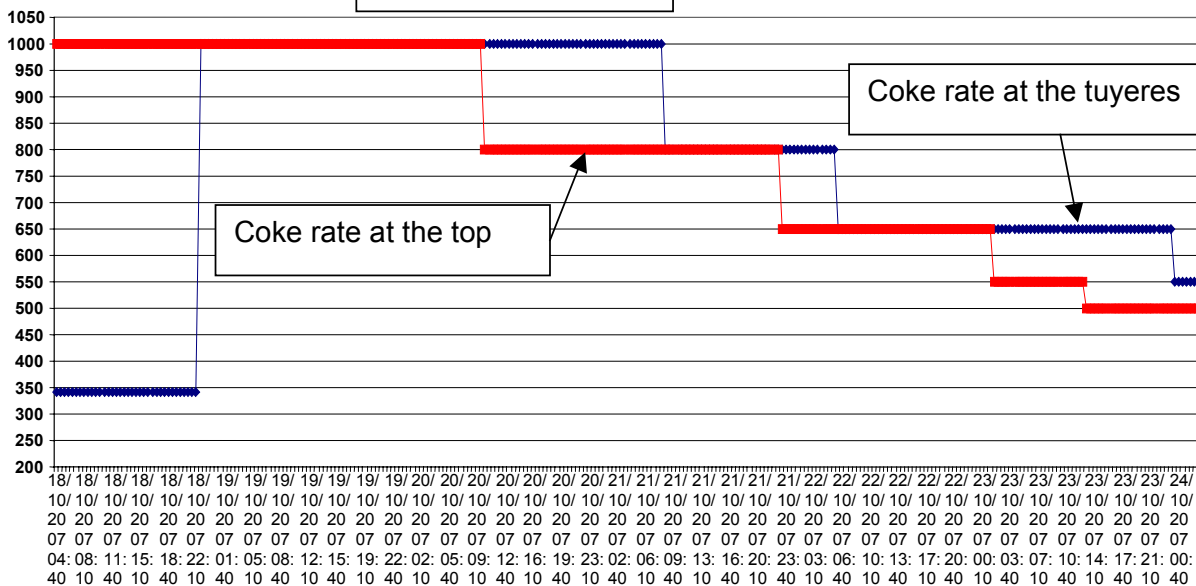
Figure 14 - Coke rate decreasing

One of the highlights of this recovery was the coke rate decreasing during this process that was made very quickly observing more the behavior of the silicon content in the pig iron than the hot metal temperature as a guide of the furnace thermal level (Figures 14,15 and 16).

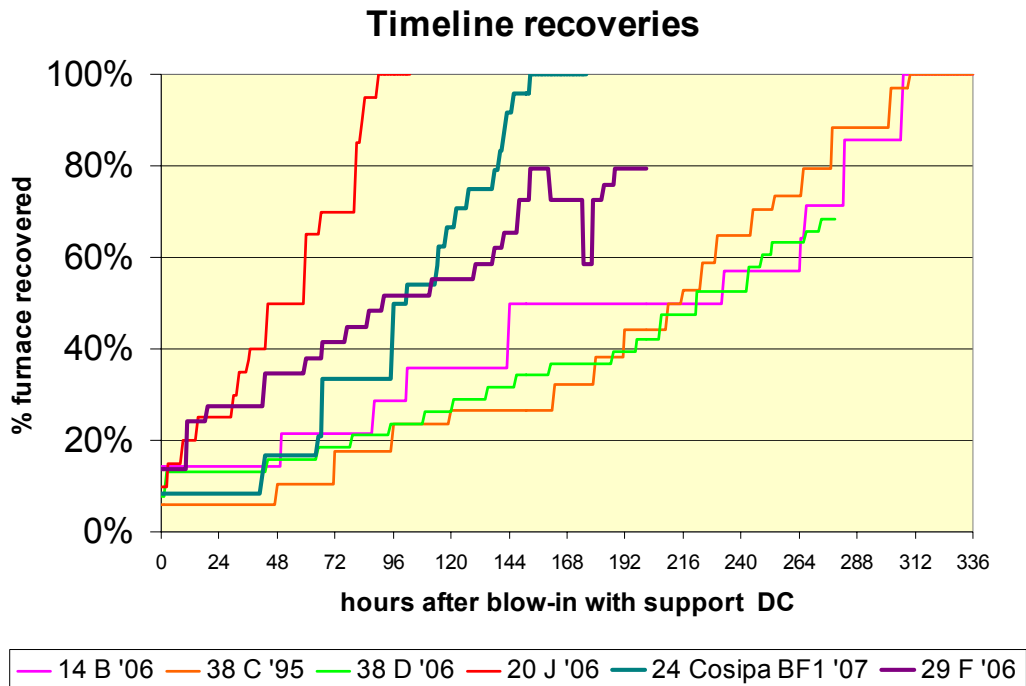
The Figure 17 present several recoveries according with the DC experience and support showing this recovery as one of quickest worldwide and the quickest with PCI.
