## REDUCING THE WARPING EFFECT OF HOT ROLLED SAE15B29 FLAT BARS\*

Boron steel is used in the industry due to its great wear and impact resistance. During the hot rolling production of 15B29 steel flat bars it is a recurrent problem that the bars will present warping while on the cooling bed. Control this phenomenon is an opportunity to have better productivity, preventing metallic losses. Through the observation of the macro and microstructure samples produced with different reheating temperatures and cooling rates, it was found the presence of residual stresses and cracks on warped bars macrostructure. The residual stresses appearance suggest that the material cooling is too fast. Billets temperature on the reheating furnace of 1230°C reduced to 1100°C and the production pace slowed down. Bars temperature when arriving the cooling bed was reduced from higher than 670°C to 625°C. The results obtained made it possible to produce the material with better quality, reducing the warping effect at the cooling bed. The major influence on the materials warping was identified as the cooling rate at the cooling bed and the reheating furnace temperature was adjusted to provide a homogeneous

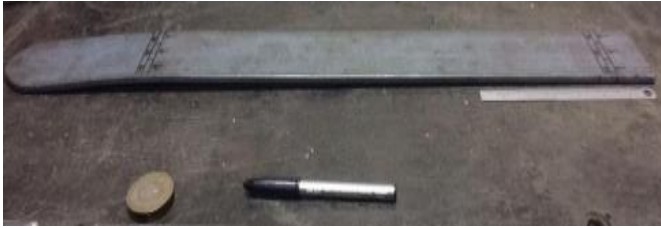
Figure 2 – Sample piece of a flat bar.

To realize the material microstructural analysis samples were taken from SAE 15B29 flat steel bars (60 mm x 8 mm section). The samples for the microstructure evaluation were taken from the same bar, taking pieces from the warped and straight parts of the bars after passing through the cooling bed as seen in the Figure 2.

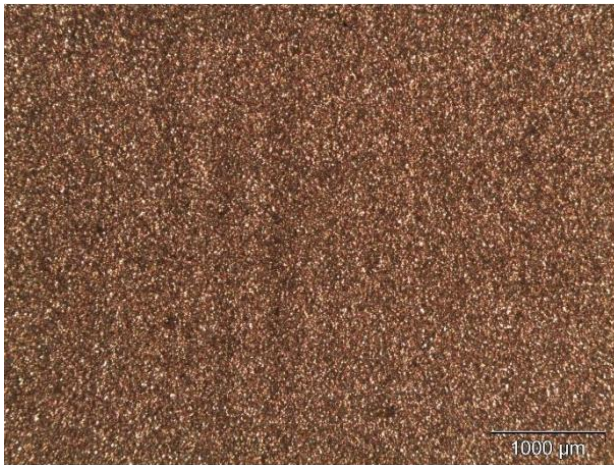
Figure 9 Etched straight sample. 2,5x zoom.

in a microscope to compare the warped and non-warped part Oliveira [2]. The Figure 9 and the Figure 10 shows the etched straight sample in two zoom rates.
