# OVERVIEW OF HOT BLAST STOVES AFFECTED BY STRESS CORROSION CRACKING <sup>1</sup>

*Friedrich Eschmann<sup>2</sup>  
José Carlos Diniz<sup>3</sup>  
Werner Saffran Rabelo<sup>4</sup>*

<sup>1</sup> *Technical contribution to 62nd ABM - International Annual Congress, July 23<sup>rd</sup> to 27<sup>th</sup>, 2007, Vitória - ES - Brazil*

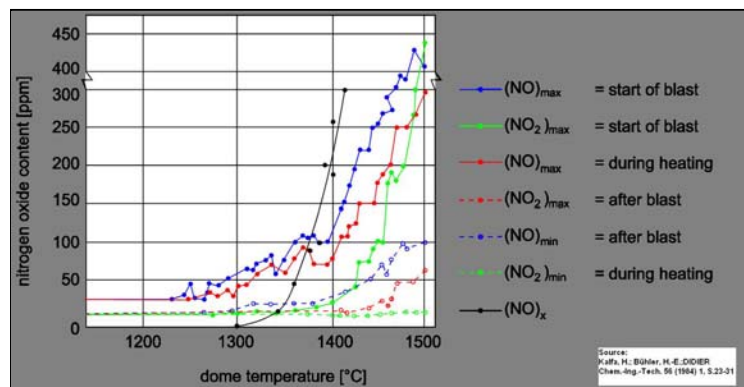
**Figure 3:** Influence of Dome Temperature on Concentration of Nitrogen Oxide

Through investigations by operators, plant designers, universities and other institutions led to the understanding that the background of the problem is a combination of corrosive agents – arising from NO<sub>x</sub> production at high temperatures and from BF gas contents – condensing on the stove shell, sensitive shell material and stress. Figure 3 shows measurement results out of this time, further details may be taken from literature. From this understanding, preventing methods against Stress Corrosion Cracking for new stoves could be delivered.

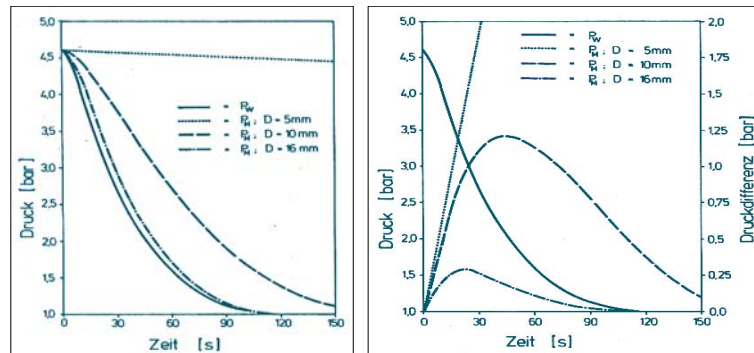
**Figure 13:** Chronological Pressure Relief in the twin shell interspace and Progression of Pressure Differential between stove and twin shell gap in relationship to the relief pipe diameter

Figure 13 shows as an example the absolute pressure and the pressure differential working on the shell, depending on the design of the gap and the piping. It is quite obvious that too small piping would lead to an overpressure in the gap, exposing the old shell to outside pressure. Paul Wurth knows about a plant with double shell and no pressure relief, where the original size of the gap largely increased in some areas, indicating a buckling of the old shell.

By connecting the relief system to the cold blast entrance of the stove it is ensured that during the blast cycle the pressure in the gap between the shells is always slightly higher than inside the old shell, i.e. no gas contaminated with NO<sub>x</sub> will enter the gap.
