STAVE REPLACEMENT PROJECT – TERNIUM BF 2¹

Abstract

Following some premature damage to staves on the blast furnace number 2 at Ternium Siderar San Nicolás works an investigation of the cause of the problem was carried out. This analysis included for discussions with a number of blast furnace operators around the world. Ternium operational experience in dealing with worn staves proved to be valuable in terms of follow up, damage correction and prevention of damage experienced. This experience was also important in designing the new staves. These concepts are discussed in the paper. The output of the analysis was a decision to replace all rows of copper staves on the Ternium blast furnace. The replacement project was scheduled to be carried out in 2012 during a stoppage of the blast furnace. This paper will review the issues with the original stave performance related to the operation of the blast furnace and the design of the new staves. The paper will also describe the shutdown associated with the stave repair and techniques used to remove and replace the staves. When presented, the paper will discuss the latest performance of the staves on the blast furnace.

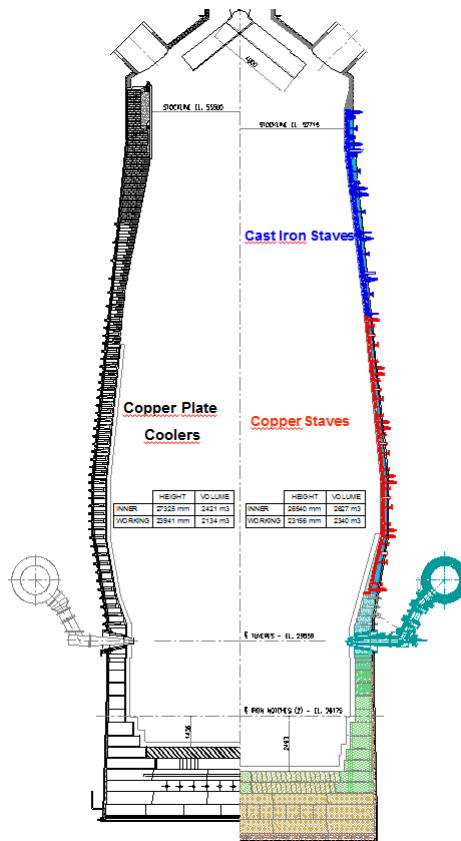
Figure 1.

Table 1 and Figure 1 show the comparison of the BF 2 dimensions and cross-section in the third and fourth campaigns.
