## FAILURE ANALYSIS OF ROTARY KILN'S TERTIARY AIR DUCTS \*

Rotary kilns are continuous process equipment used on calcining of nickel ore. The chemical and physical reactions are created by means of heat up the material to predetermined temperatures. Tertiary air fans are attached to the kiln shell to maintain oxidizing/reduction conditions. Special ducts orientate the air flow inside the kiln. In the present work, two types of failure on distinct tertiary ducts mounted on the same kiln are reported. Chemical analysis, hardness test, metallographic and fractographic examinations were carried out. Fabrication related problems and creep were identified as the root causes of damages.

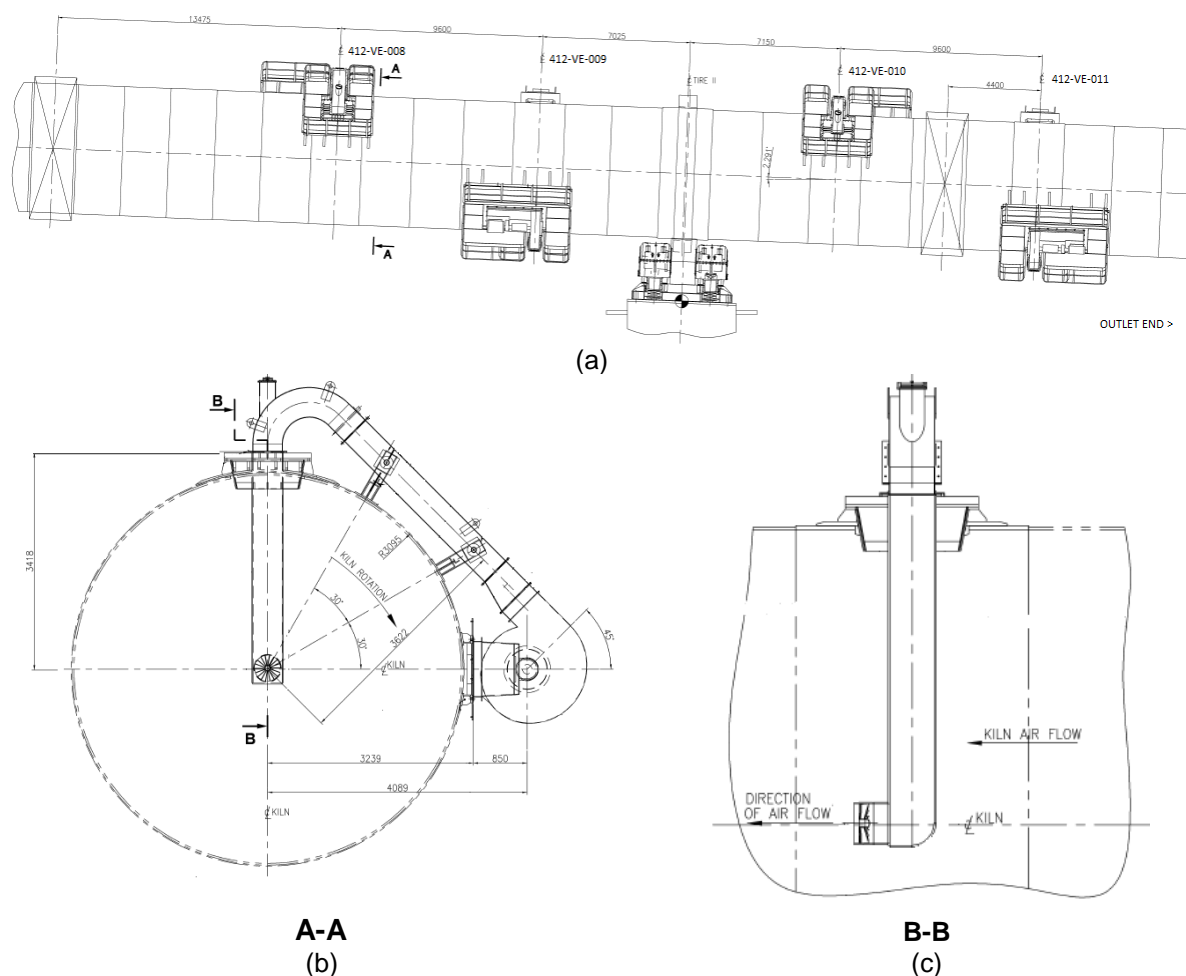
Anglo American Barro Alto nickel plant has two RK with following dimensions 6.1 m x 7.0 m diameter x 185 m long. Each one has a series of four tertiary air fans located on the kiln shell. Figure 1 shows the portion of the RK #2 (412-FC-002) with the location of the tertiary air fans (412-VE-008, 009, 010 and 011). The air flow is introduced and oriented into the RK by means of pipes termed "tertiary air ducts" (Figures 1.b and 1.c).

**Figure 1.** (a) Tertiary air fans along the RK #2 shell; (b) section A-A; (c) section (B-B). After [2].

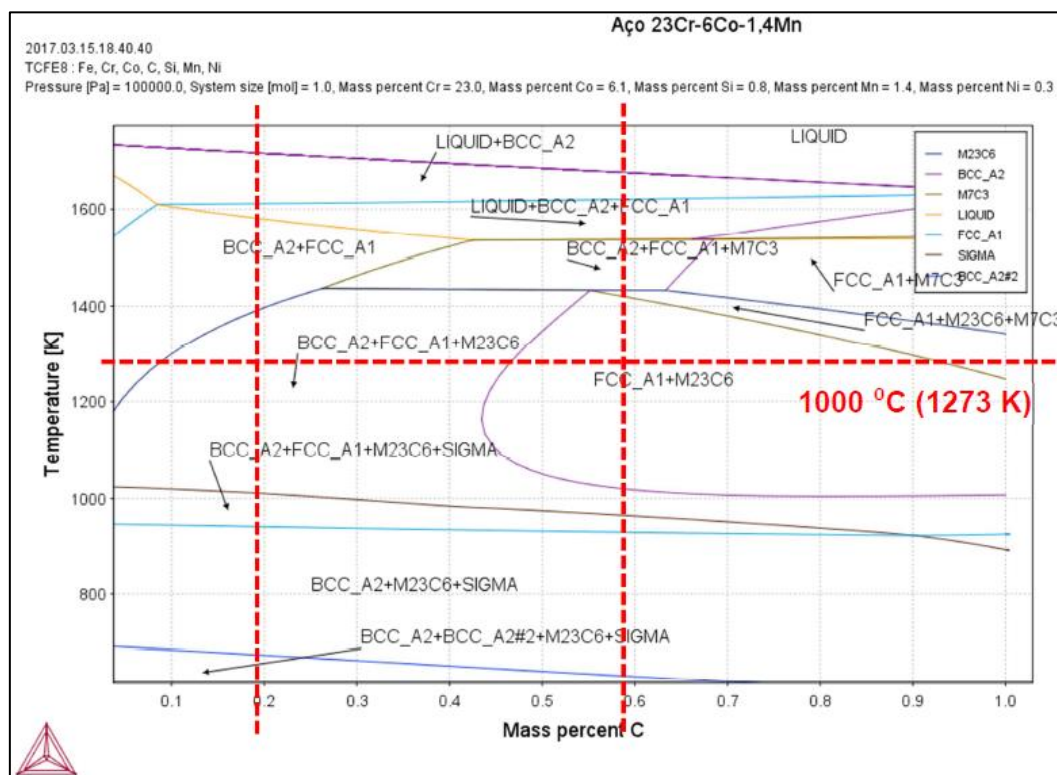
Figure 11 presents the equilibrium pseudo-binary phase diagram obtained by Thermo-calc software. The ducts were submitted to temperatures of almost 1000 °C.

At equilibrium, and the temperature maintained at 1000 °C, the alloy with 0.57 %C (fractured duct) presents austenite (FCC\_A1) and the  $M_{23}C_6$  secondary carbide phases. It can be note that in the solidification sequence of this alloy a ternary eutectic

reaction is expected with the formation of the  $M_7C_3$  carbide and this carbide undergoes decomposition for  $M_{23}C_6$ . The carbides observed in interdendritic regions (Figures 7) are probably the carbides  $M_{23}C_6$ .

**Figure 11.** Pseudo-binary equilibrium diagram of a steel containing 23 % Cr, 6 % cobalt and 1.4 % manganese as a function of carbon content.
