## PERFORMANCE ANALYSIS OF GALVALUME STEEL SHEETS FOR METALIC ROOF TILES\*

### **Abstract**

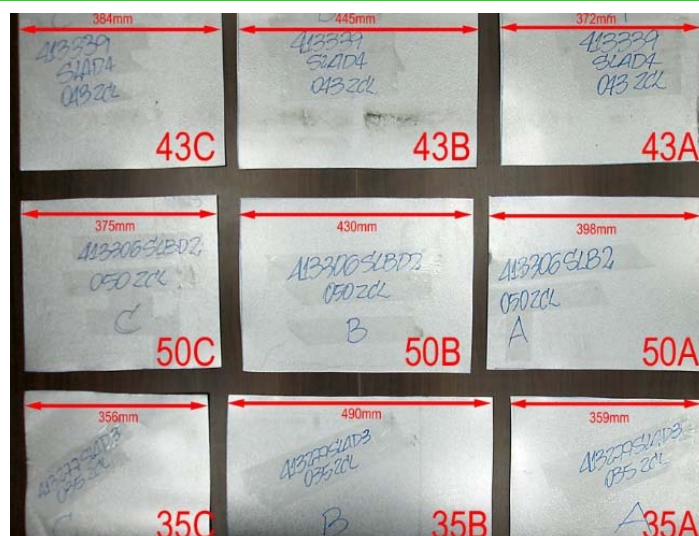
**Figure 2.** The used samples of galvalume/aluzinc steel coils (1200mm nominal wide). The numbers shown the width of the samples and the identification code that was adopted here.

It was sampled three coils, each one obtained by its width ( $w=1200\text{mm}$ ) from a different nominal thickness coil:  $t=0.35$ ;  $0.43$  and  $0.50\text{mm}$ . These samples were identified as following: "413306 SLB02 0502CL"; "413339 SLAD4 0432CL" and "413277 SLAD3 0352CL" for  $0.50$ ;  $0.43$  and  $0.35\text{mm}$  nominal thickness, respectively. From each coil were cut three different samples labeled "A"; "B" and "C" which have from  $359$  to  $490\text{mm}$  width. Thus, a grand total of  $9$  (nine) pieces (samples) were delivered by representative supplier to be analyzed according to showed by Figure 1. Each received sample was identified as  $99X$ , where  $99$  is the nominal thickness, in centesimal millimeters, and  $X$  is the respective position along the width: A (near where the problem occurred), B (center) and C (other mill's edge). Figure 2 shows the visual aspect of all samples. Moreover, for the sample  $99A$  it was employed another classification:  $99A.N$  for normal region and  $99A.A$  for 'abnormal' region, in which occurs the problem reported by a metallic roof manufacturer.

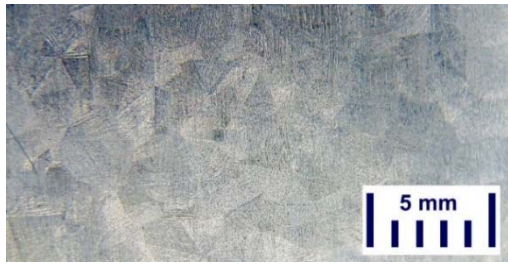
Normal (10X)

**Figure 4.** Normal (N) and abnormal (A) surfaces on sample 43A as seen by light microscopy.

It can be noted by the photos taken by stereo microscope (Figure 4) that the bright region is formed by a coarse deformation pattern on aluminum-zinc-silicon alloy (galvalume/aluzinc layer), which is more easily seen at magnifications of 200X. Whereas the galvalume/aluzinc layer is homogeneous, it seems that the steel substrate deforms more intensely in the 'abnormal' region (A.A) than in the other

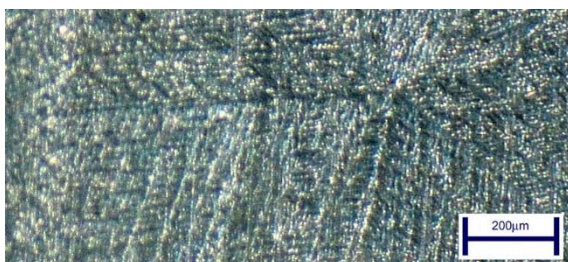
Normal (200X)

(A.N). This difference deformation of the steel substrate can generate the coarse-like deformation structure of the aluminum-zinc-silicon alloy crystals as viewed on surface (Figure 4 at 200X).

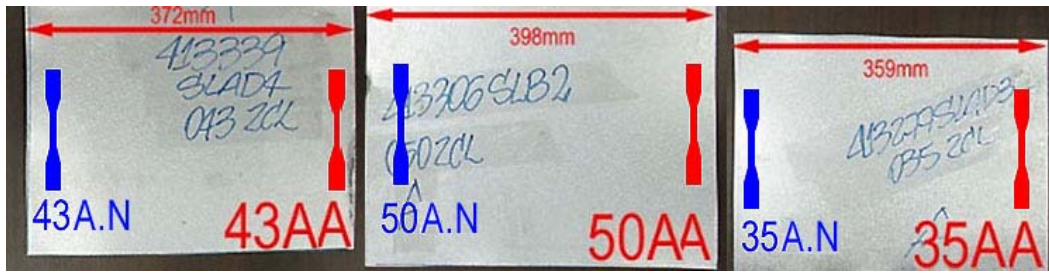
**Figure 6.** Tensile test specimen sampling: left side (blue or XXA.N) – normal; right side (red or XXA.A) – abnormal.

Figure 8 summarizes the results obtained with samples from normal and abnormal regions and the graph of Figure 9 shows a comparison between the mechanical behaviors of these two regions. As can be noted by Figure 6, this variation of mechanical behavior occurs in very near regions of the sheets. The separation of each normal-abnormal sample is only about 350mm.

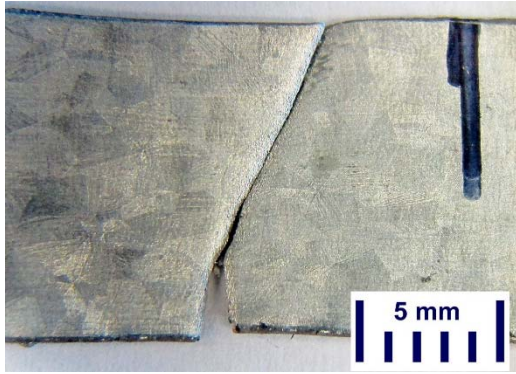
Sample 43A.N (Normal - 10X)

The surfaces of the tensile test specimens showed a remarkable difference in terms of the galvalume/aluzinc layer aspect. While normal samples behaved as expected, with steel and layer deforming together, samples obtained in the abnormal regions do not. A 'fish scale' feature was observed at galvalume/aluzinc layer near fracture on each tensile specimen from abnormal region. Figure 9 illustrates this difference pointed out by stereo microscopy surface photos.

**Figure 9.** Tensile test samples surfaces as viewed near fracture with increased magnifications by stereo microscopy.

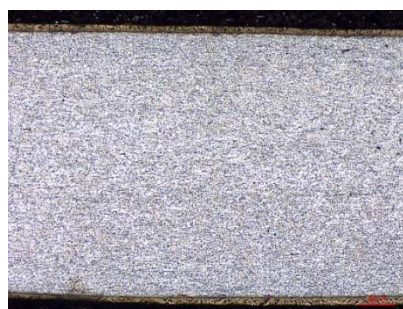
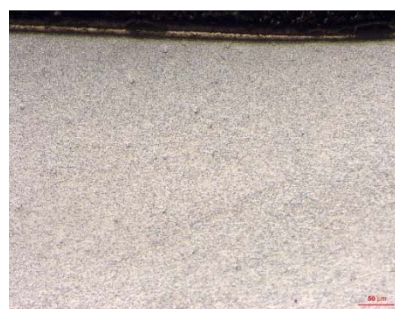
**Figure 12.** Comparison of normal and abnormal samples through low magnification.

A direct comparison of the micrographs of normal and abnormal regions (Figure 12 x Figure 13) does not show major differences between them. Only a slight difference on the amount of fine carbides can be noted in the normal samples.

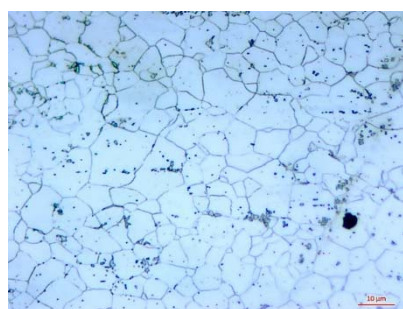
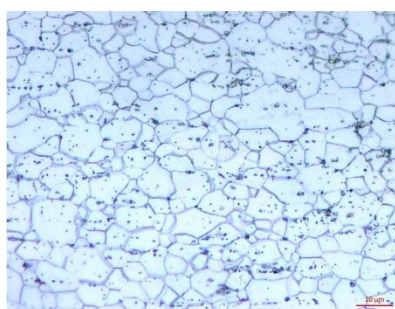
**Figure 13.** Micrographs of normal sample 50A.N (2% Nital Etch). The average grain size ( $d$ ) are indicated.

Thickness of galvalume/aluzinc layer was homogeneously constant in all samples around  $20\mu\text{m}$  in all samples. The measured grain size (according to the ASTM E112) varied between #10 ( $\approx 12\mu\text{m}$ ) to #12 ( $\approx 5\mu\text{m}$ ). The average grain size presents slight variations through thickness and a stronger dependence on sample thickness as it can be seen in Figure 12 and 13.

50A.N - Center (1000X) /  $d \approx 5,1 \mu\text{m}$

50A.N - Near surface (1000X) /  $d \approx 6,1 \mu\text{m}$

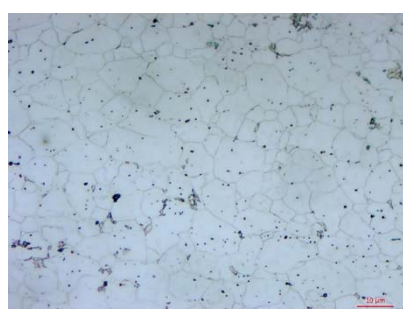
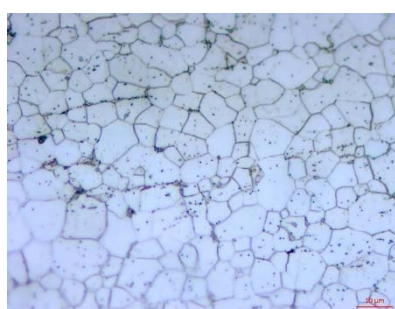
**Figure 14.** Micrographs of abnormal sample 50A.A (2% Nital Etch). The average grain size ( $d$ ) are indicated.

50A.A - Center (1000X) /  $d \approx 6,8 \mu\text{m}$

50A.A - Near surface (1000X) /  $d \approx 5,6 \mu\text{m}$
