CHARACTERIZATION OF INTEGRITY OF MACHINED PARTS¹

Abstract

This work presents a study of the condition of machined surfaces in the milling of hardened steel with high-speed steel (HSS) mills without and with coating. Tests were carried out in dry and with minimal quantity of lubricant (MQL) conditions.

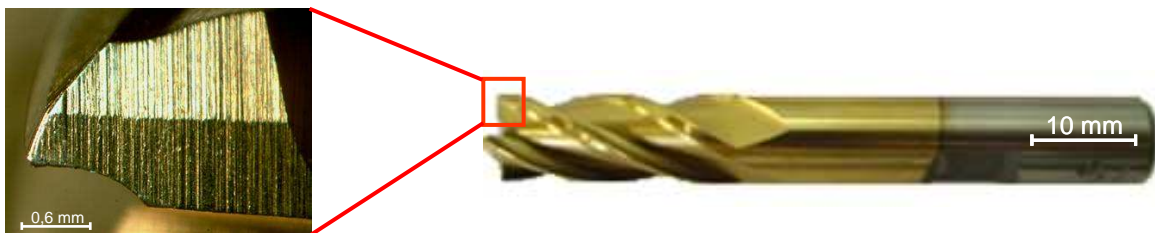
The tools applied in tests were DIN 844 high-speed steel mills, uncoated and coated with titanium nitride (TiN), with diameter of 6 mm and four cutting edges. Figure 1 shows the tool and the detail of secondary cutting edge.

Figure 1. Tool DIN 844 used in the tests.
